# Boeing Composite Airframe Damage Tolerance and Service Experience

Allen J. Fawcett (ATF/DER) and Gary D. Oakes (ATF)  
Boeing Commercial Airplanes  
787 Program

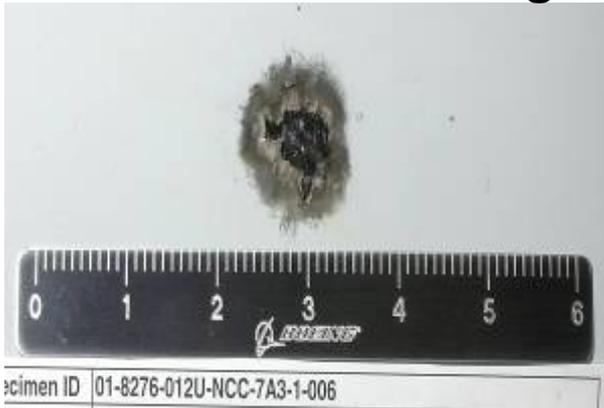
**787 composite panel; nominal strike causes superficial damage only. This damage would be expected to be within ADL and the airplane would be dispatched with deferred structural repair**

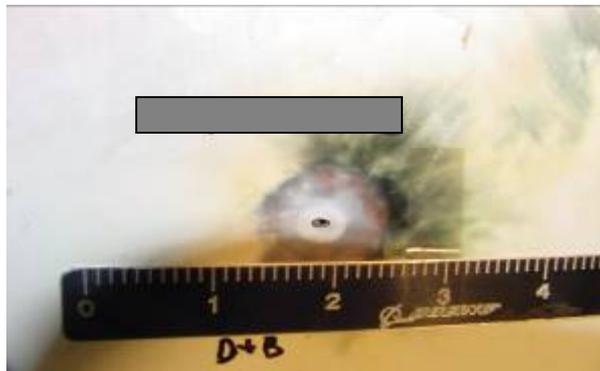
**Aluminum panel; nominal strike punctures through a similar gage aluminum panel. Immediate structural repair required to dispatch the airplane. Operational schedule impacted**

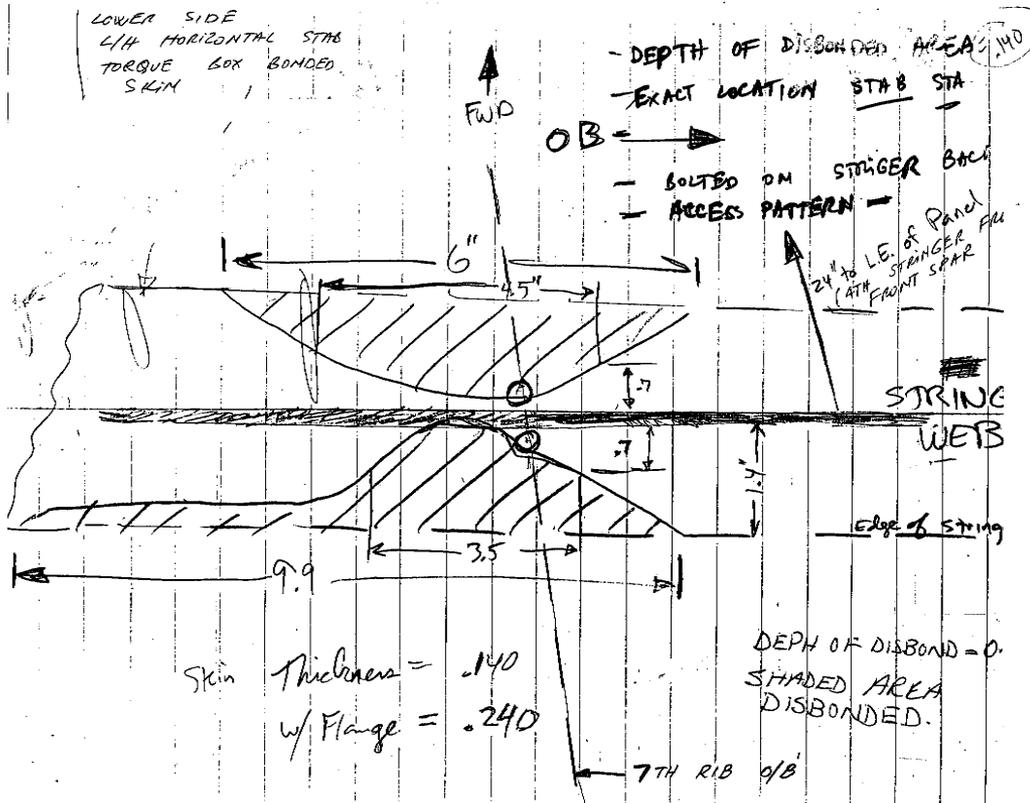
## Empennage Stringer Disbond - Engine Thrown Debris

**AOG Damage Description**

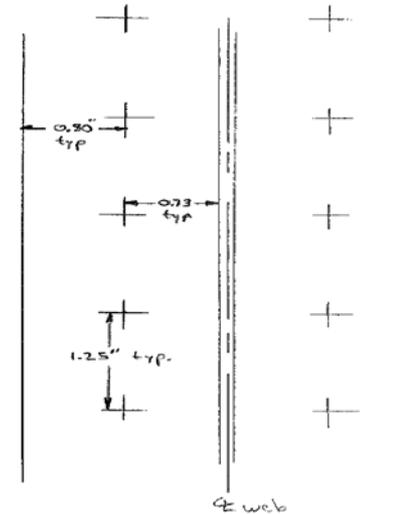
## Straight-forward, effective repair

1/4" dia. fasteners  
Extend fastener pattern 4" (approx. 3 fast.) beyond any disbonded area

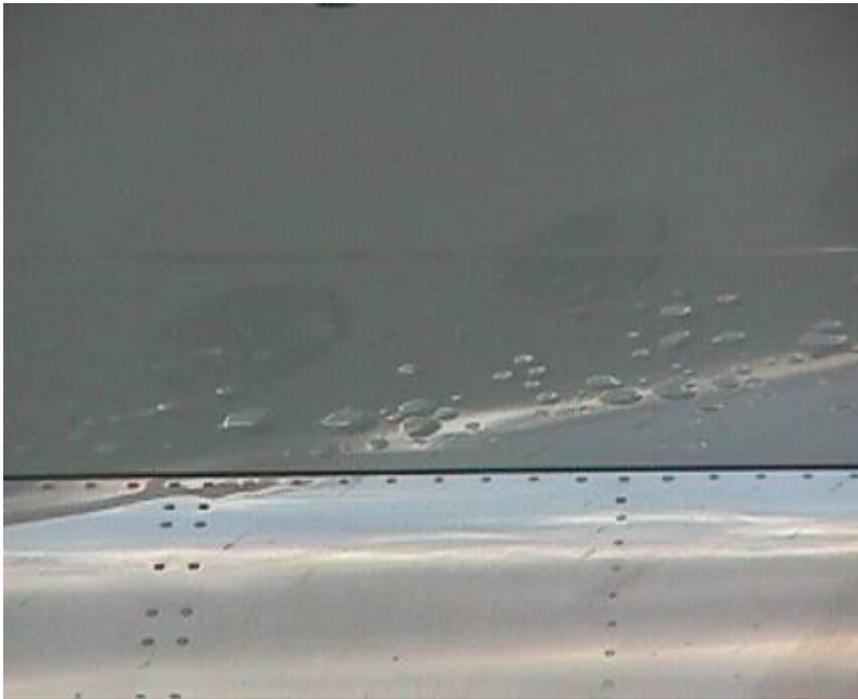
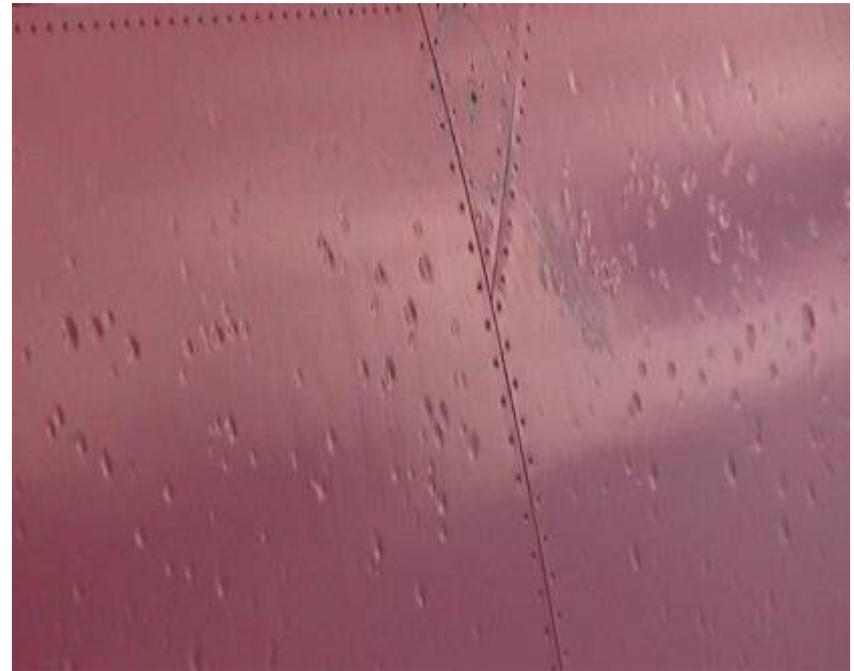
2.5" to 3.0" hail dented the fixed 5 ply honeycomb structure shown here but did no damage to the CFRP main torque box

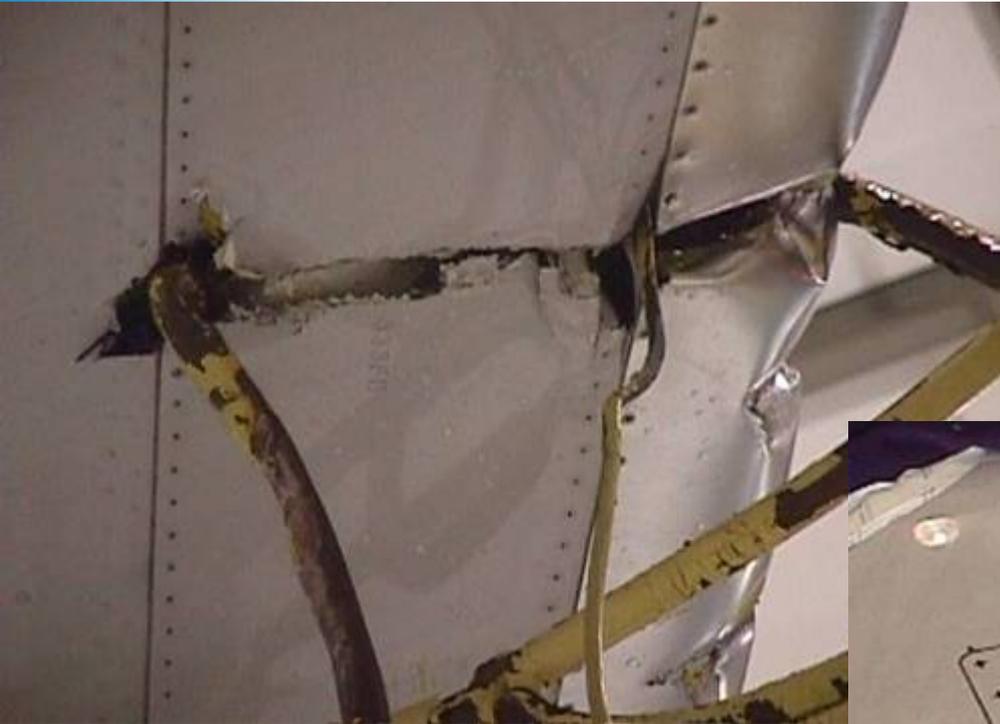
**Skin/Spar Damage—Ground Handling Equipment Impact**
