# Safe Composite Repairs – Substantiation Linking Repair Test Data to Observed Fleet Performance

FAA Workshop for Composite Damage Tolerance and Maintenance  
Chicago, IL July 19-22, 2006

**John M. Welch**

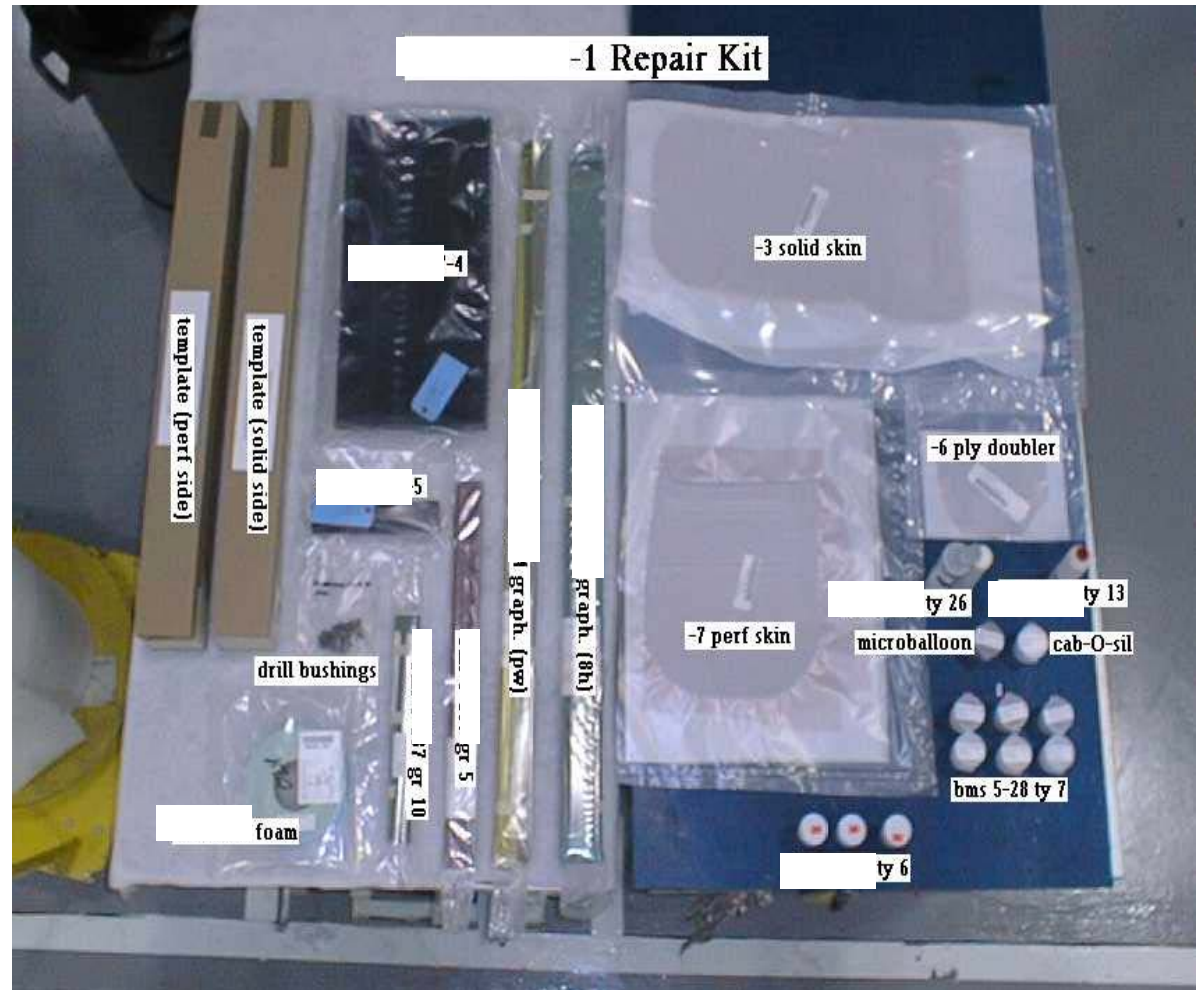
## Thrust Reverser Inner Wall Damage from Start Bleed Duct

- Bleed Valve Failure Repair Kit.
  - All necessary components to perform repair
  - Accompanied by detail repair instructions
  - Maintenance center estimated 30-45 days for effort.
- Accomplished repair on 3 units - took 5, 4, and 3 days respectively.
- Provided 8110, carrier provided 8130.

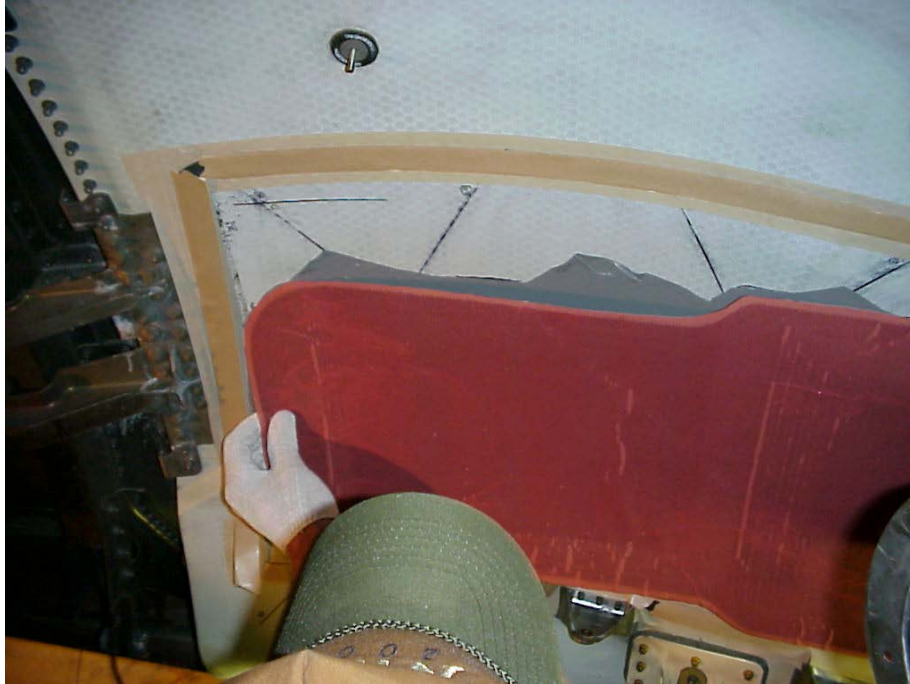
Consolidated Repair Patch being placed

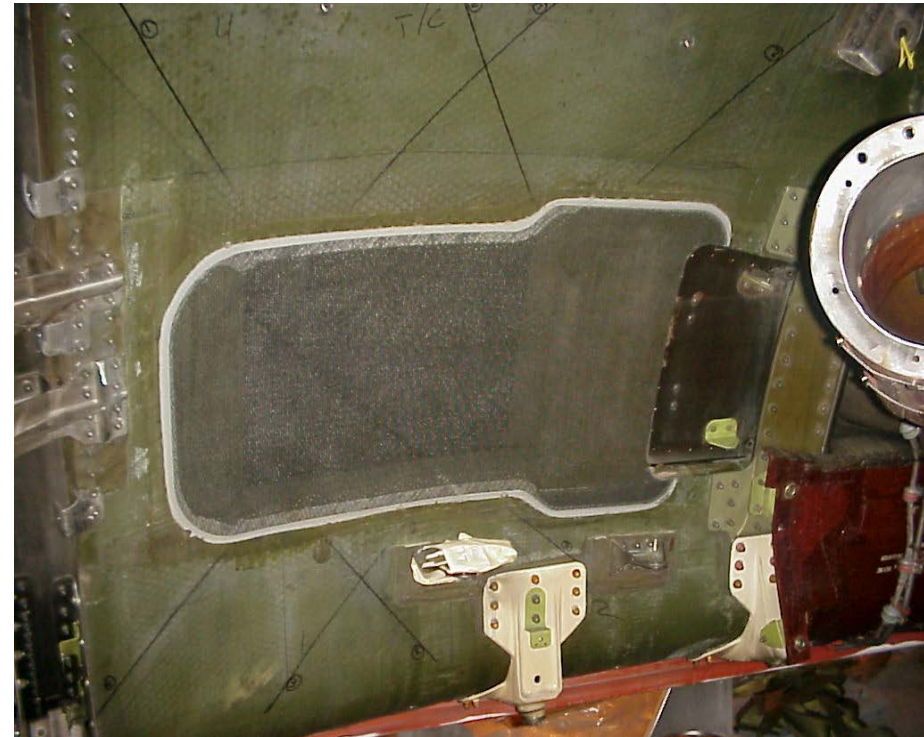
Cured Repair Patch

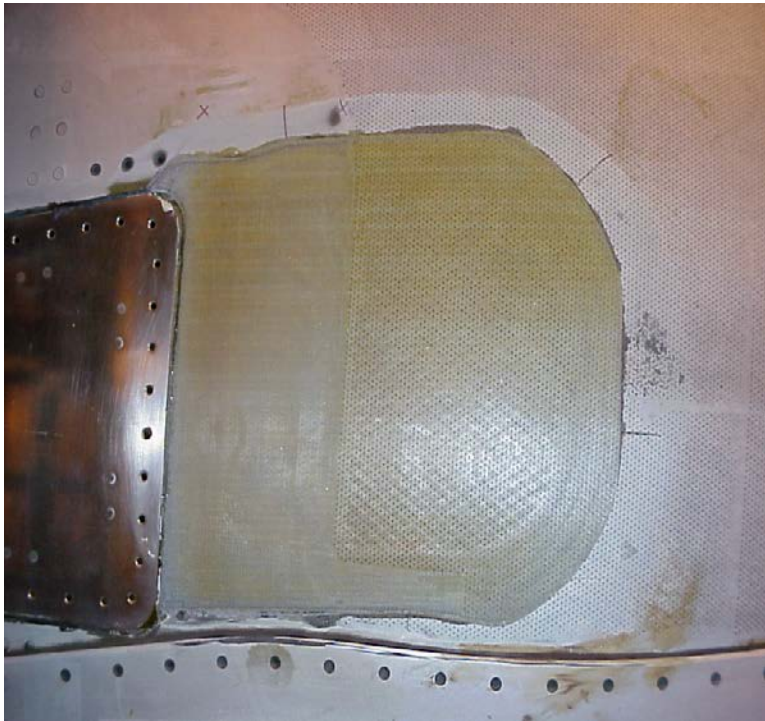
← Restored Perforations

Final Painted Repair

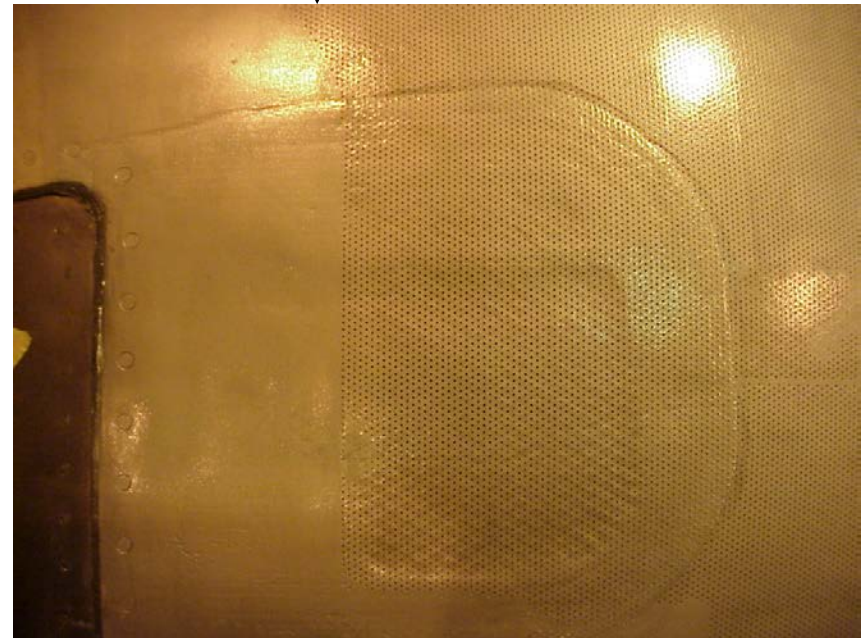
3 Units  
Repair Area = 7 sq ft  
Exceeding 8000 cycles, 50000 hours (oldest)  
First performed circa 1997  
Was thought to be largest we would ever see

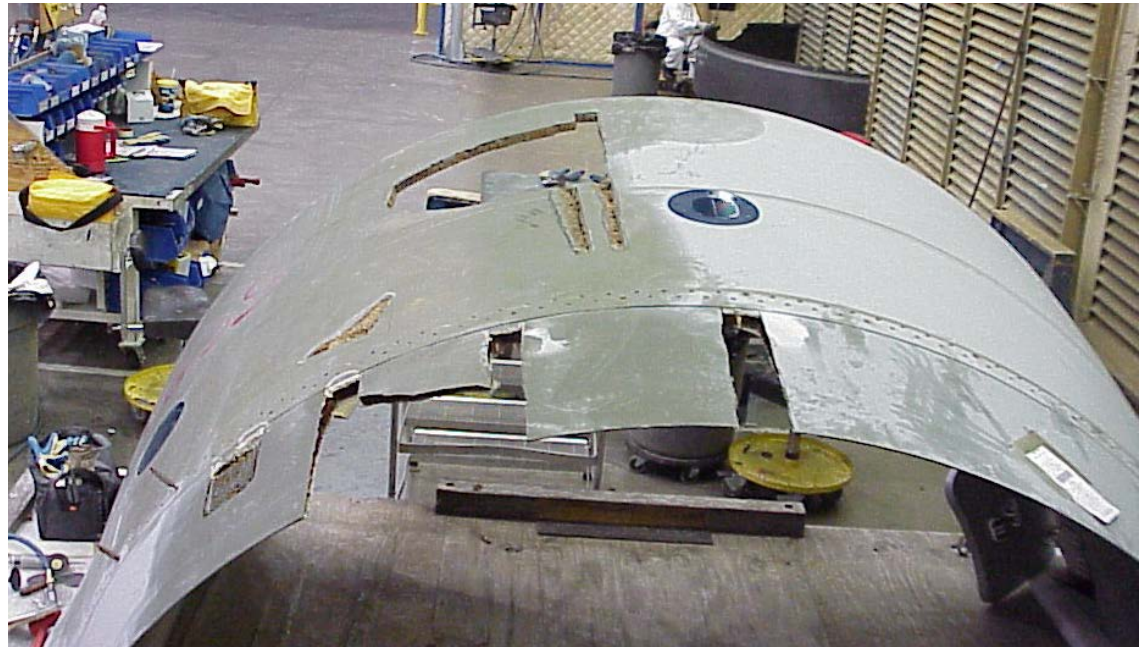
## Large Area Trans-Sleeve Repair

- **Trans-Sleeve Repair Kit, for foreign carrier**
- **All necessary components to perform repair**
- **Accompanied by detail repair instructions**
- **Hardware had been out of commission for over 1 year.**
- **Accomplished repair on 1 unit – took 10 days.**
- **Provided 8110, carrier provided 8130.**

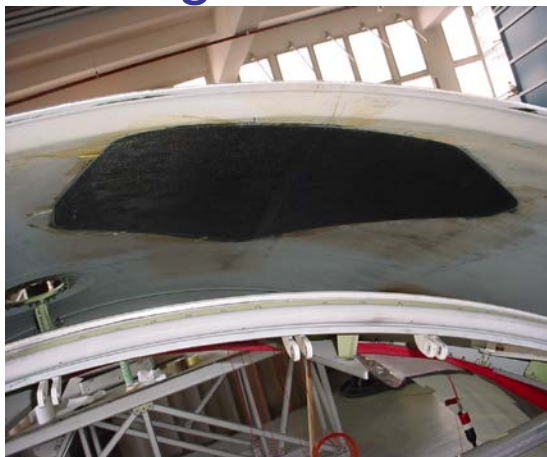
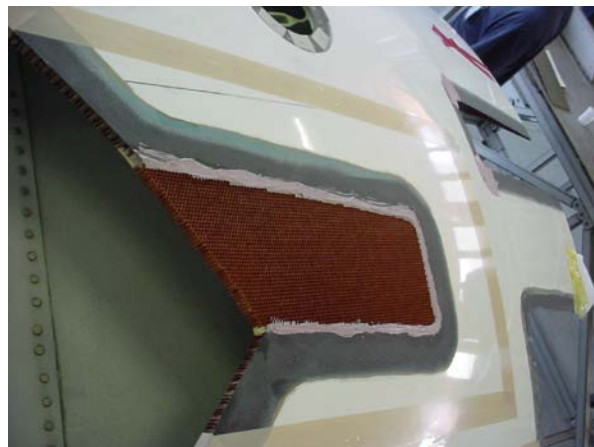
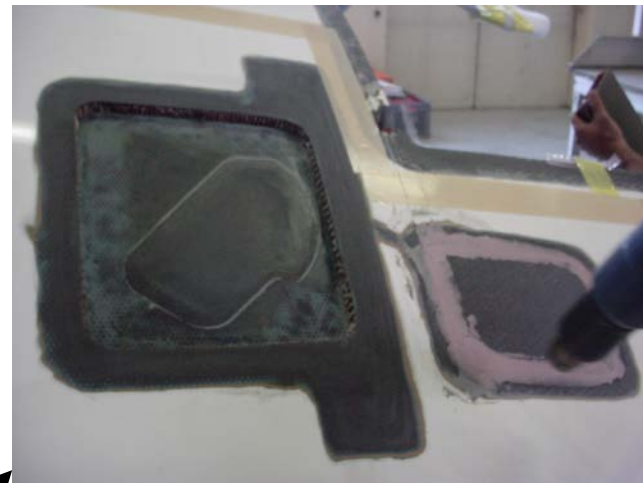
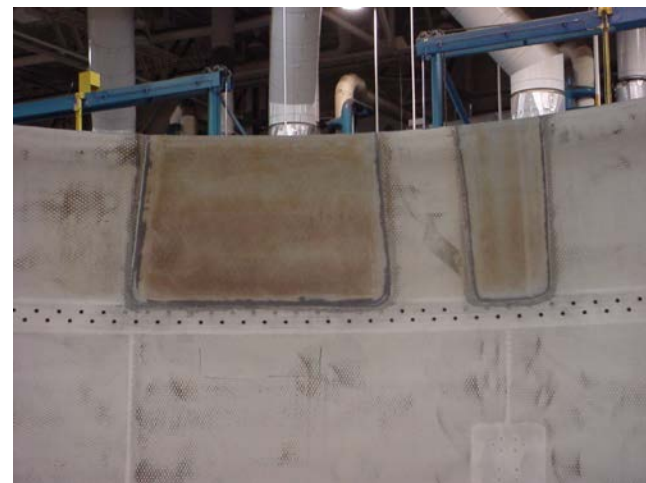
Through Penetration

Several Stages of Core Repair

Innovative "Cavity" Repair

Perforate Restored

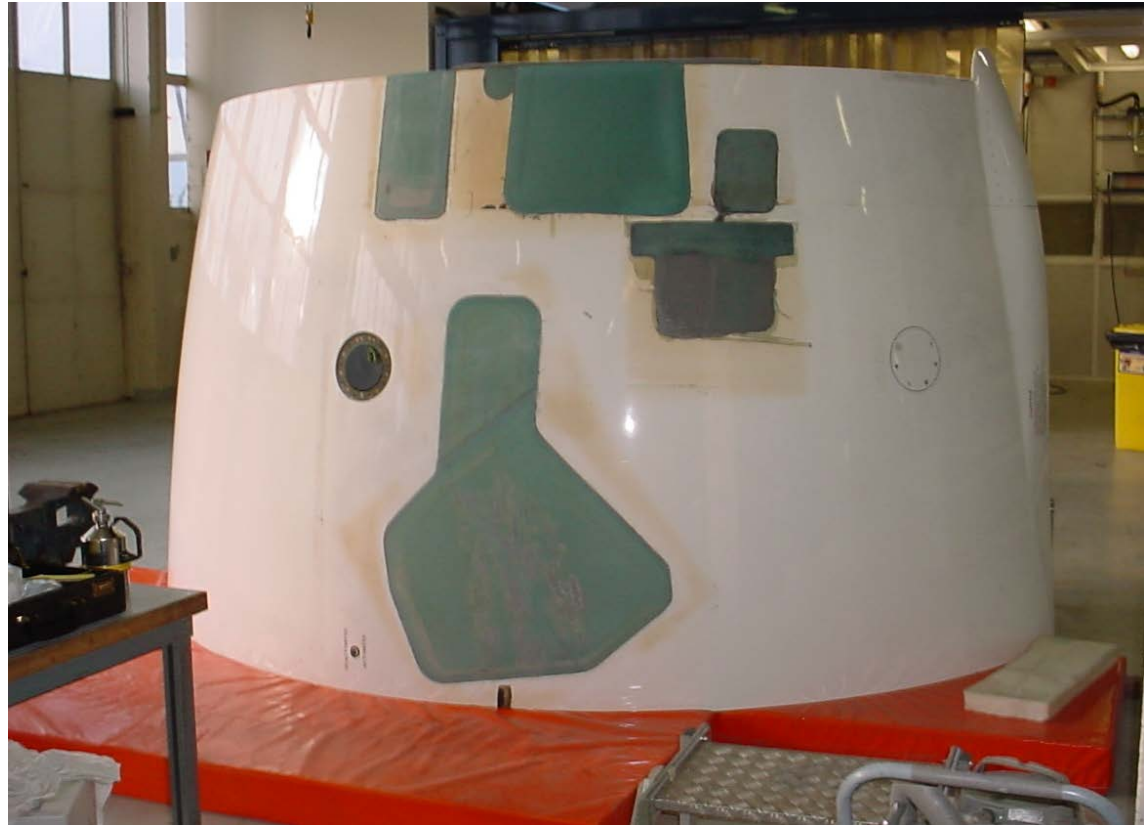
- **Trans-Sleeve Repair Kit – completed prior to paint**

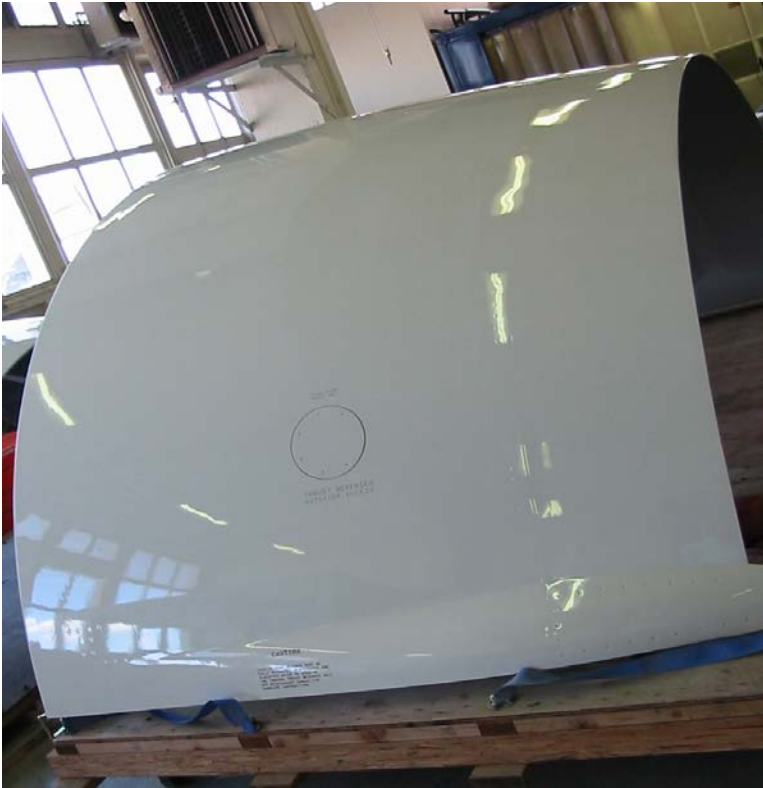
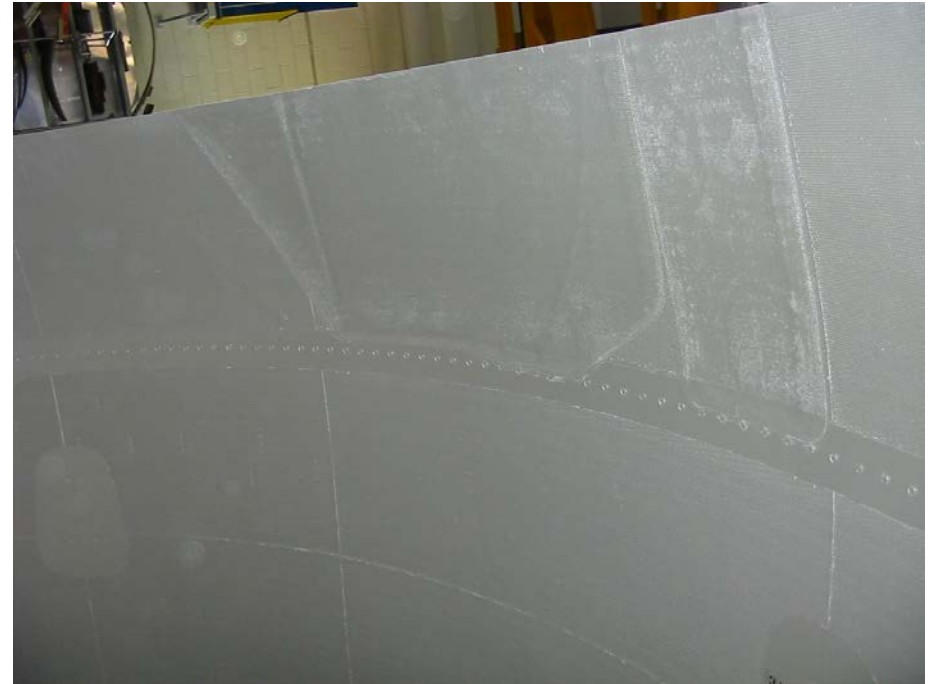
1 Unit

Repair Performed on site at Foreign Carrier

Repair Area = 25 sq ft

6000 cycles, 48000 hours

Performed circa 2001

“Certainly” this was largest we would ever see

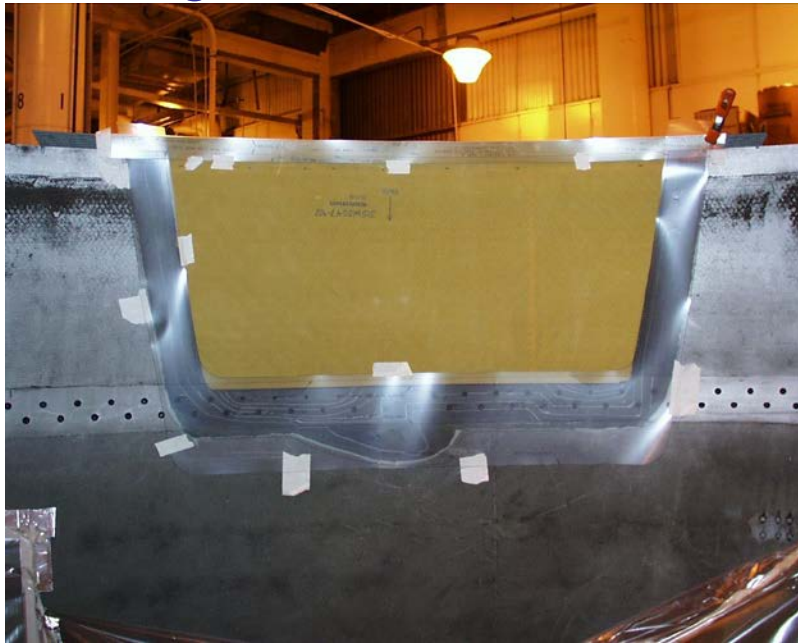
Carrier Provided Dimensions-  
We provided Everything else  
Including mylars for Indexing

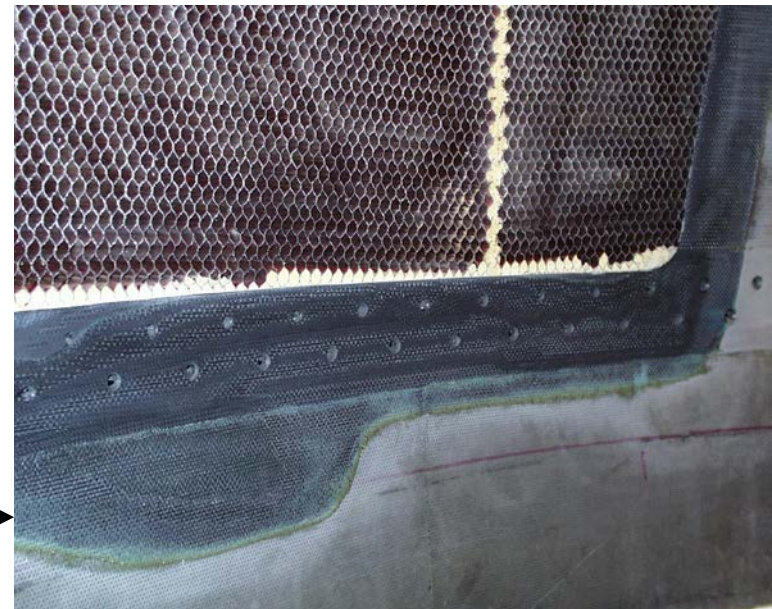
Core Replaced and  
Taper Sanding Complete

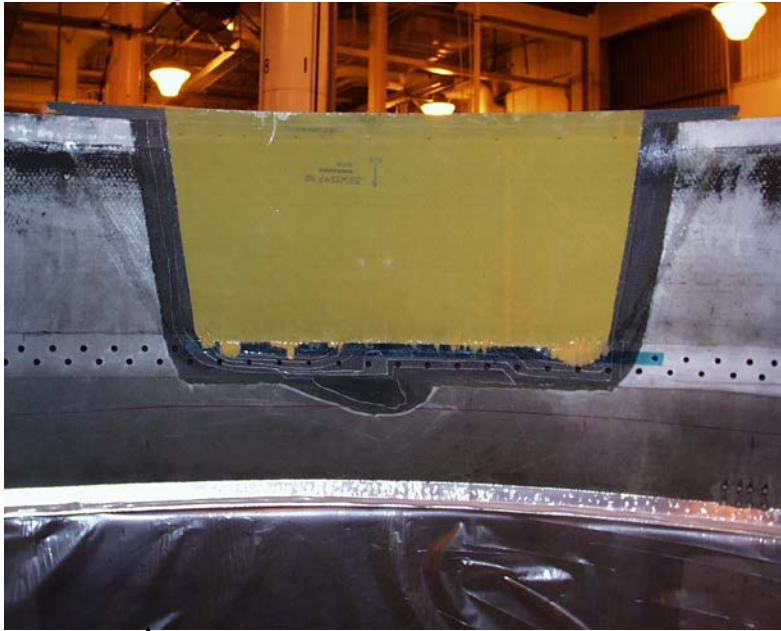
↑  
Core Replaced

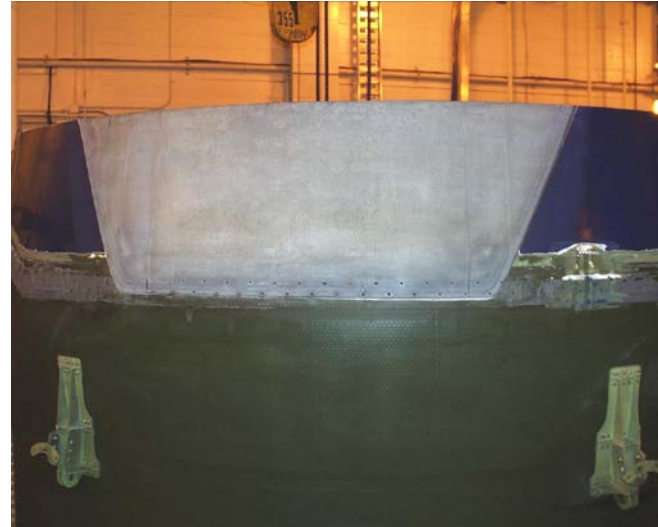
↑  
Solid Side Replaced

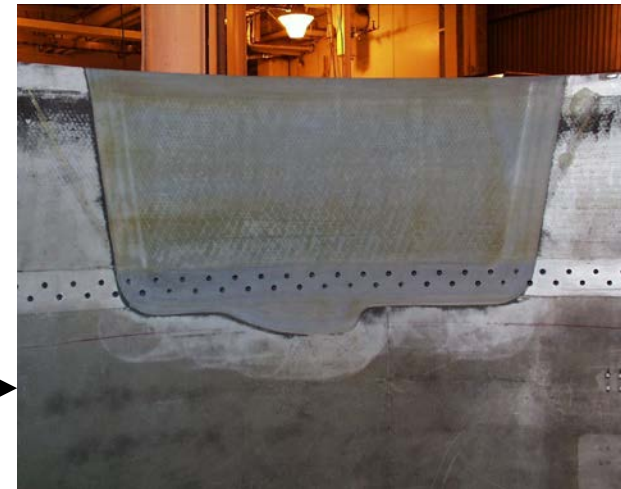
→  
Perforate Restored

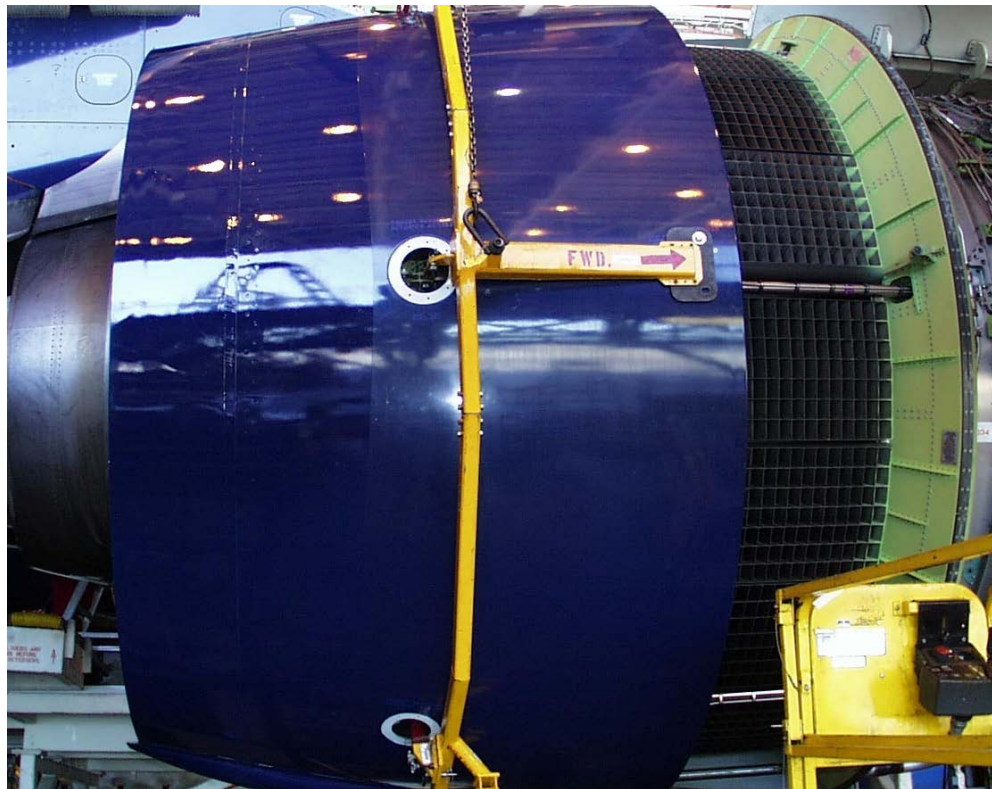
- **Trans-Sleeve Repair Kit – completed**
- **Provided 8100, carrier provided 8130**

1 Unit  
Repair Performed by Carrier  
Kit Provided on Contract  
Repair Area = 15 sq ft  
1500 cycles, 16000 hours  
Performed circa 2001

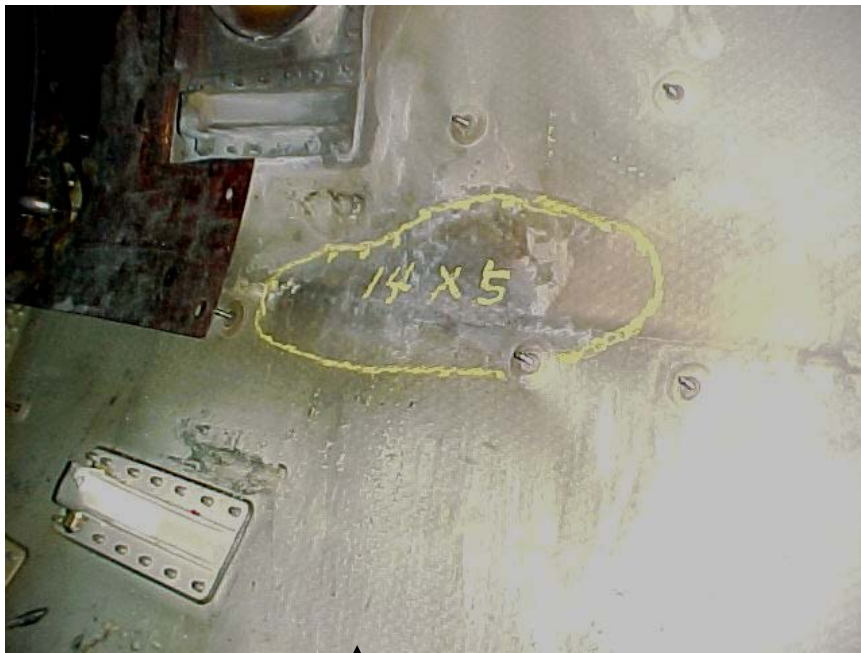
Overheat Damage at Blanket Seam

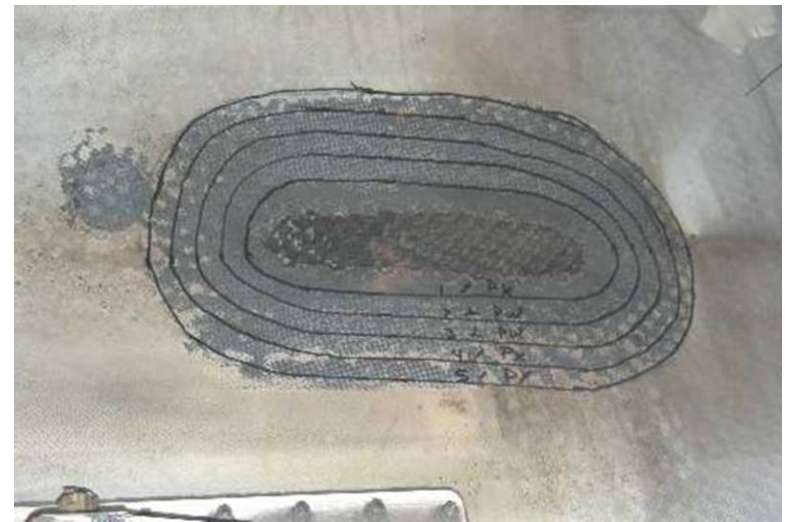
Taper Sand

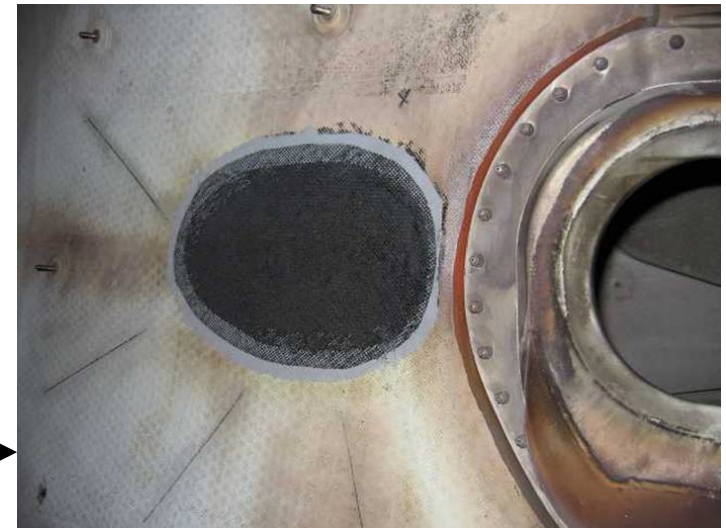
Bonded Repair

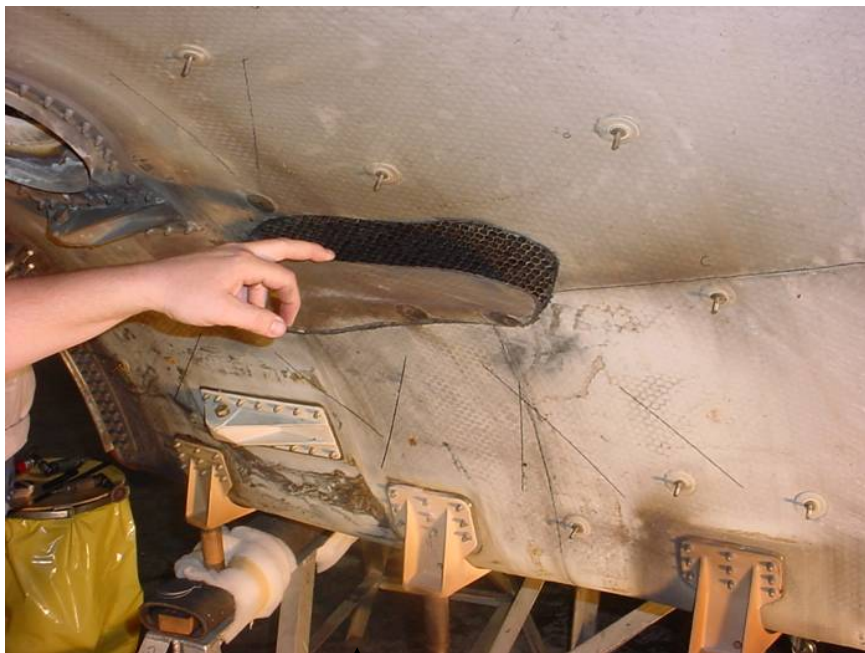
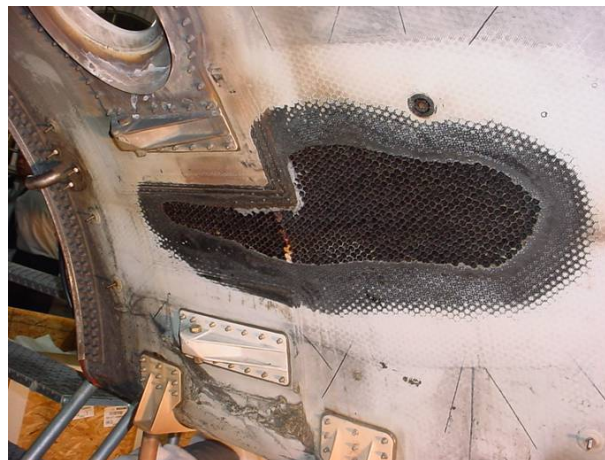
Taper Sand

## Overheat Damage at Blanket Seam

24 Units

Repair Area = 1 to 5 sq ft

6000 cycles, 32000 hours (oldest)

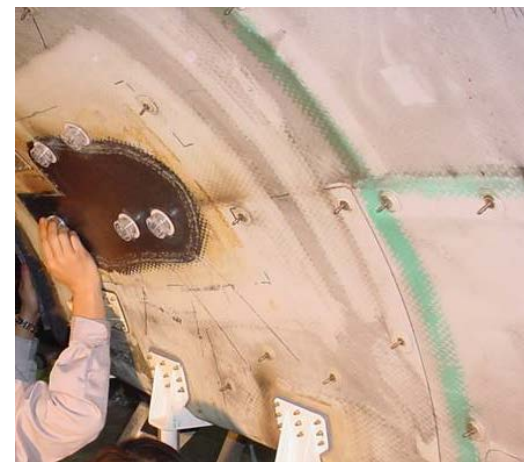
## Bonded Repair

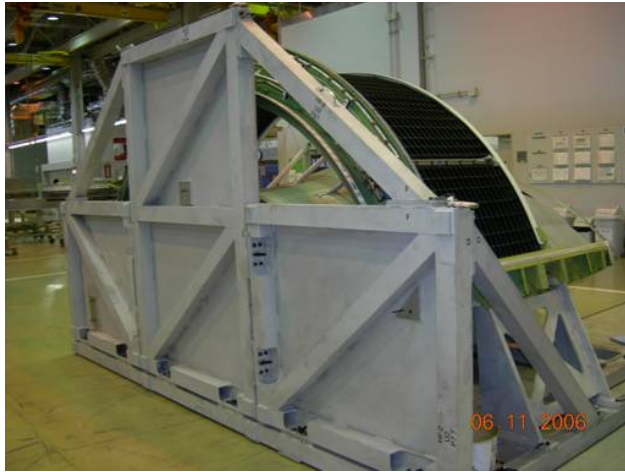
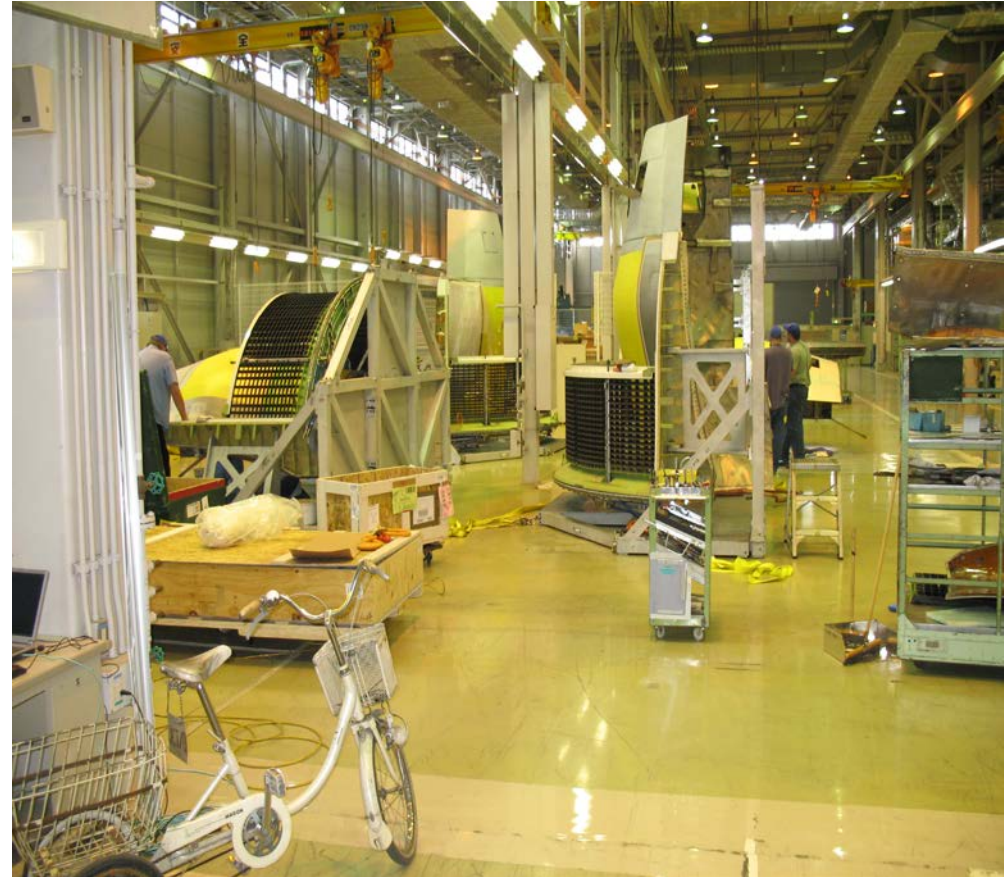
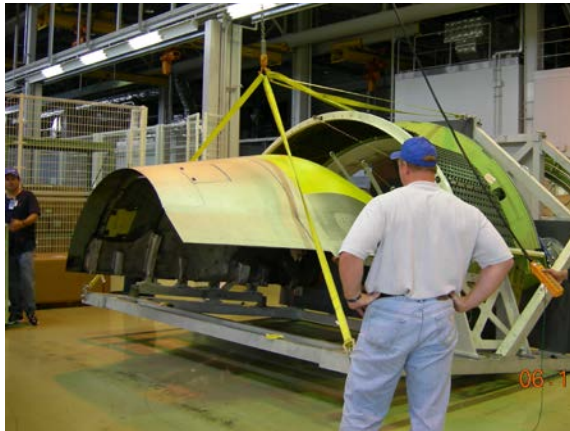
Necessary Tooling to get T/R into Repair Position

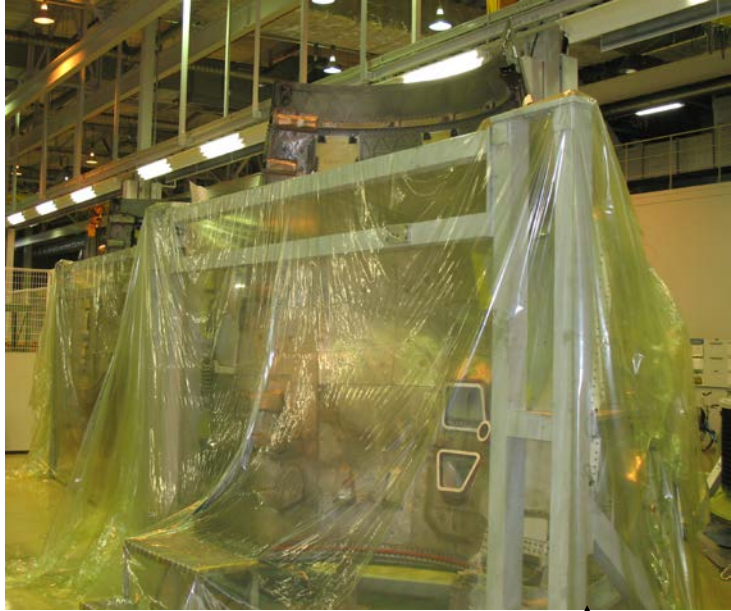
Special "Tent" for Facility Request

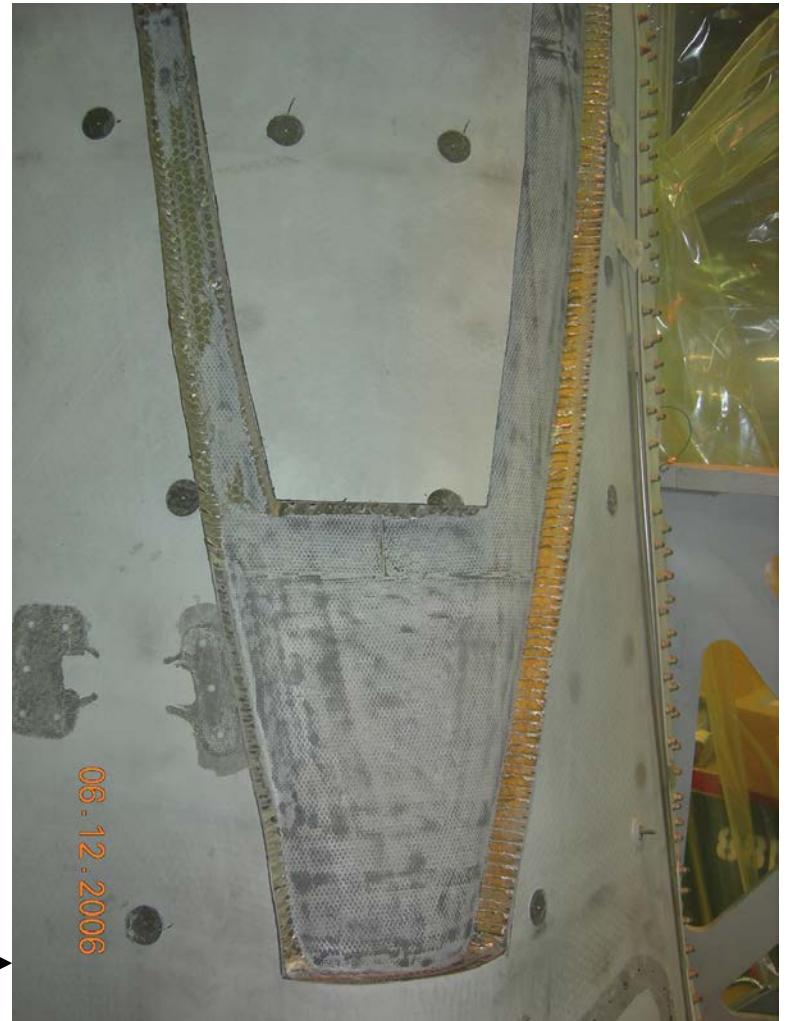
Core Removed

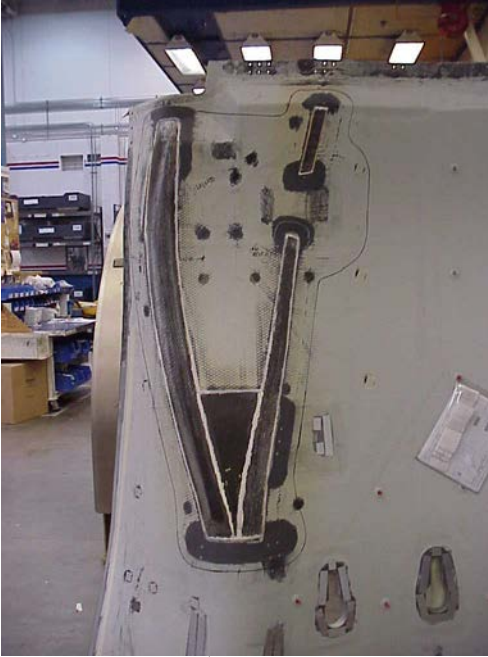
↑  
Core Replaced

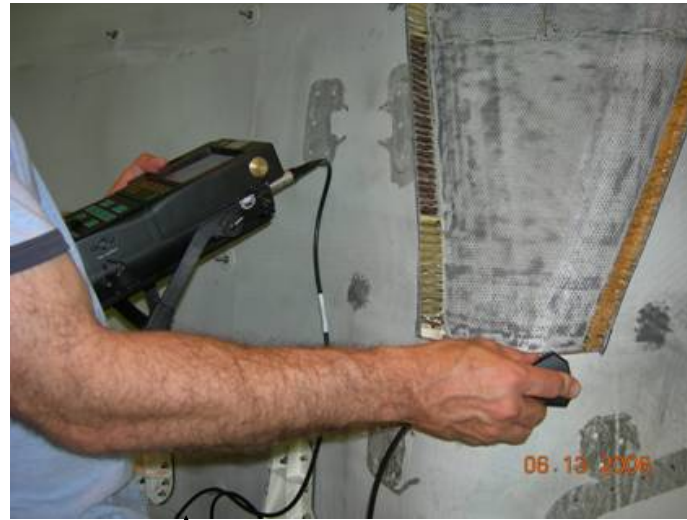
↑  
NDI, Prior to Core Replacement

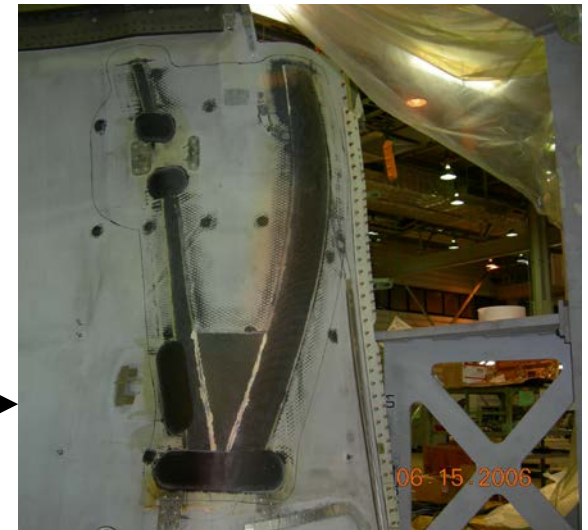
→  
Doubler Replaced

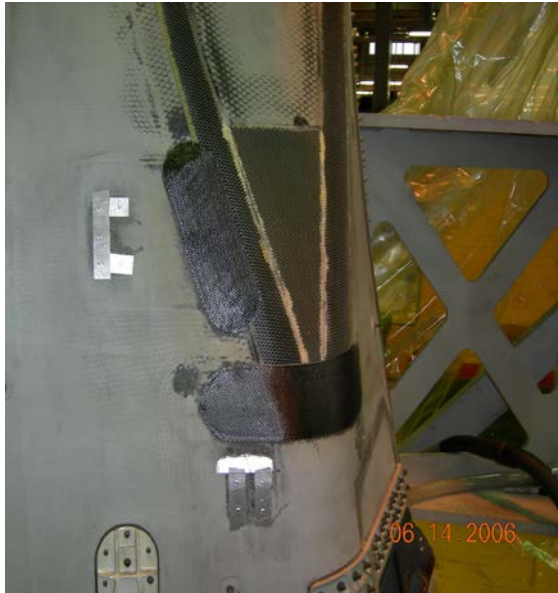
Doublers Replaced

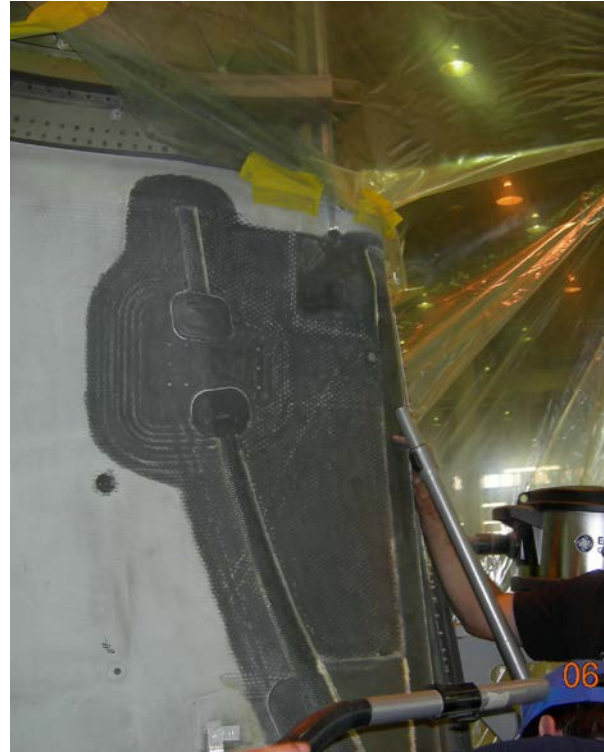
Final Taper Sanding

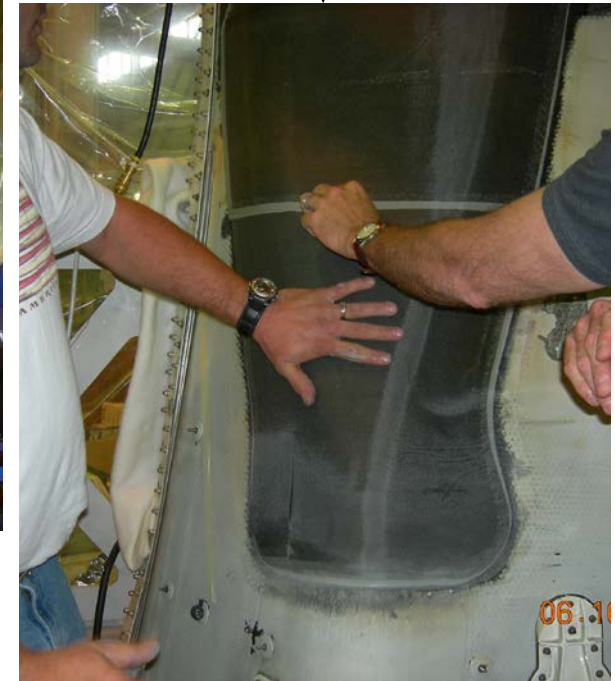
Fwd & Mid Kits Applied

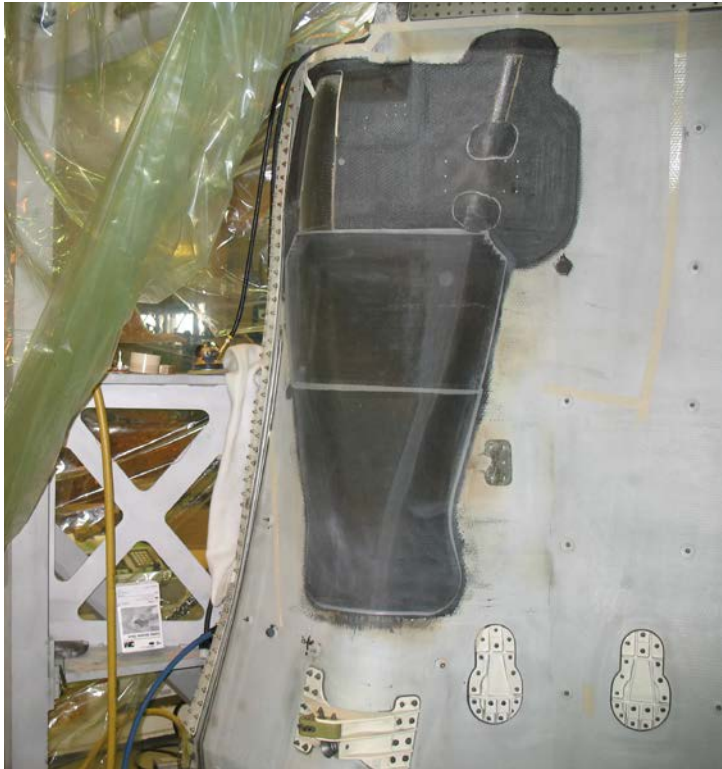
Fwd & Mid Kit Cured

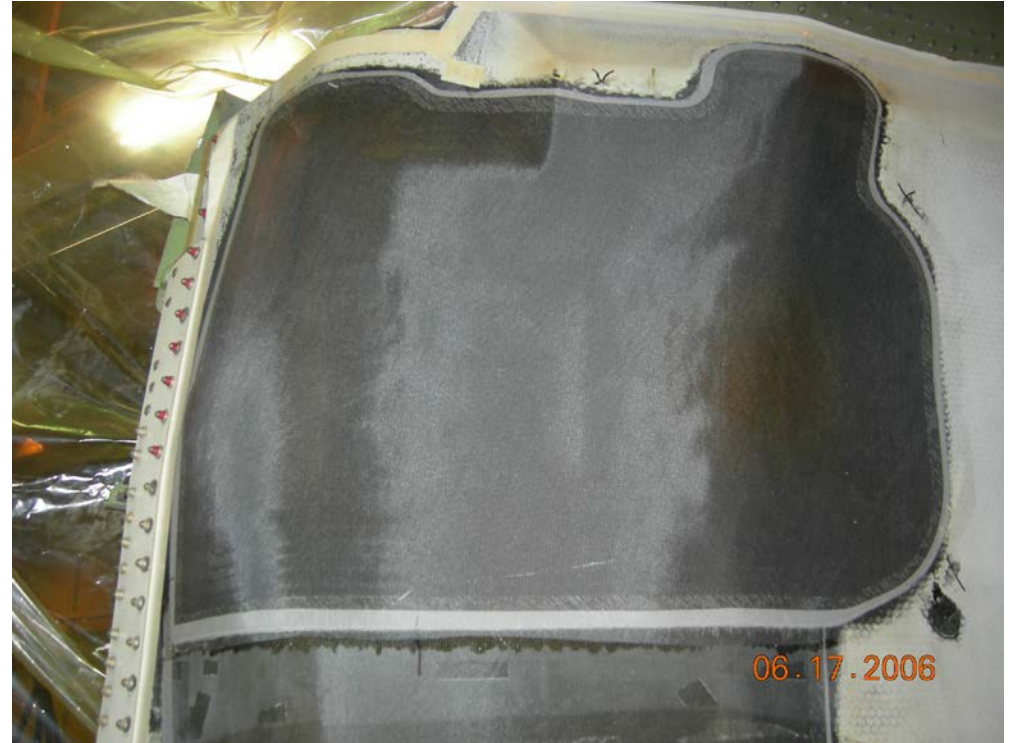
Aft Kit Applied

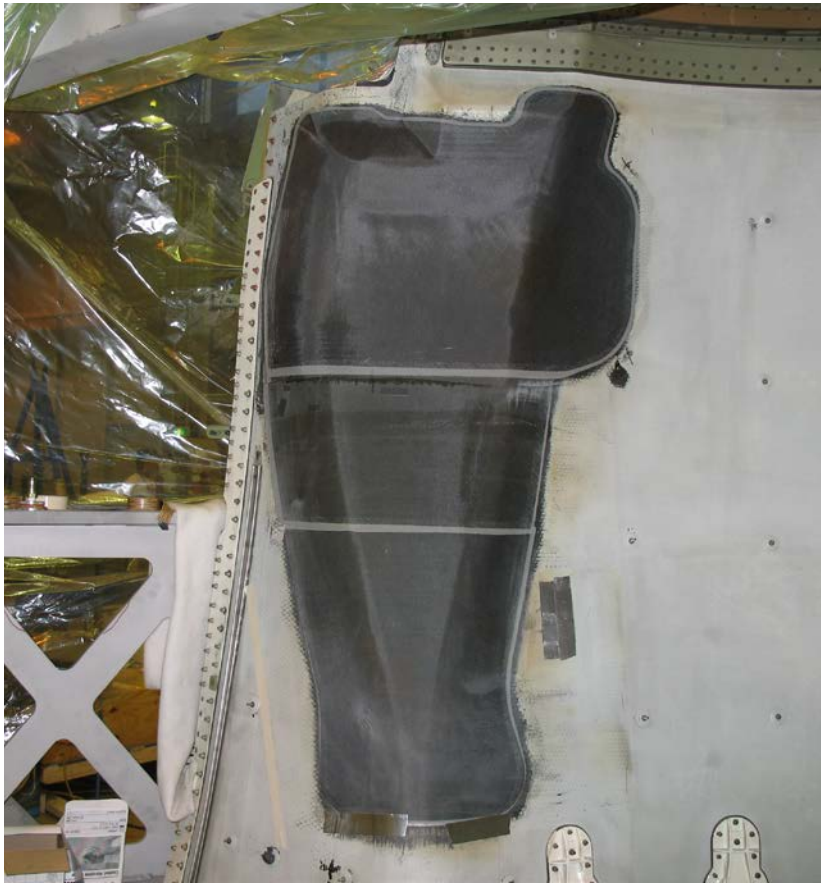
Compliance Repair Kit Complete

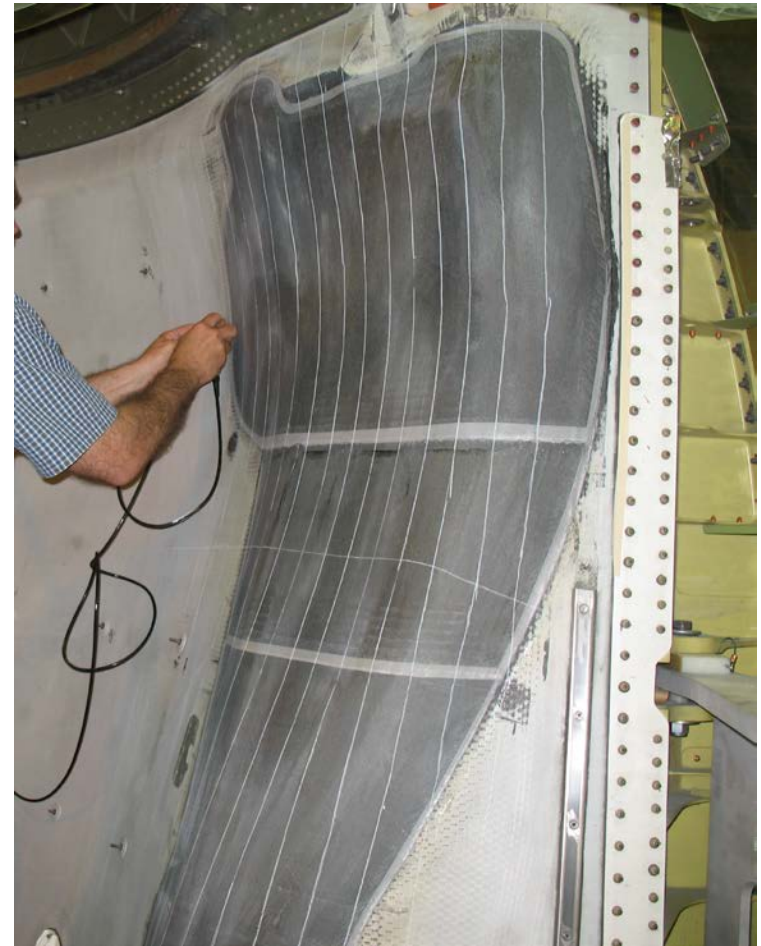
NDI Being Performed

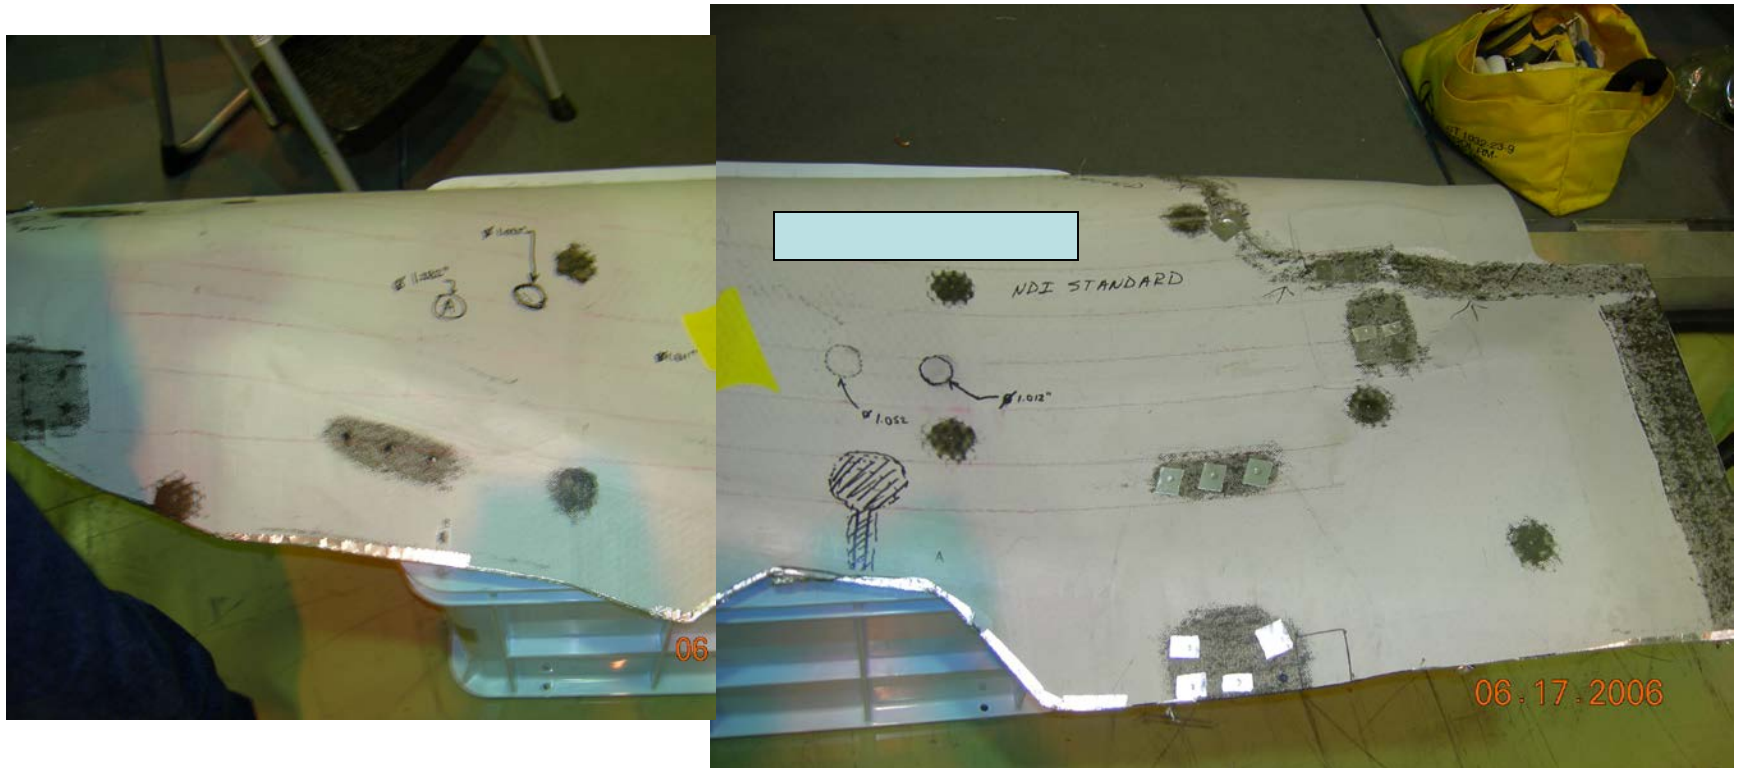
NDI Standard on-site
