# Safe Composite Repairs – Substantiation Linking Repair Test Data to Observed Fleet Performance

FAA Workshop for Composite Damage Tolerance and Maintenance  
Chicago, IL July 19-22, 2006

**John M. Welch**

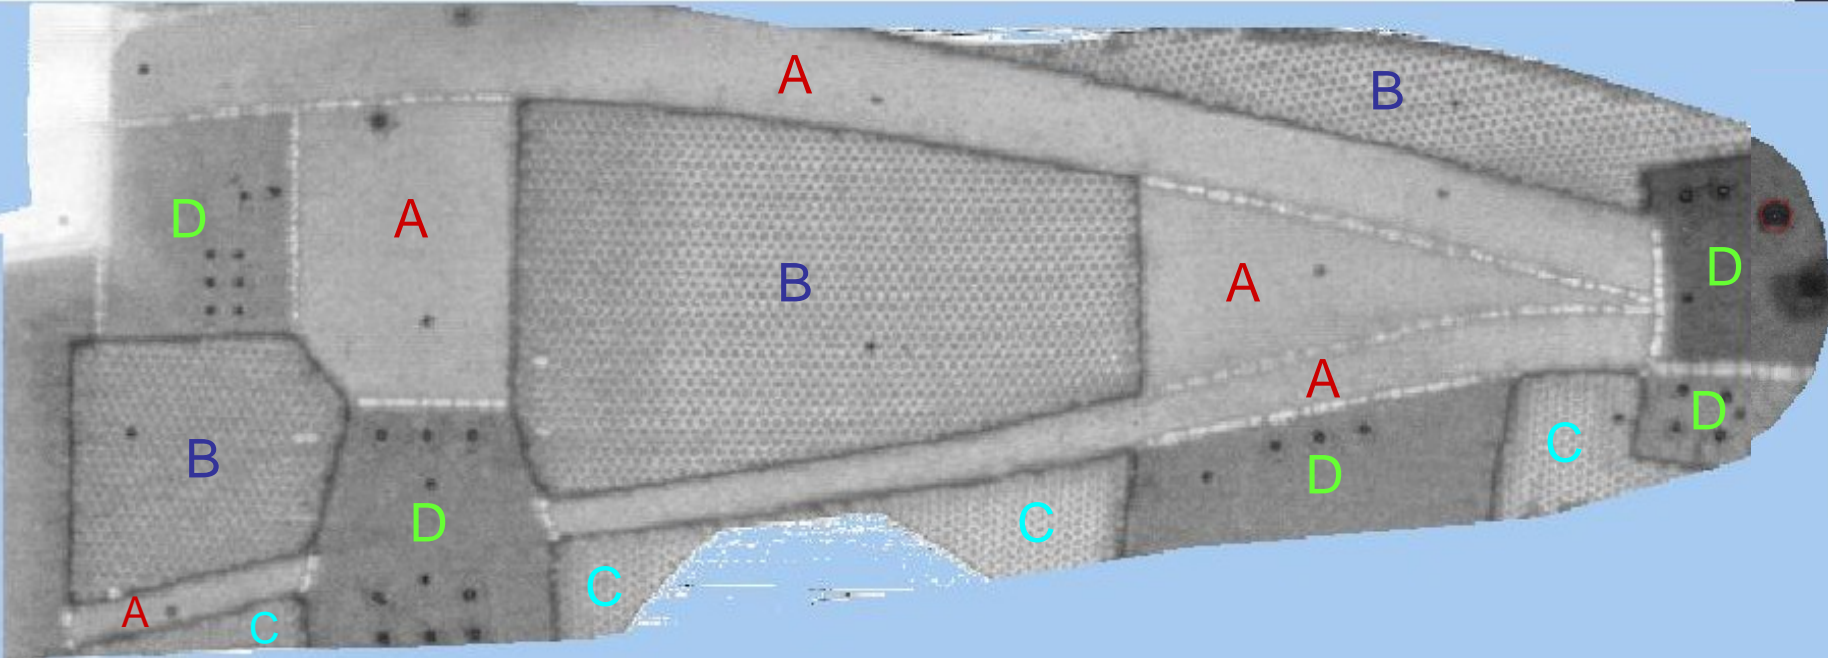
Details and Inclusions  
Were validated using  
several types of NDT  
methods – TTU shown

**A – 6 Ply**  
**B – 6 Ply**  
**C – 6 Ply**  
**D – 14 Ply**

NDI Plan required standard  
Containing all details of the  
Panel, and potential voids

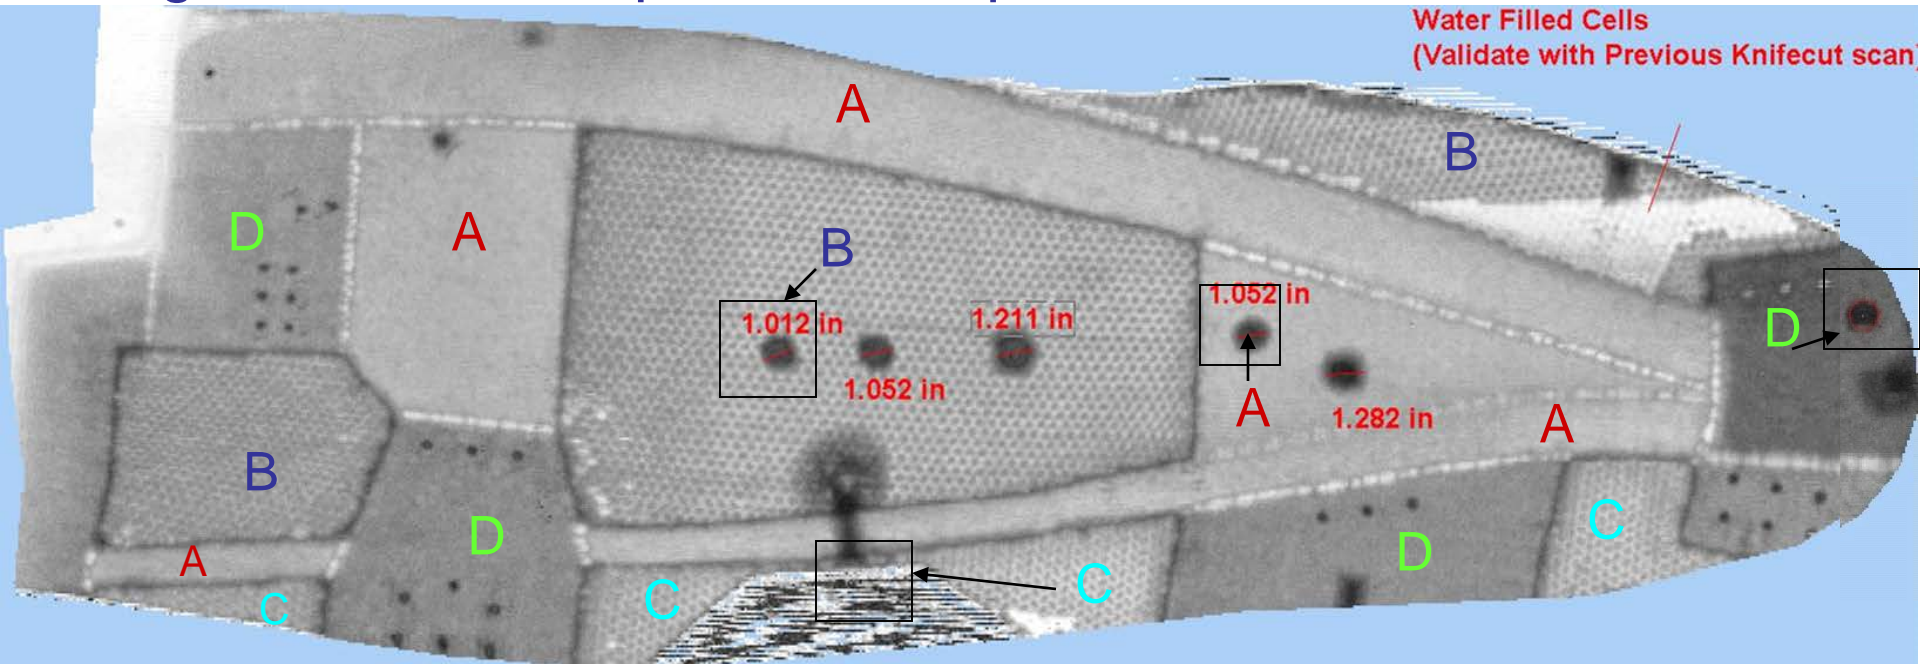
Details and Inclusions  
Were validated using  
several types of NDT  
methods – TTU shown

- A – Dense Aluminum**
- B – Double-Slotted Aluminum**
- C – Single-Slotted Aluminum**
- D – Grade 16 “High Dense”**

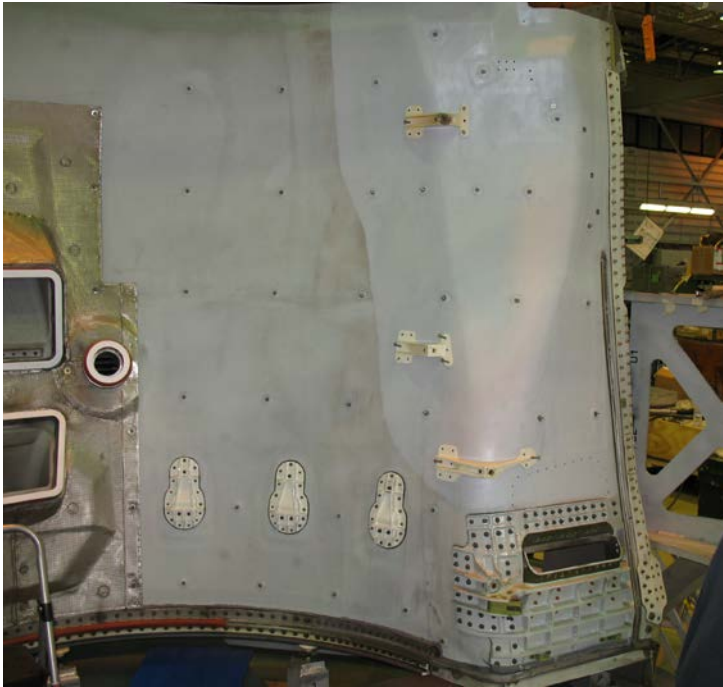
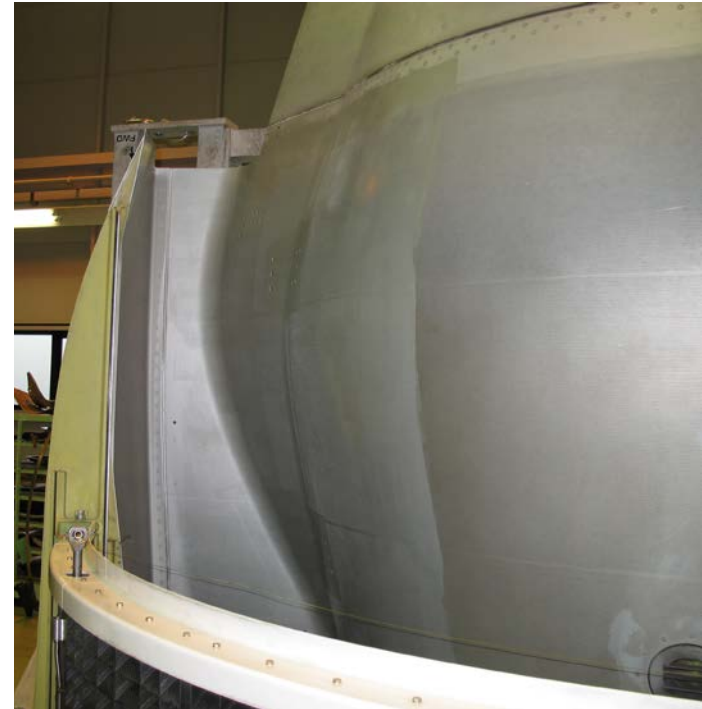
72 Units to comply, 4 complete  
Repairs Performed on-site for "Carriers"  
Repair Area = 33 and 35 sq ft (LH & RH)  
Just returned to service  
Performed 6/9 thru 6/22, 2006

- Inner Wall Repair Kit – completed
- Provided 8100, 8130
