Repair Design, Test, and Process Considerations for Lightning Strikes

CACRC/MIL-HDBK-17 Conference
Amsterdam, Netherlands May 7-11, 2007

John M. Welch

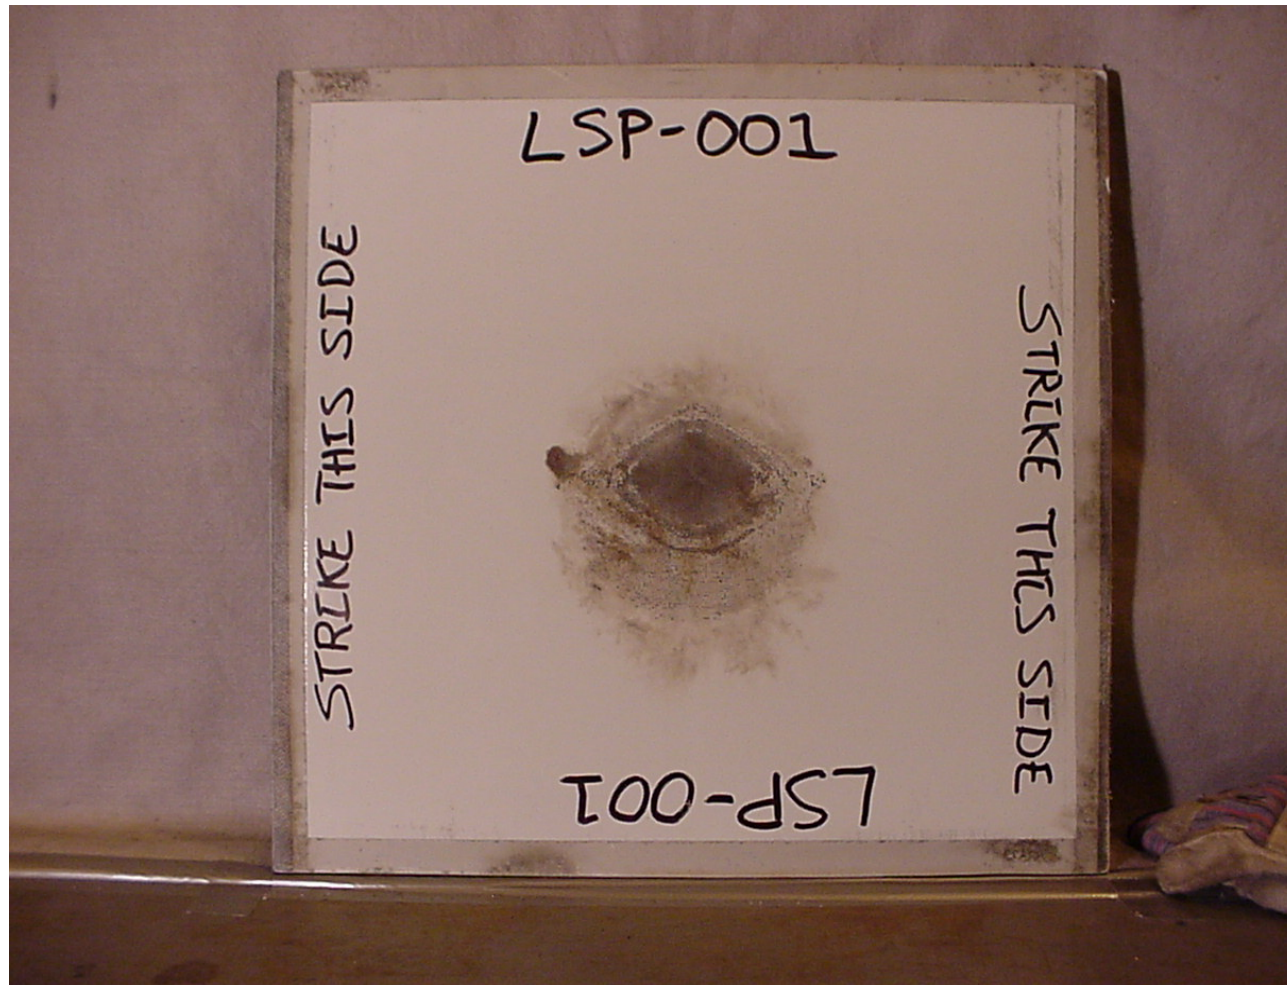
After Zone 1A strike – LSP-001

Damage size
Is 3-4 inches,
Damage depth
Limited to
Outside mesh
ply and paint.

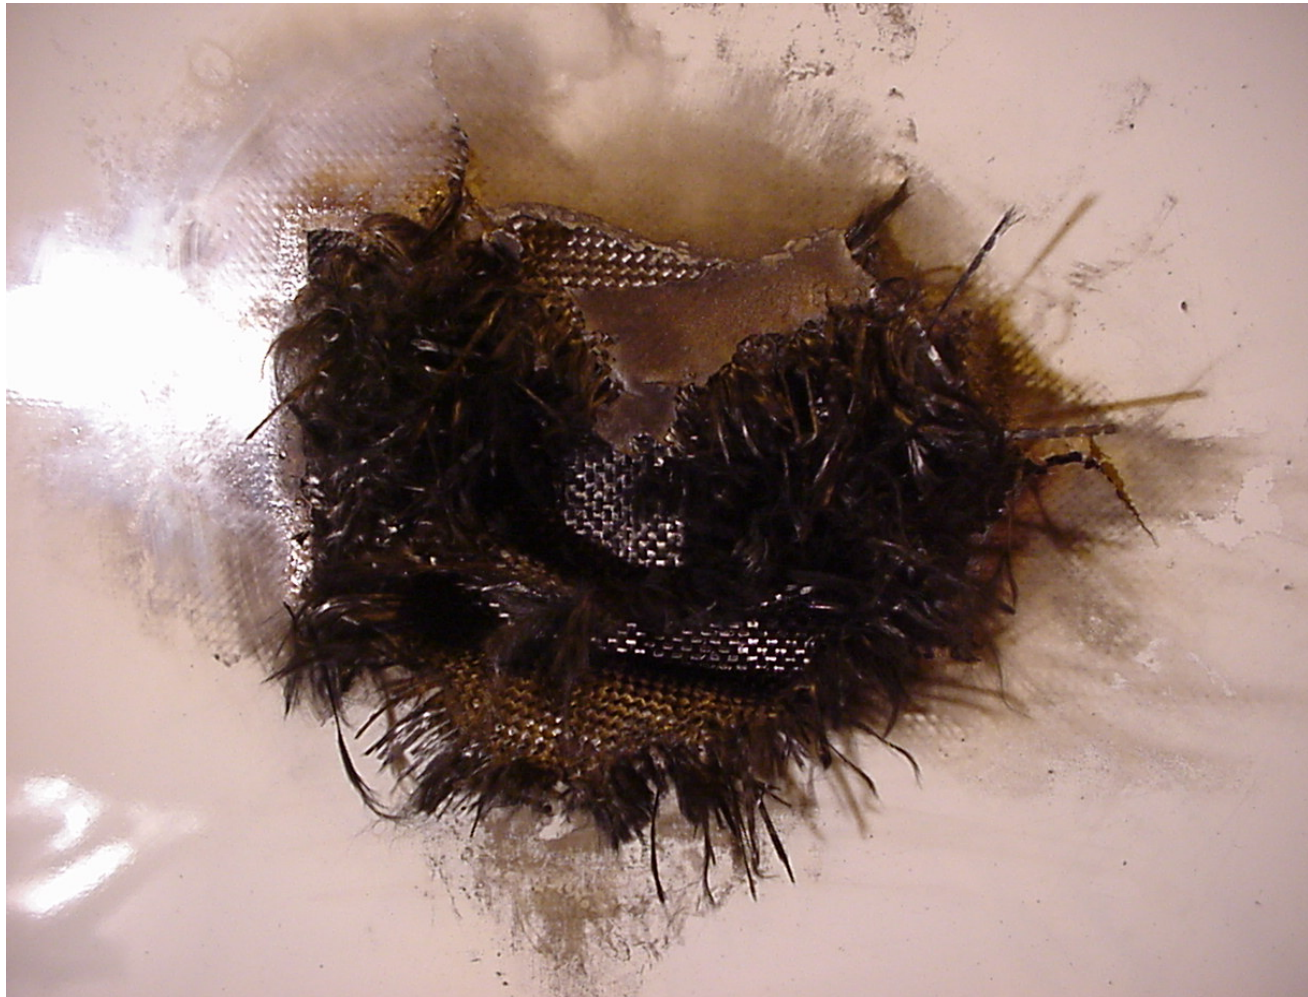
LSP-026, identical to 001, except no protection

Resultant
damage
punctured
both facings
with considerable
damage to core
-punched
a “thru hole”
all the way through
this 1 inch panel.
damage size 9 inches
in any one direction.

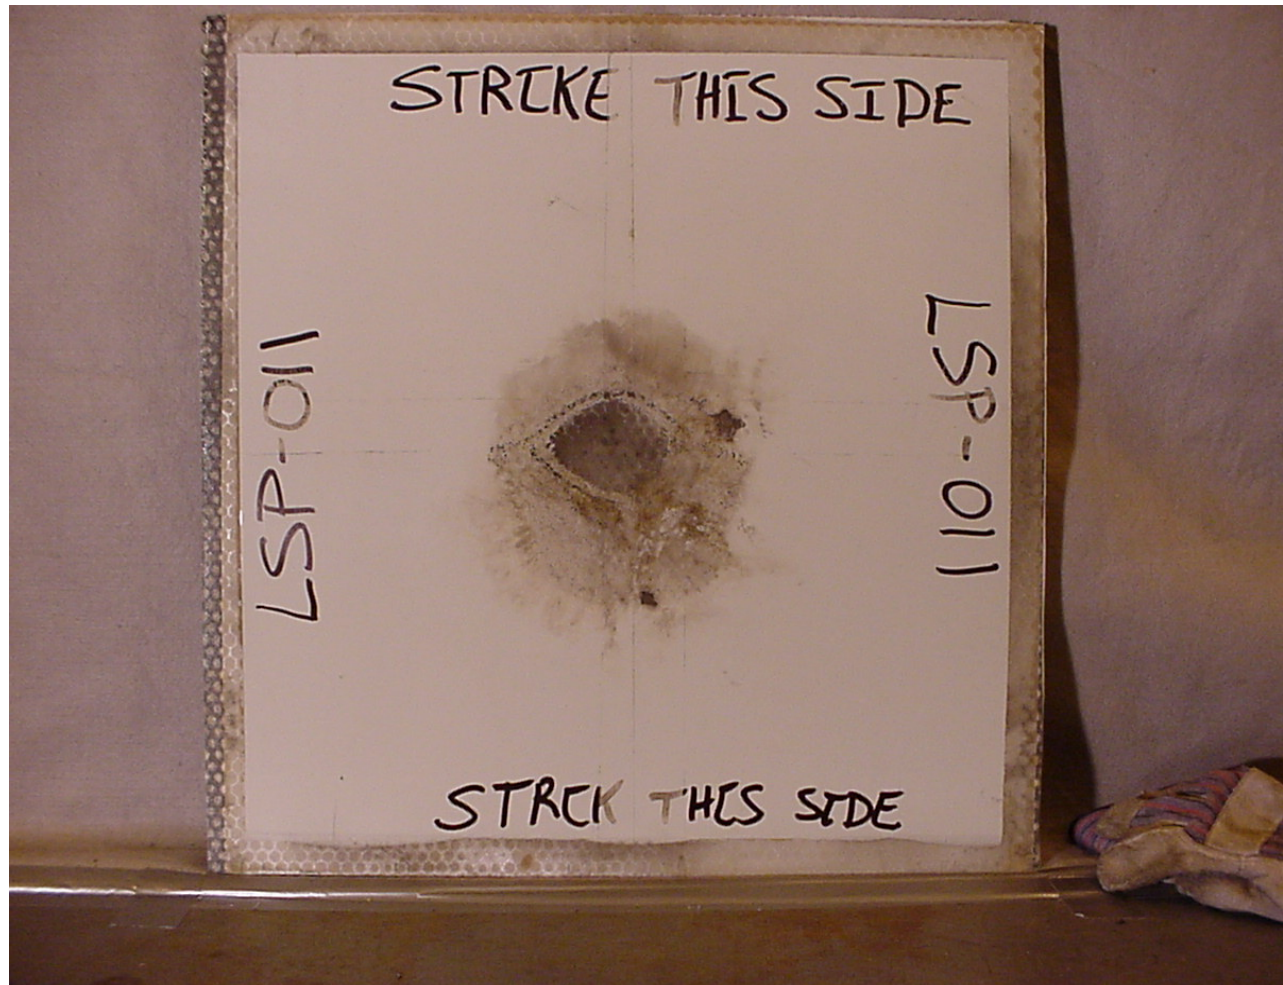
After Zone 1A strike – LSP-011

Damage size
is 3-4 inches,
damage depth
limited to
outside mesh
ply and paint.

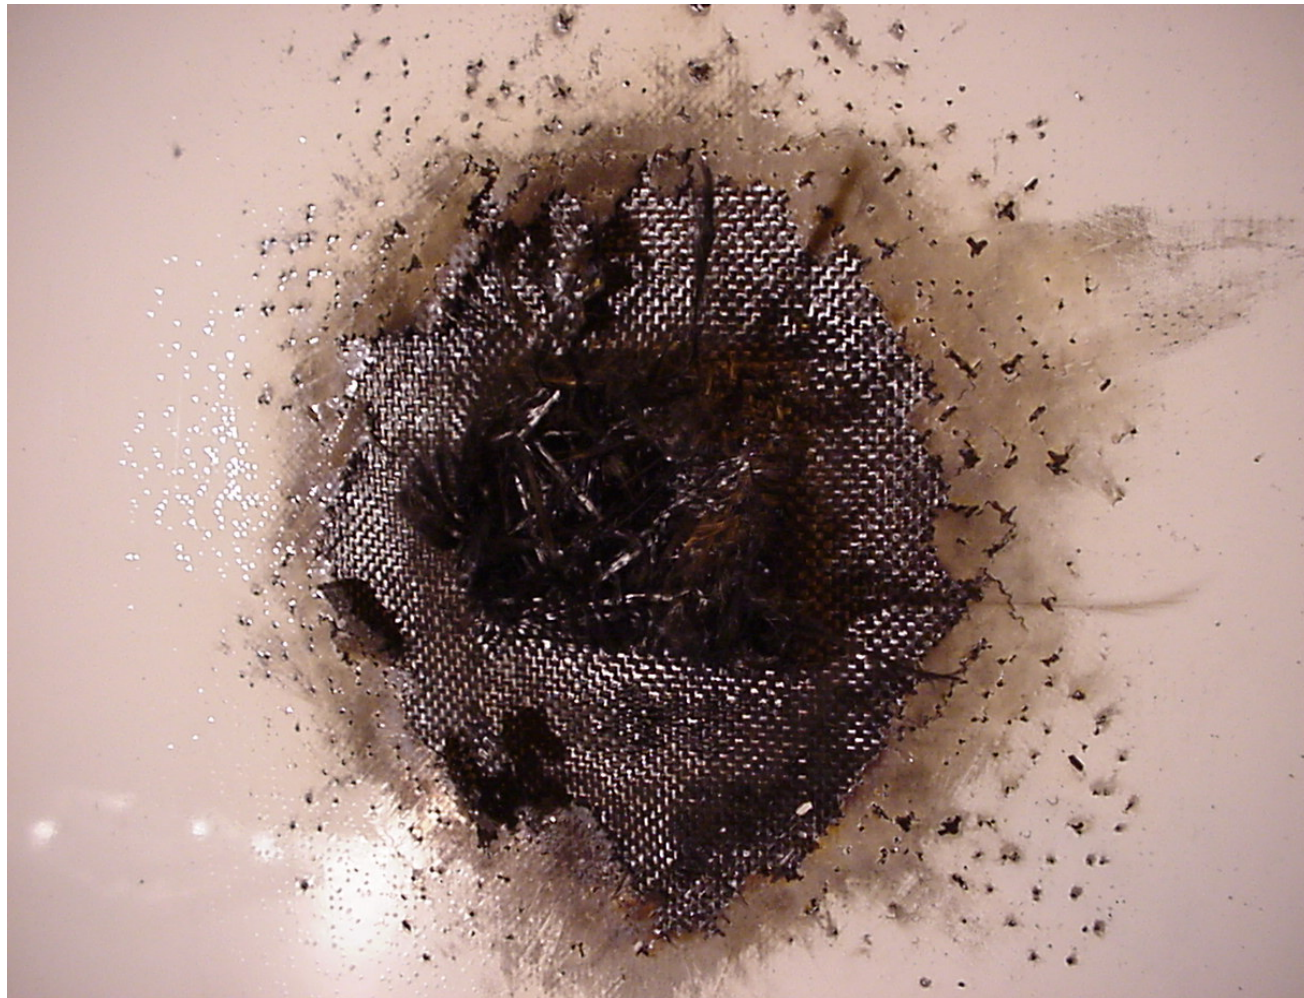
Close-up of LSP-027, identical to 011 except No Protection

Resultant
damage
punctured
both facings
with considerable
damage to core
-punched
a “thru hole”
all the way
through
this 1 inch panel,
damage size 8
inches
in any one
direction.

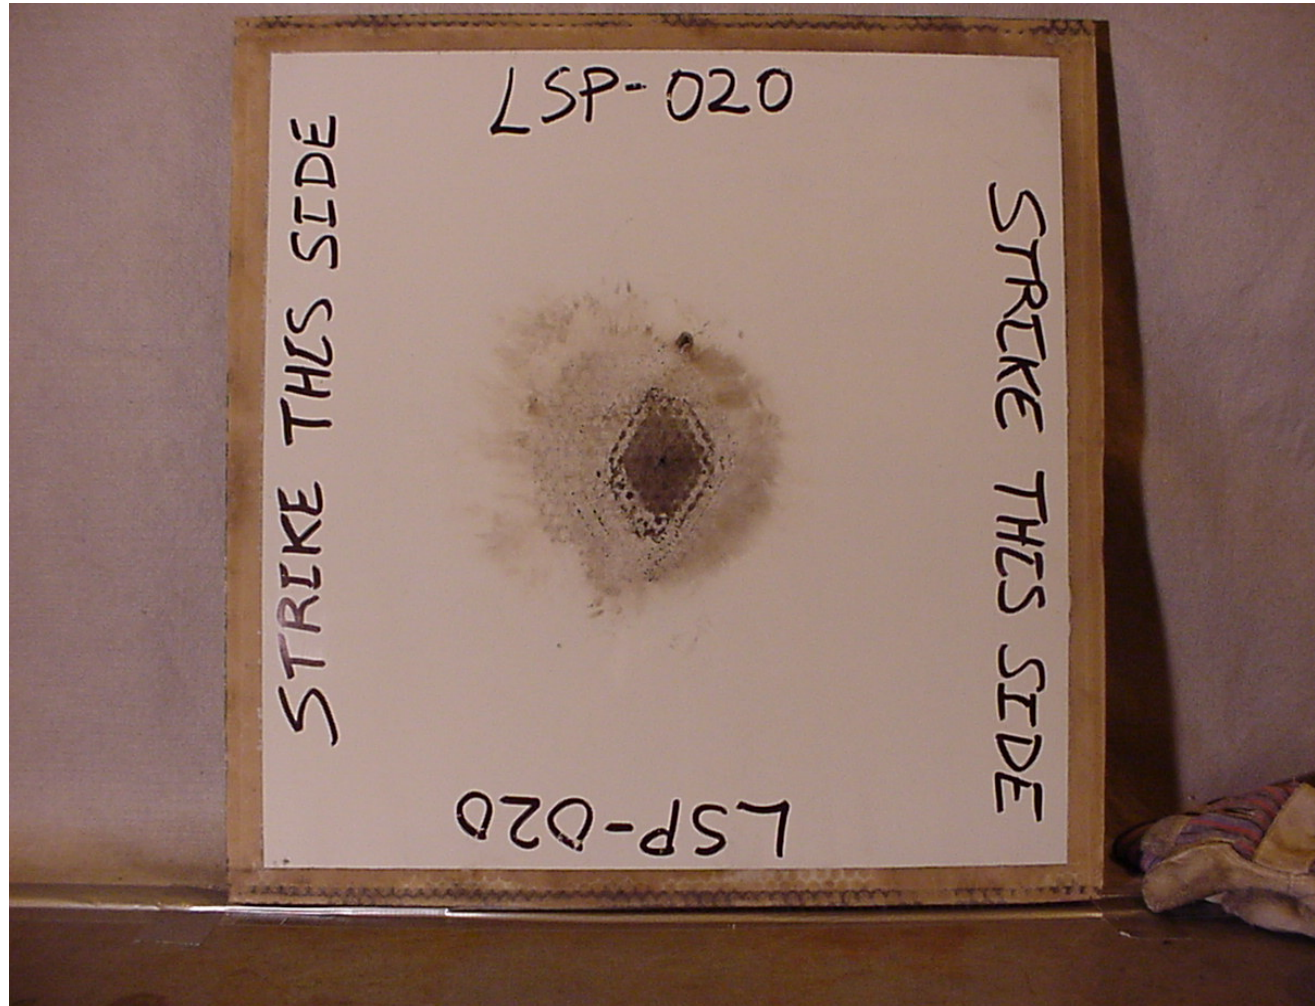
LSP-020, Aluminum Core, with protection, after Zone 1A strike

Damage size
of this panel
was consistent
with all other
protected
panels,
3-4 inches.

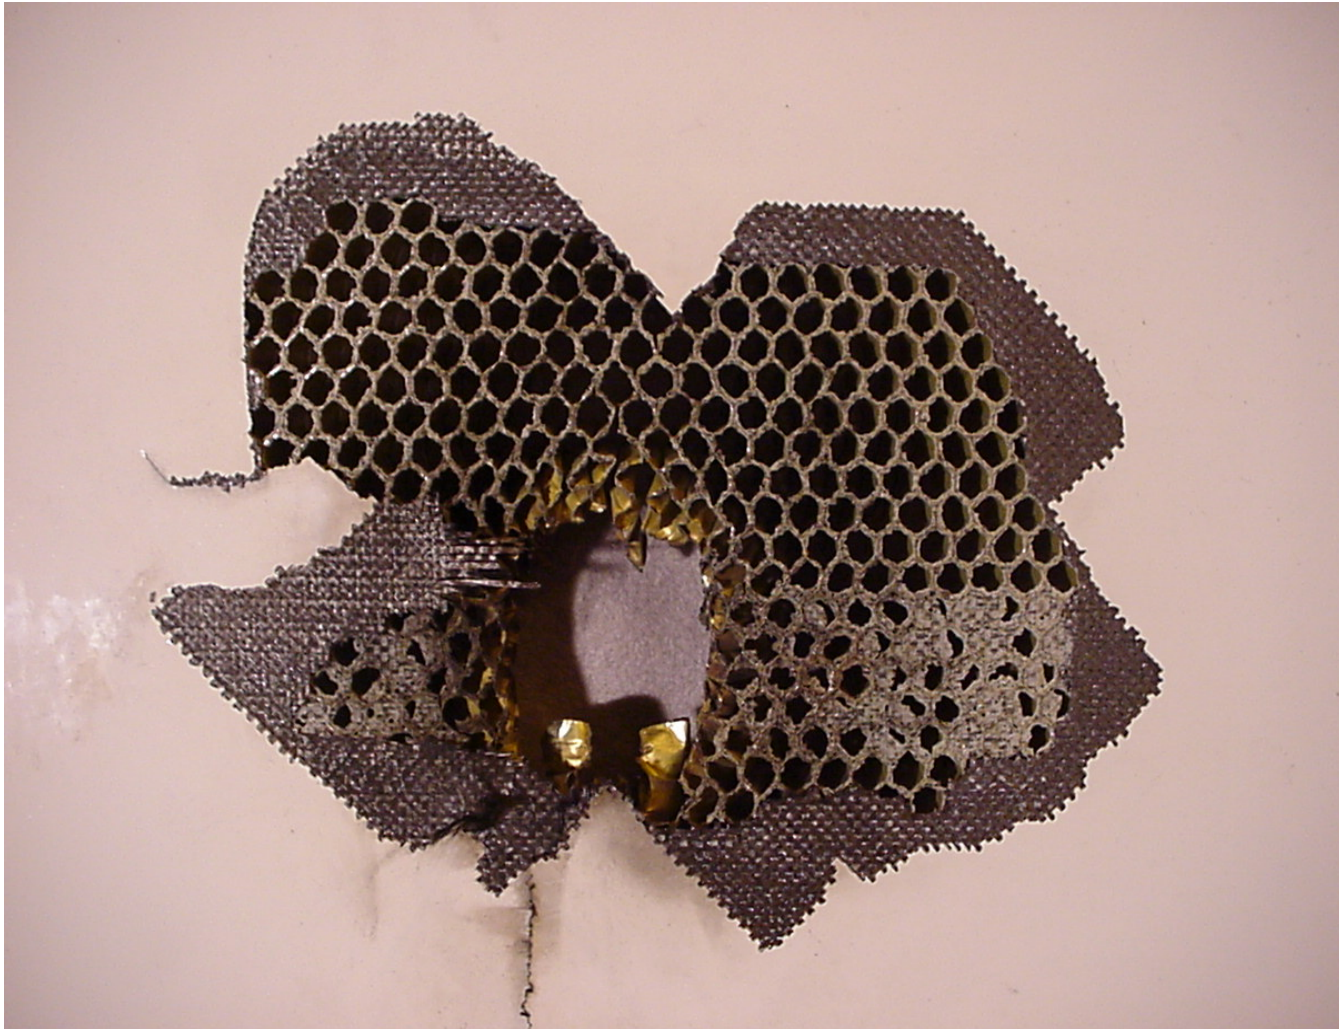
LSP-013, Aluminum core, no protection, after Zone 1A strike

Extensive damage to unprotected aluminum core panel with both facings obliterated and large chunk of core melted – entire panel is delaminated with noticeable “bend” in panel.

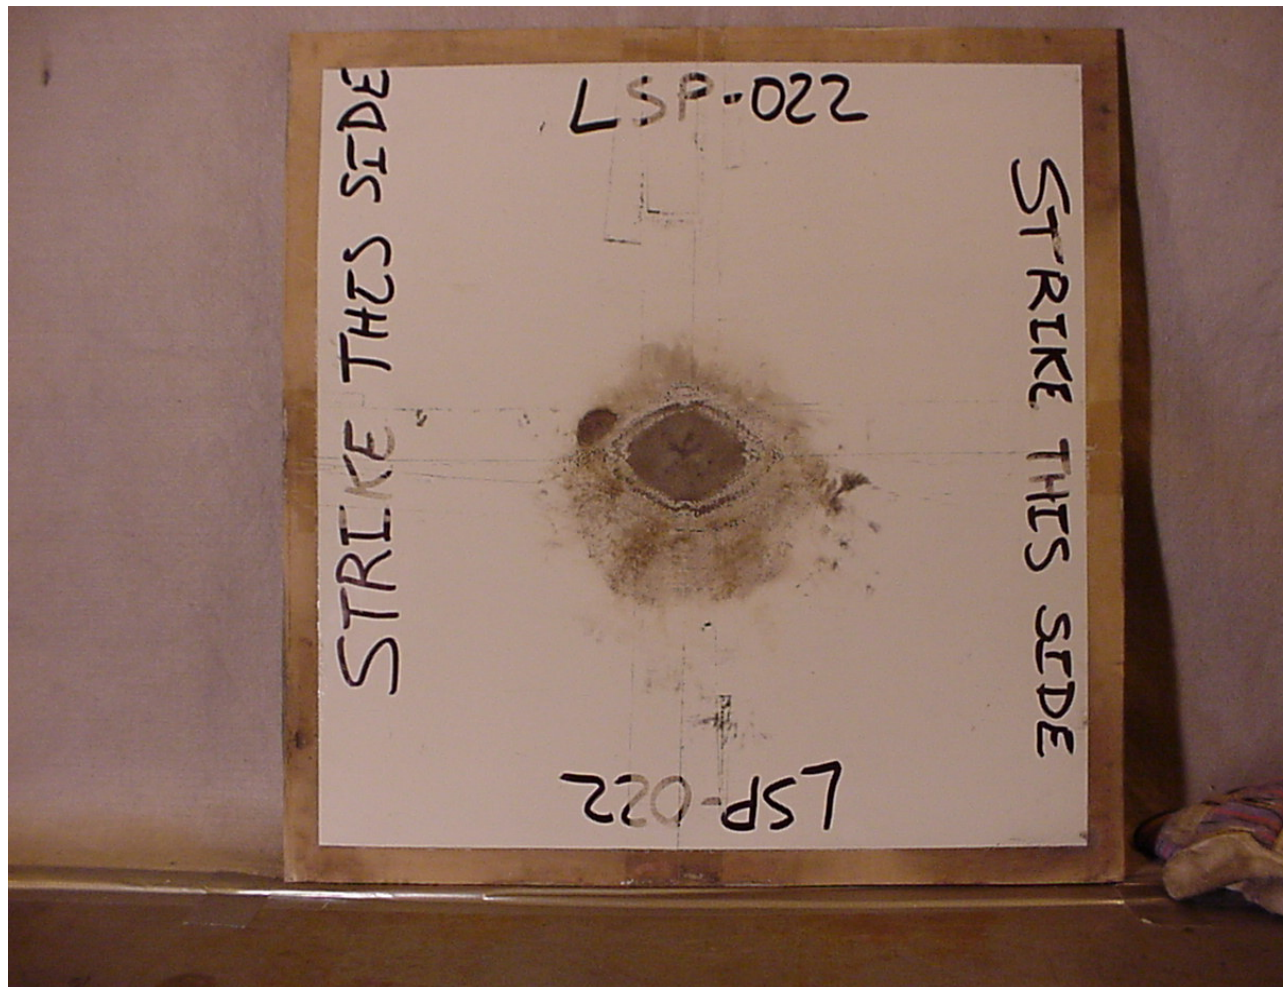
LSP-022, 0.5 inch thick Arimid core, after Zone 1A strike – nearly identical damage size and shape to 1 inch thick Zone 1A panels.

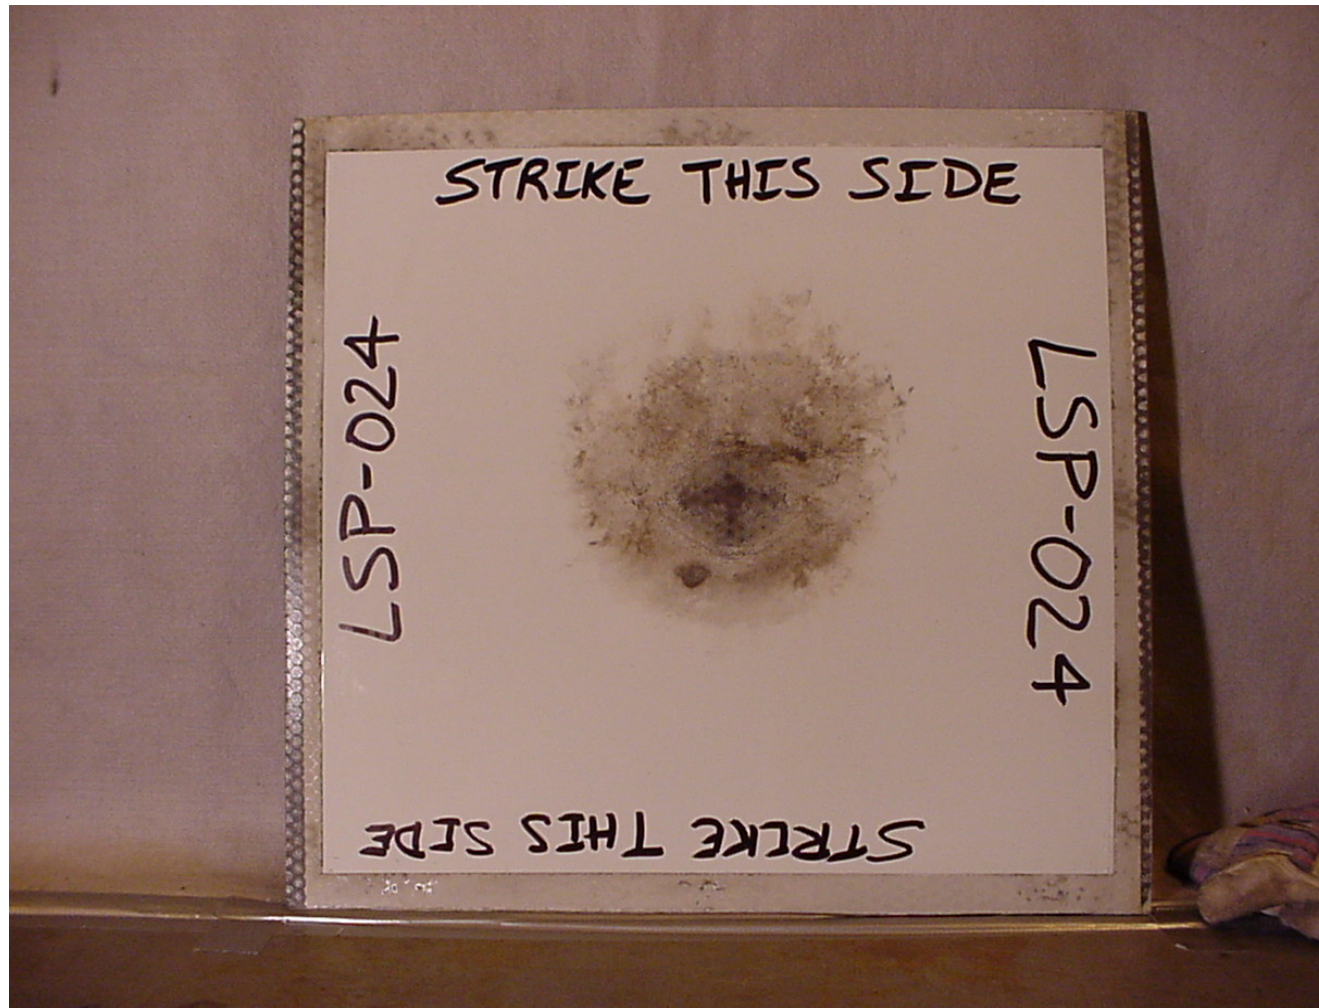
LSP-024, 0.5 inch thick, HRP core, with protection – identical to other Zone 1A strikes

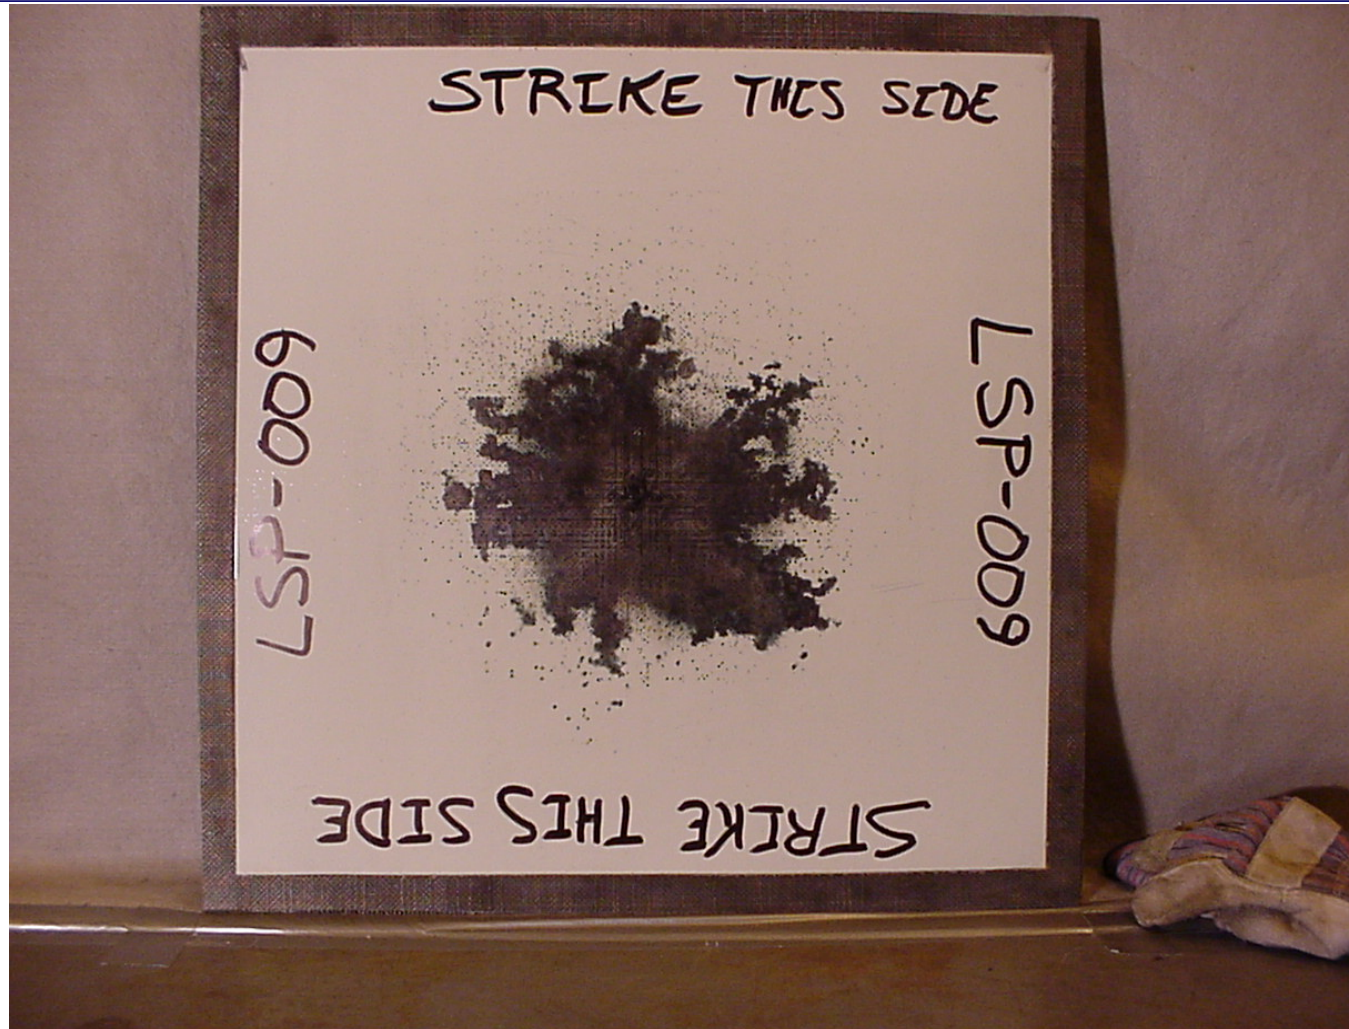
LSP-009, Interwoven Phos-Bronze mesh, Aramid core, after Zone 1A strike

Damage
Size extends
9 inches in any
one direction,
burn through
down to core
includes carbon
plies – note
interwoven mesh
damaged all the
way to panel
periphery similar
to detonation
chord over amp
response, i.e
little burrs
of interwoven
wire stick up thru
panel all over.

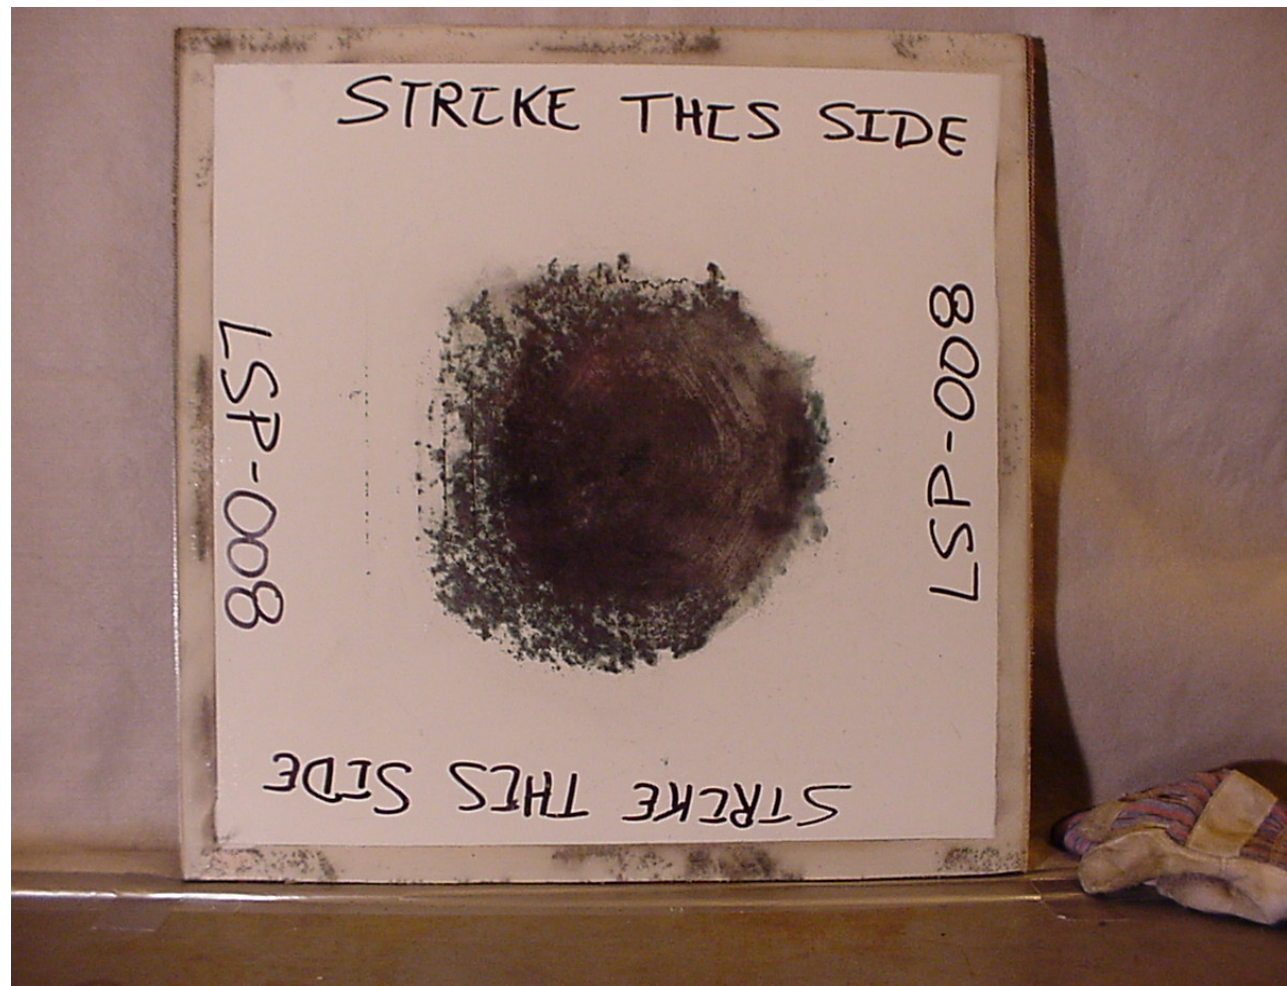
LSP-008, Copper mesh, aramid core, after Zone 1A strike

Damage size
10-14 inches,
Burn through down
To the core, damage
Extends through all
Carbon plies, with
Damage to core as
Well.

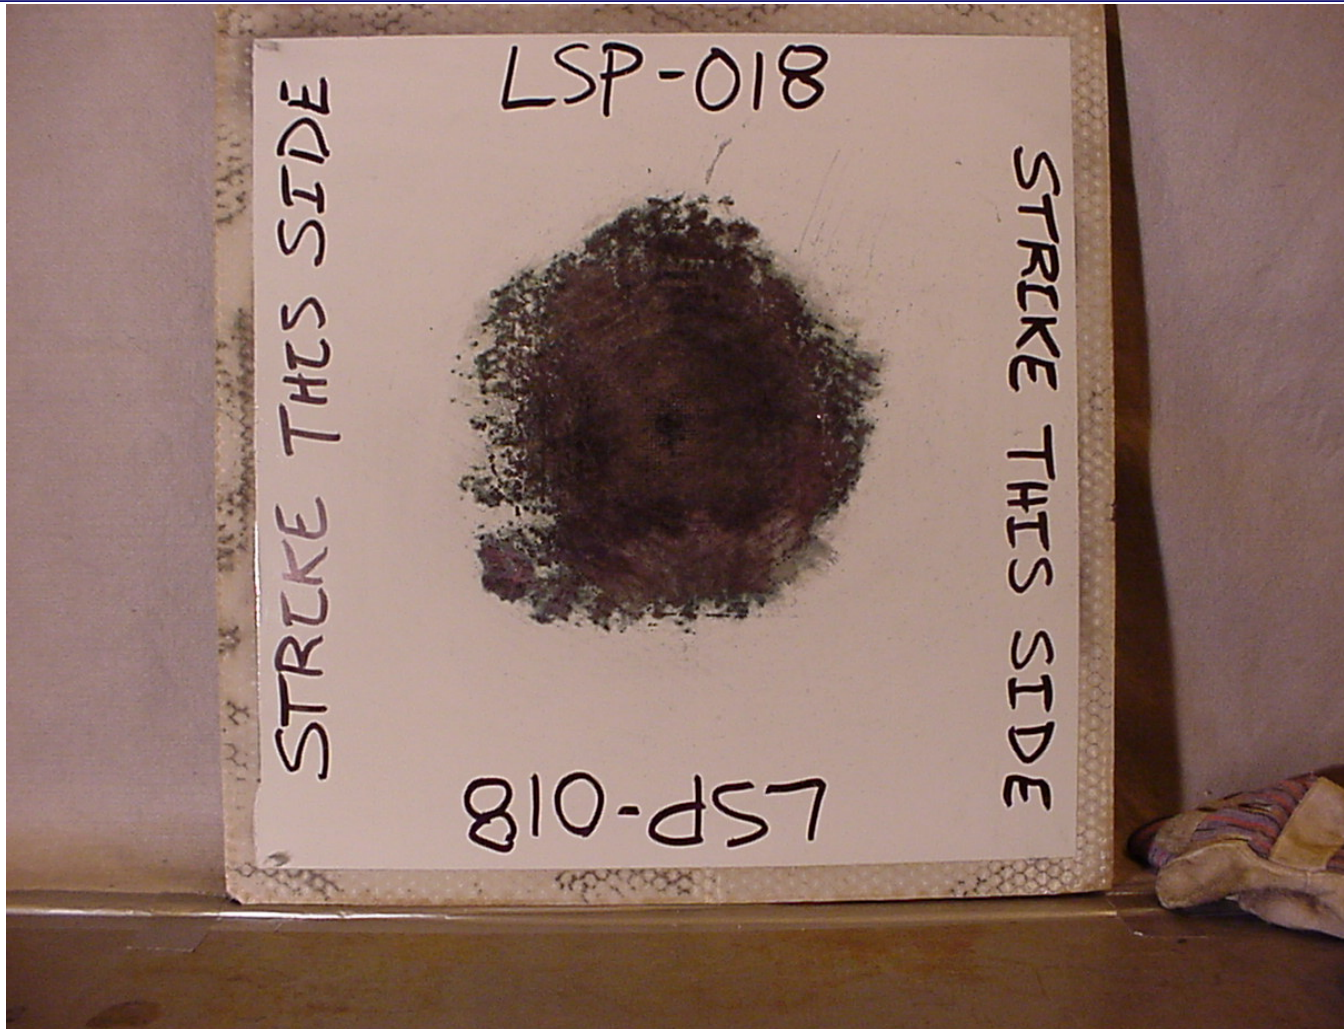
LSP-018, copper mesh, HRP core, after Zone 1A strike

Damage size
is 9-12 inches
with damage
penetrating
into the carbon
plies all the
way down to the
core.

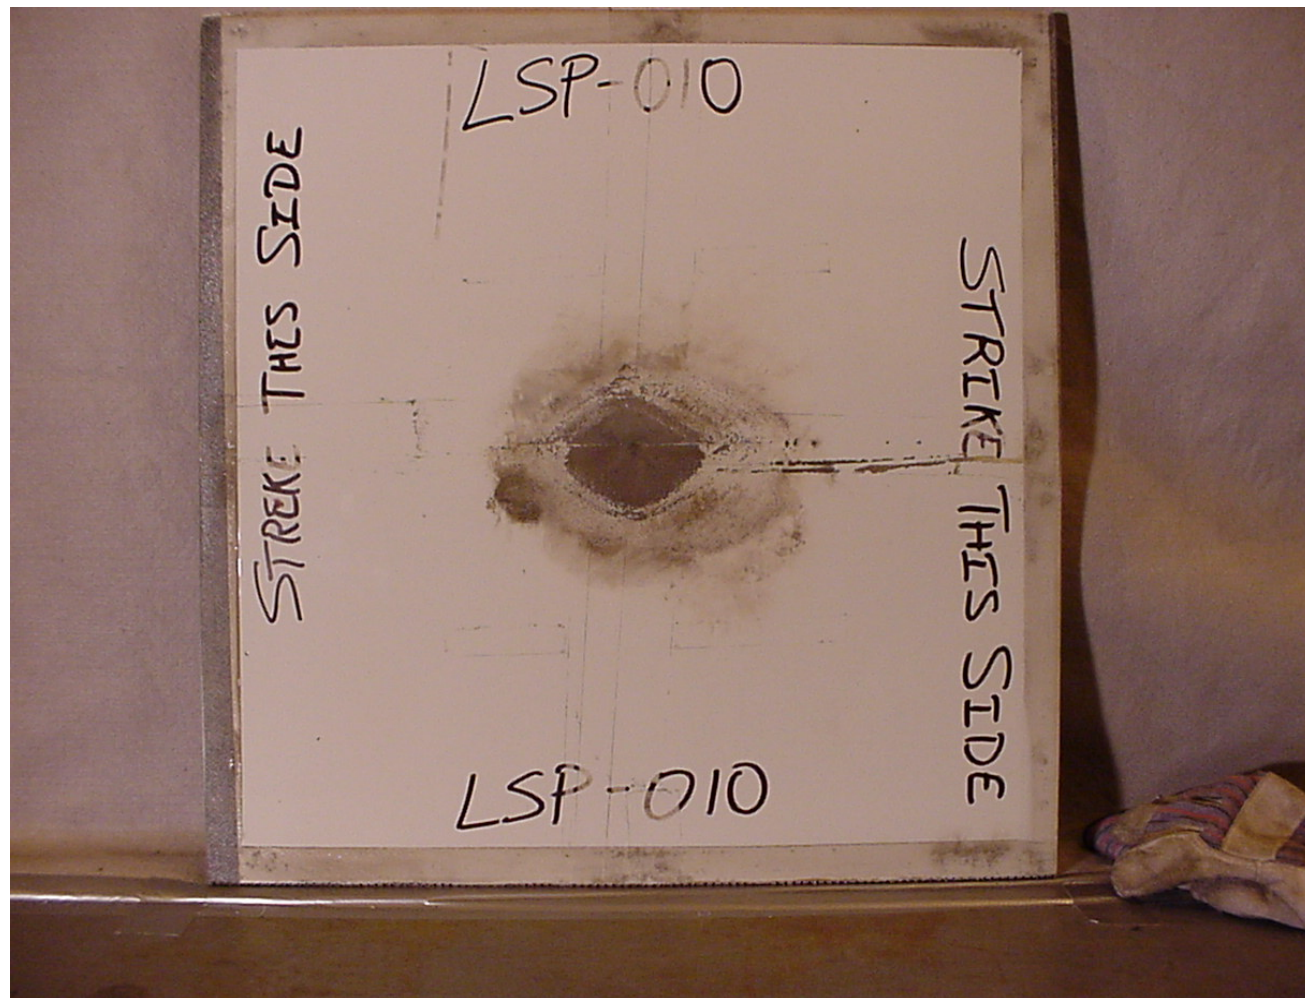
LSP-010, after Zone 1A strike

3-4 inch
Damage zone
Limited to outer
Mesh ply.

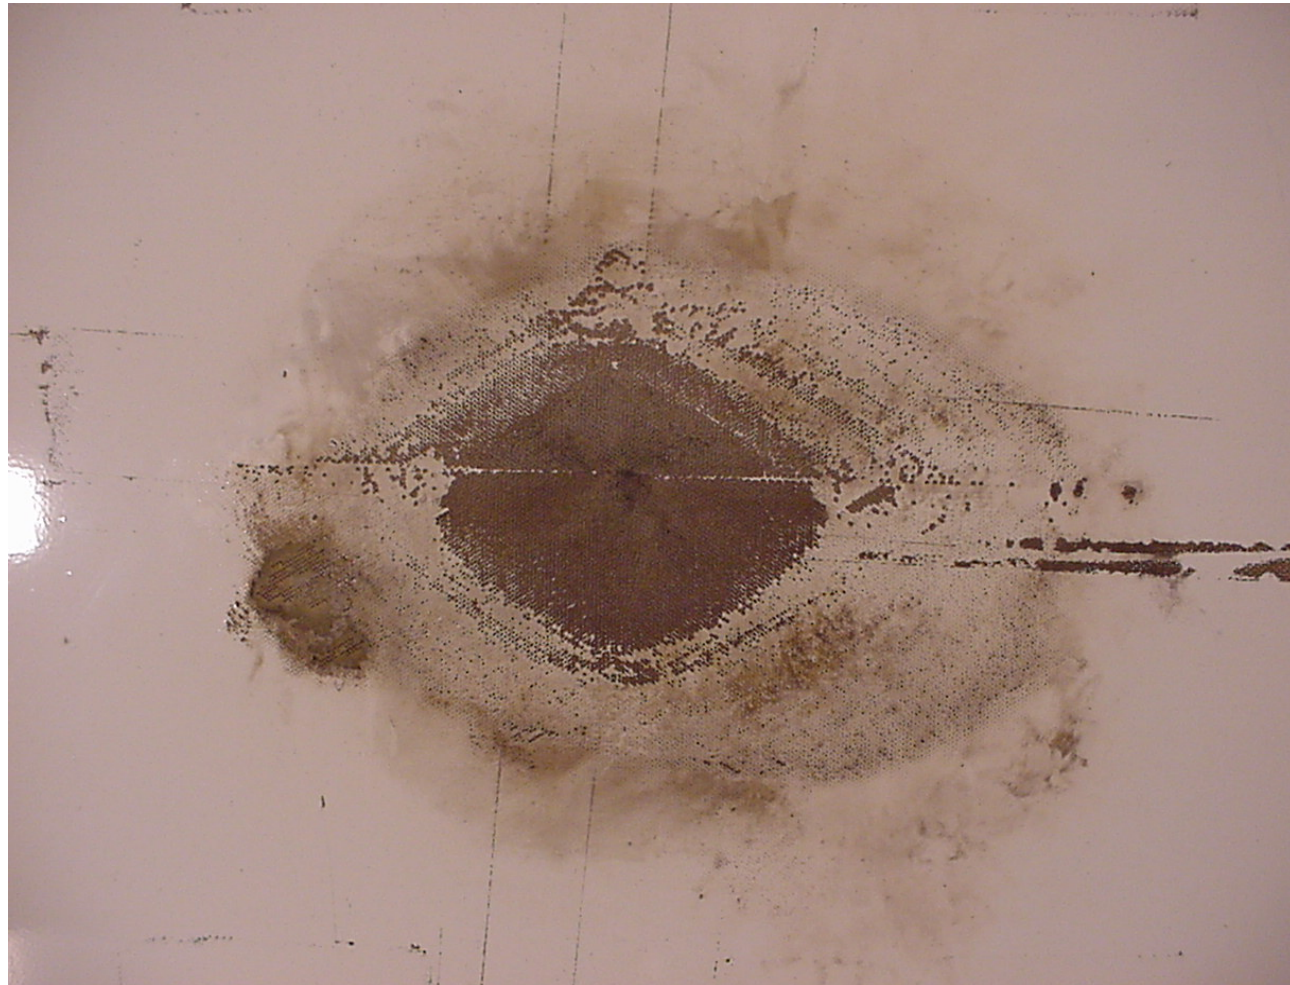
Panel 009, butt splice using aluminum mesh

Damage size
consistent with
other protected
panels using
aluminum mesh
3-4 inches, mesh
is only laminate
damaged, no
carbon plies were
impacted.

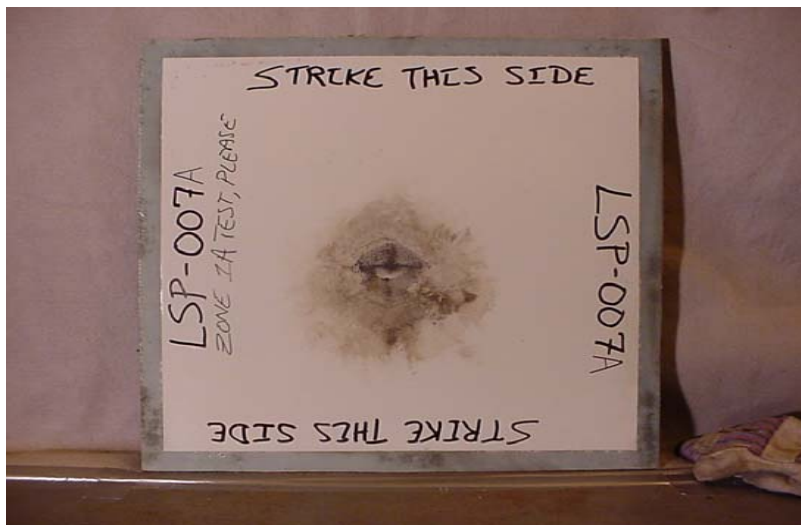
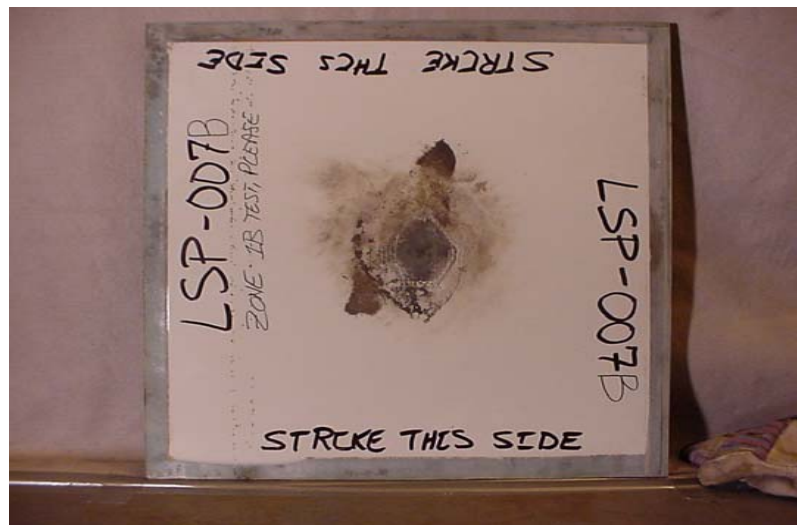
3-4 inch damage, mesh only

5-6 inch damage, mesh only

Zone 1A on left, Zone 1B on right, panel 007 using aluminum mesh protection

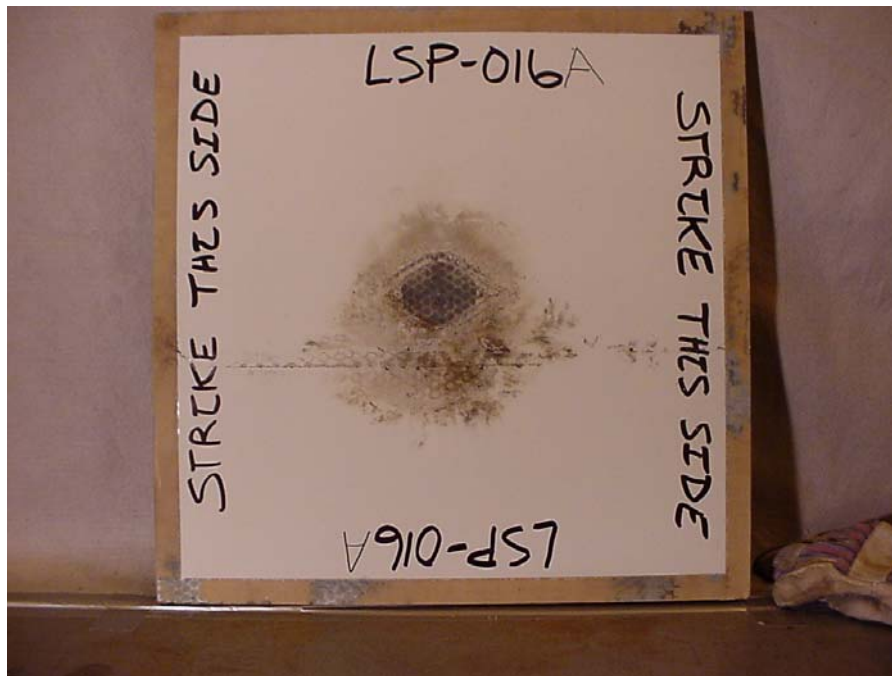
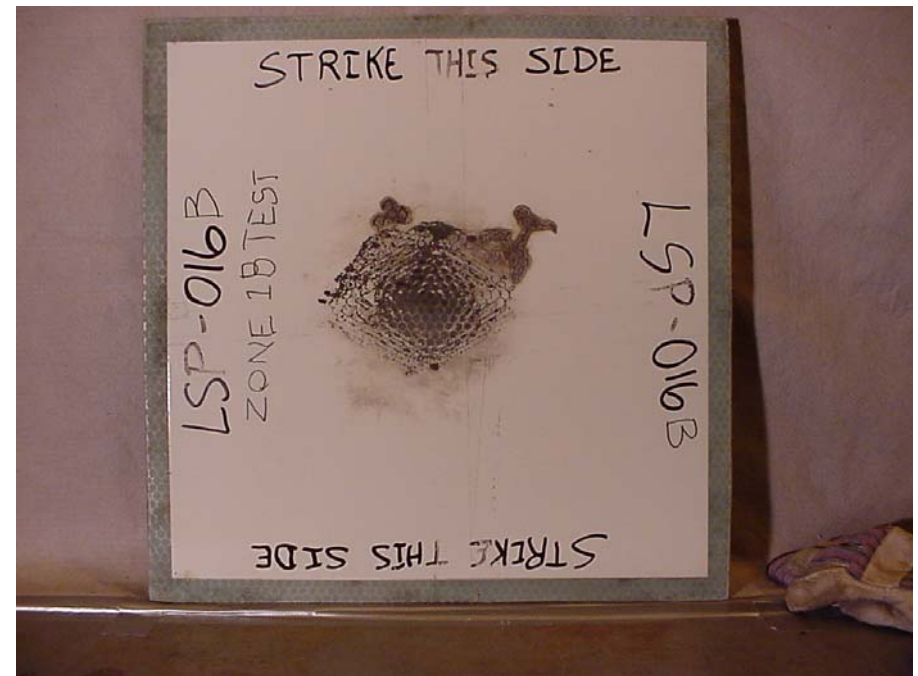
S-2 Glass 3-4 inch damage, mesh only

5-6 inch damage, mesh only

Zone 1A on left, Zone 1B on right, panel 016 using aluminum mesh protection

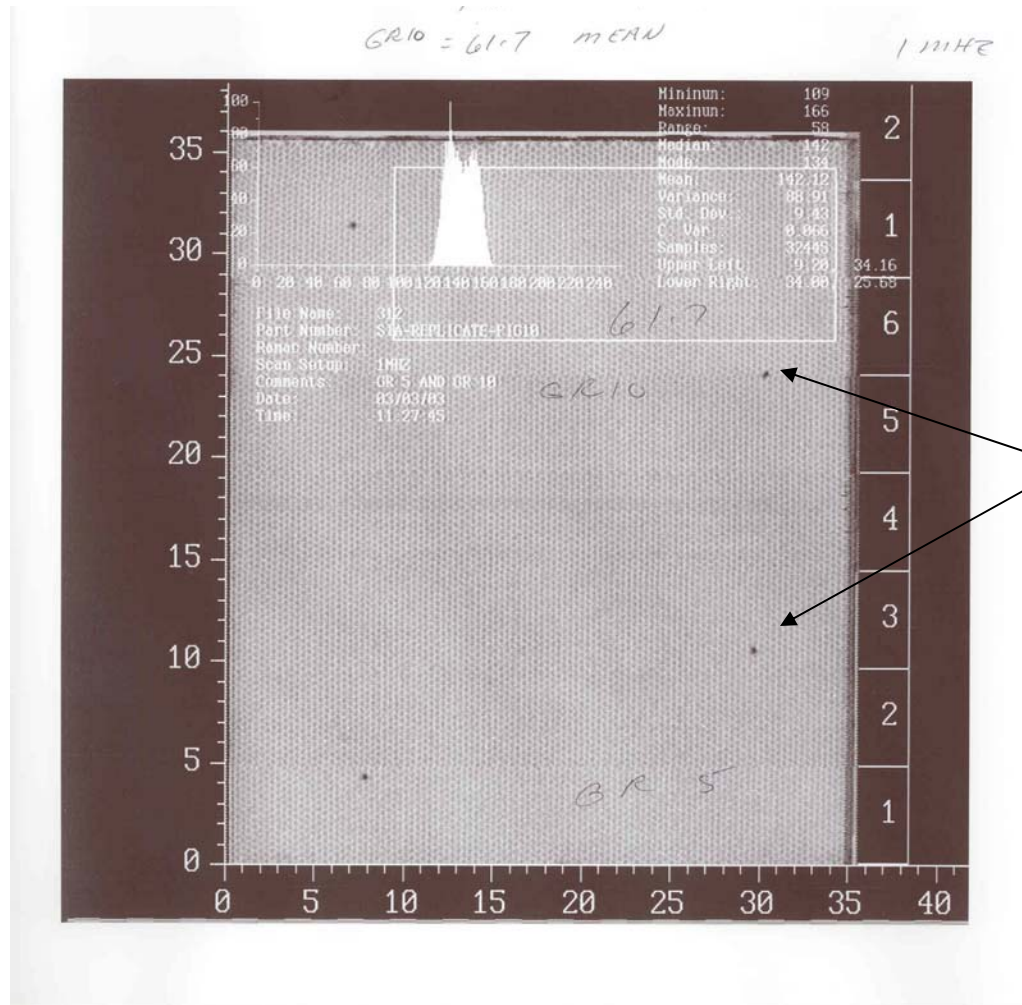
Typical NDI scan of 2' x 2' panels – nearly identical for all types – no discrepancies

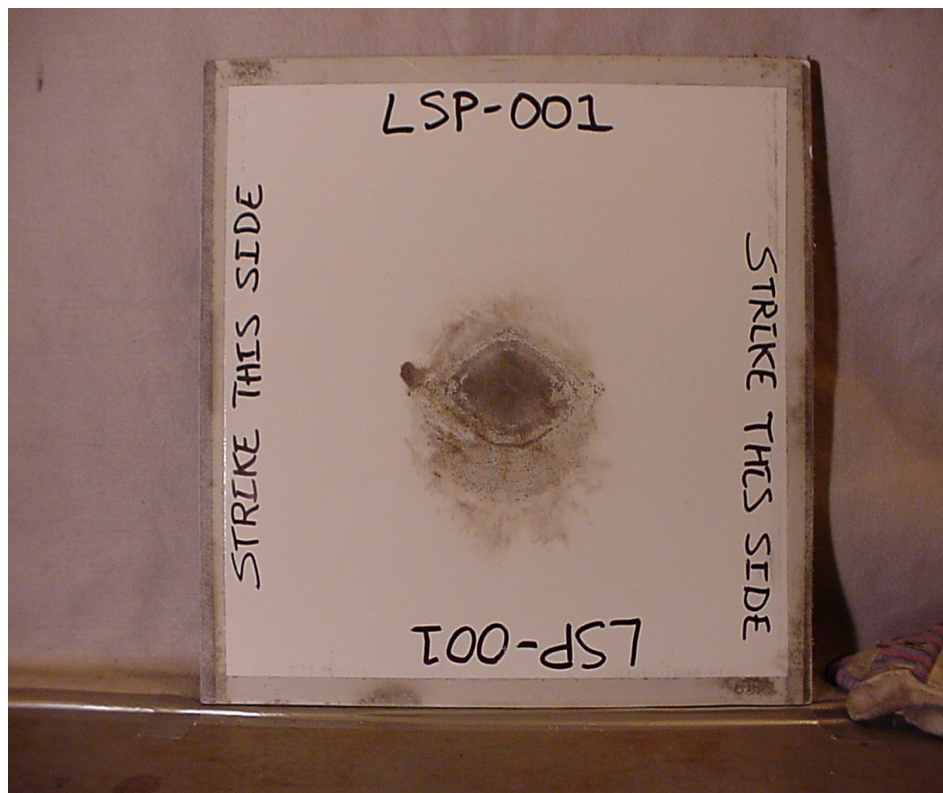
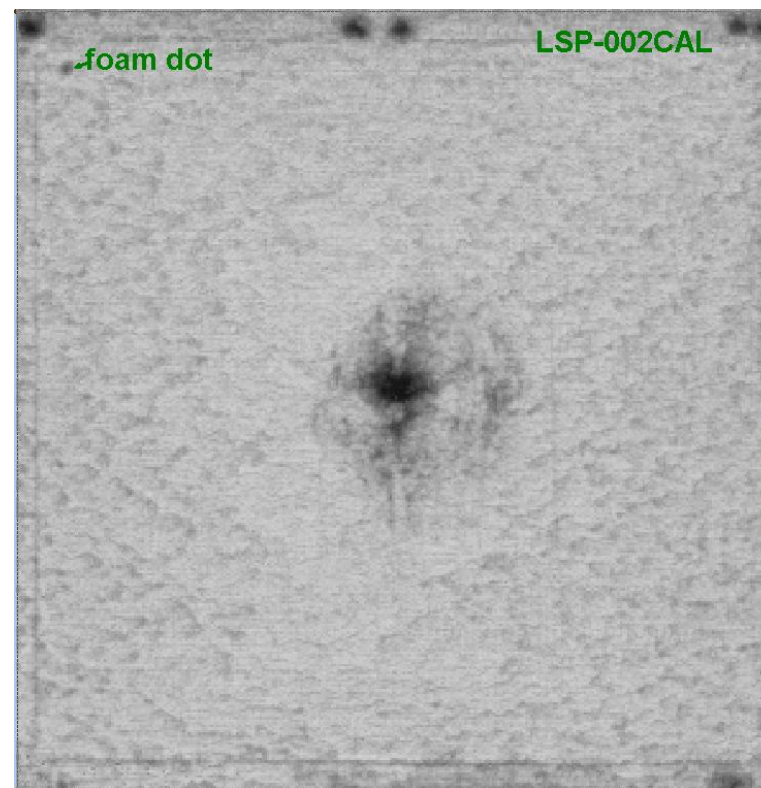
3-4 inch damage, mesh only - visual

1-2 inch damage, mesh only
-validated via TTU (NDI)

Visual damage of LSP-001, LSP-001 TTU scan on right

Note that NDI documented damage is slightly smaller than mesh burn area
