Repair Design, Test, and Process Considerations for Lightning Strikes

CACRC/MIL-HDBK-17 Conference
Amsterdam, Netherlands May 7-11, 2007

John M. Welch

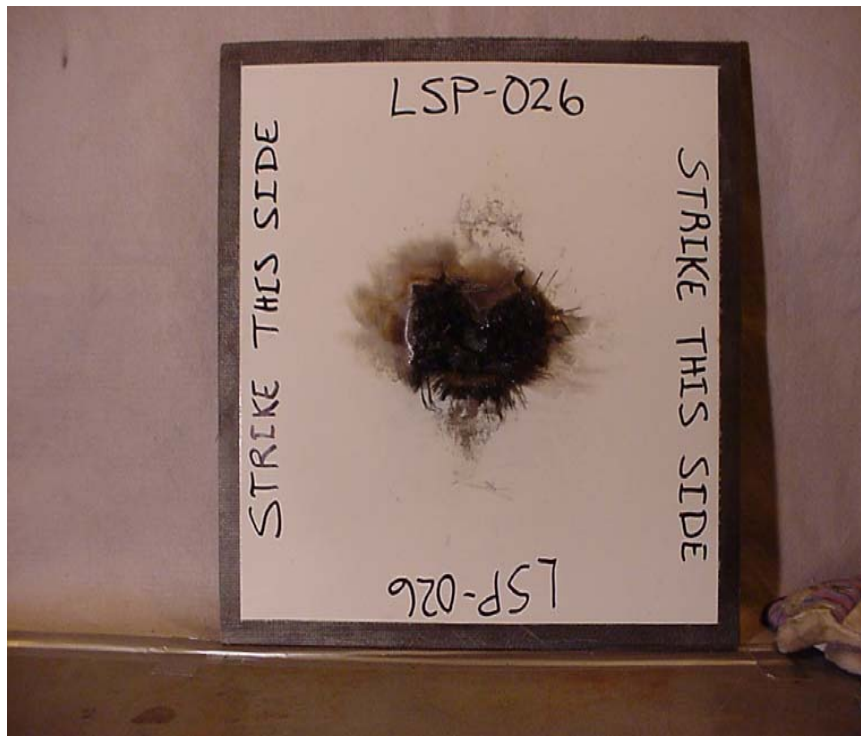
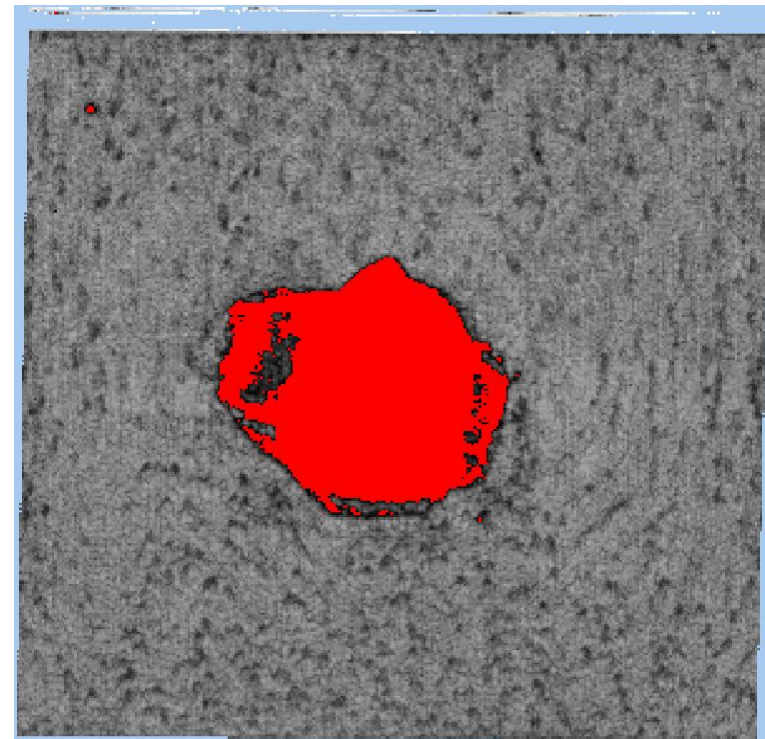
7-9 inch damage, thru hole - visual

Damage area 12 inches, plus thru hole –
Validated by TTU

Visual damage of LSP-026, LSP-011 TTU scan on right

Note that NDI documented damage is larger than visual damage on unprotected panel

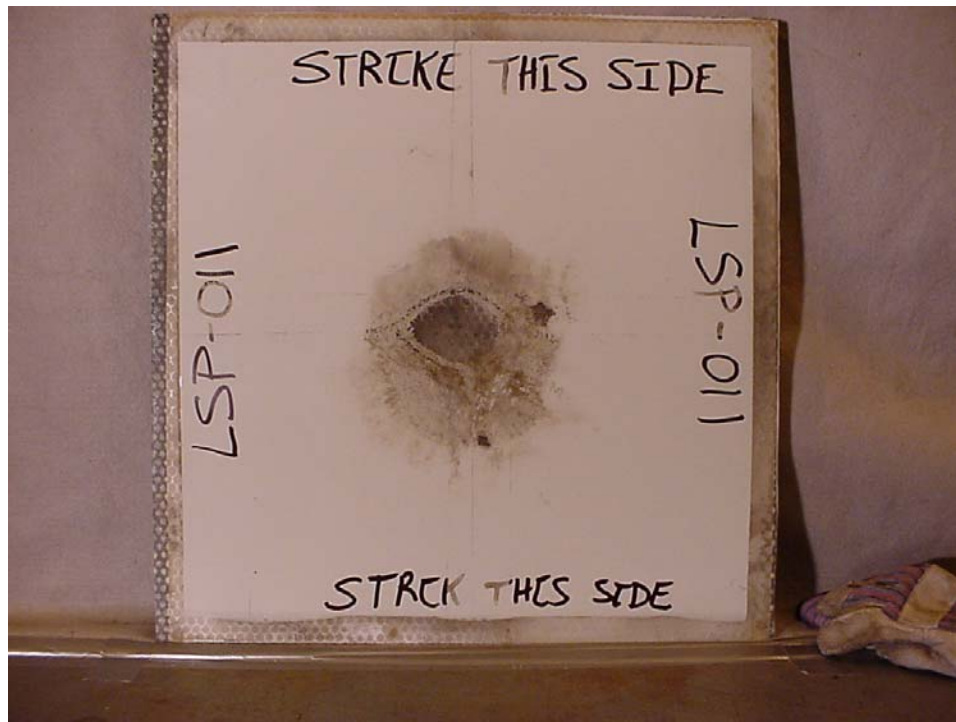
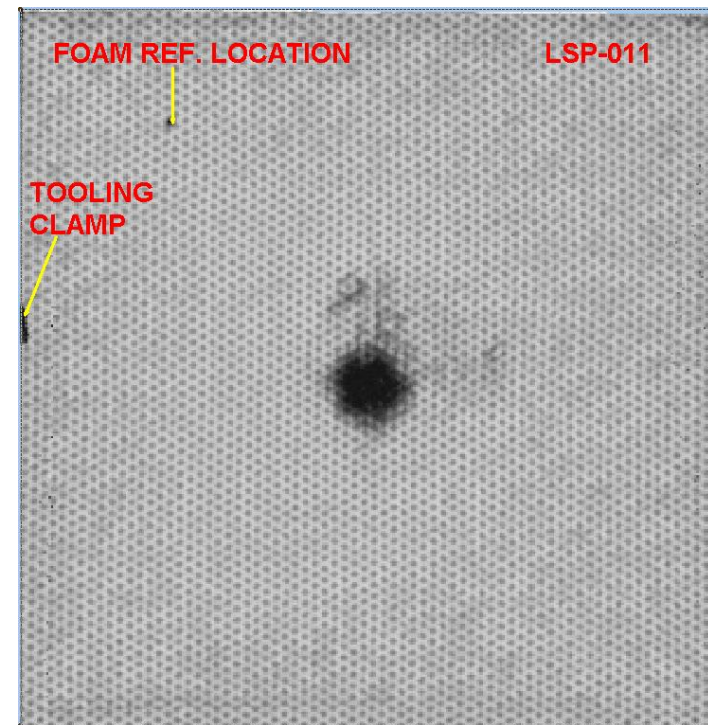
3-4 inch damage, mesh only - visual

Just under 3 inch damage, mesh only –
Validated by TTU

Visual damage of LSP-011, LSP-011 TTU scan on right

Note that NDI documented damage is slightly smaller than mesh burn area

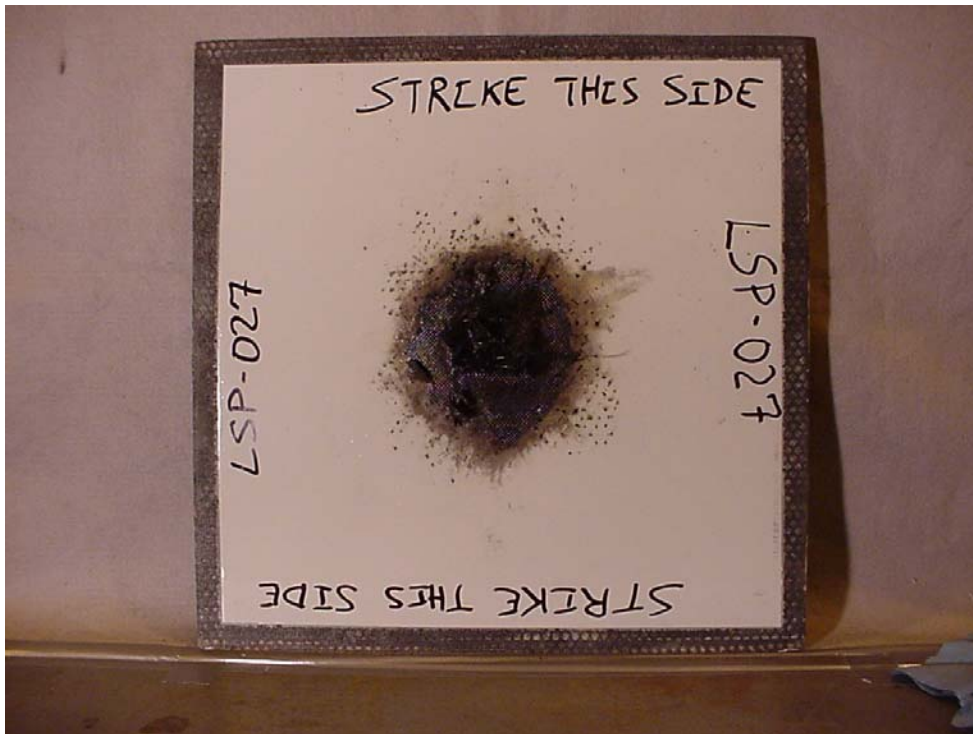
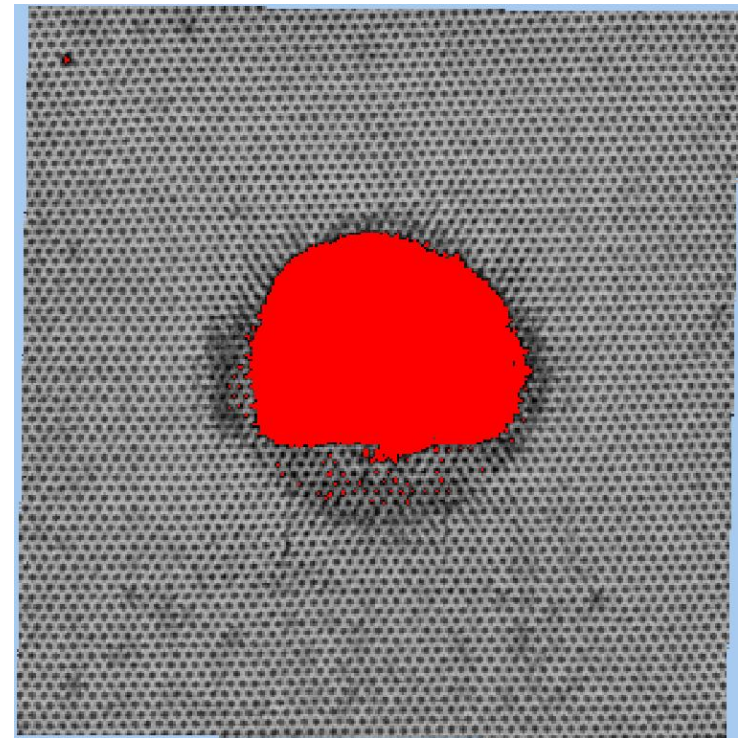
8 inch DIA damage, thru hole - visual

Damage area 10 inches, plus thru hole –
Validated by TTU

Visual damage of LSP-027, LSP-027 TTU scan on right

Note that NDI documented damage is larger than visual damage on unprotected panel

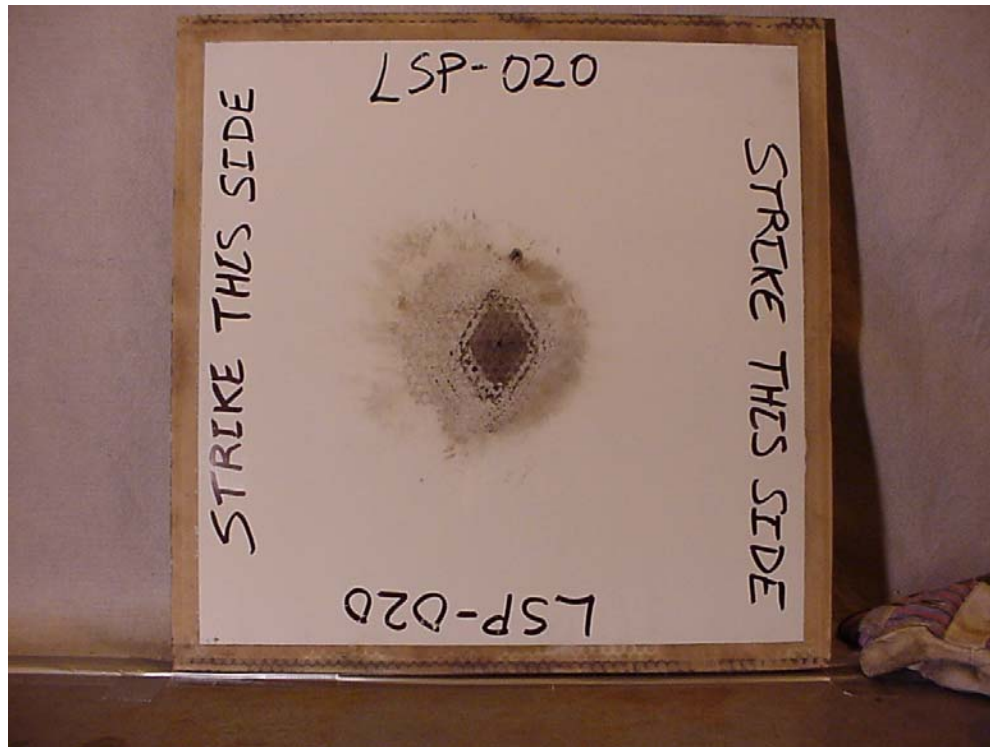
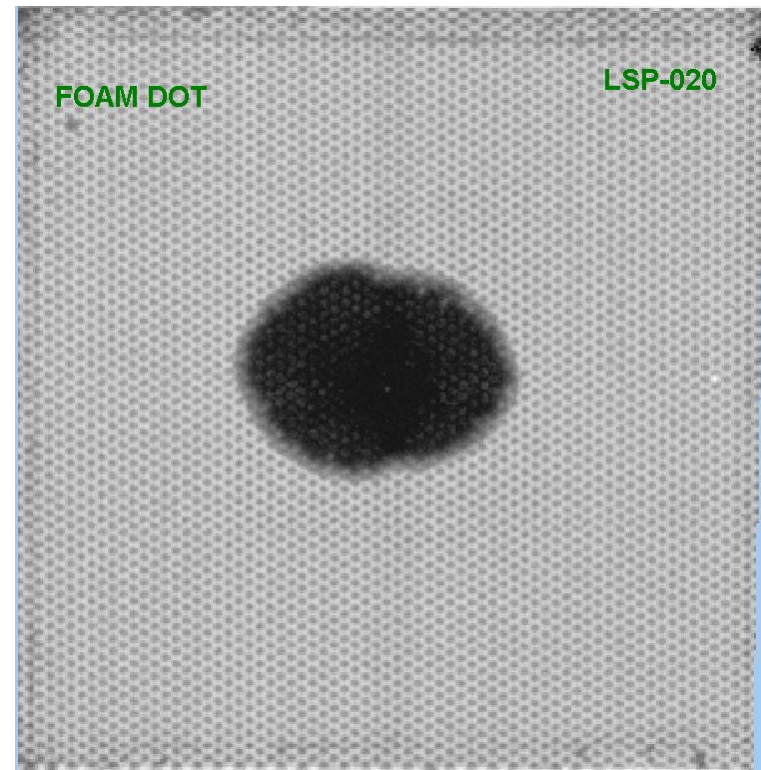
6-7 inch DIA damage, mesh and 1-2 plies

Damage area 10 inches, dis-bonded from core –
Validated by TTU

Visual damage of LSP-020, LSP-020 TTU scan on right

Note that NDI documented damage is larger than visual damage on protected aluminum core panel

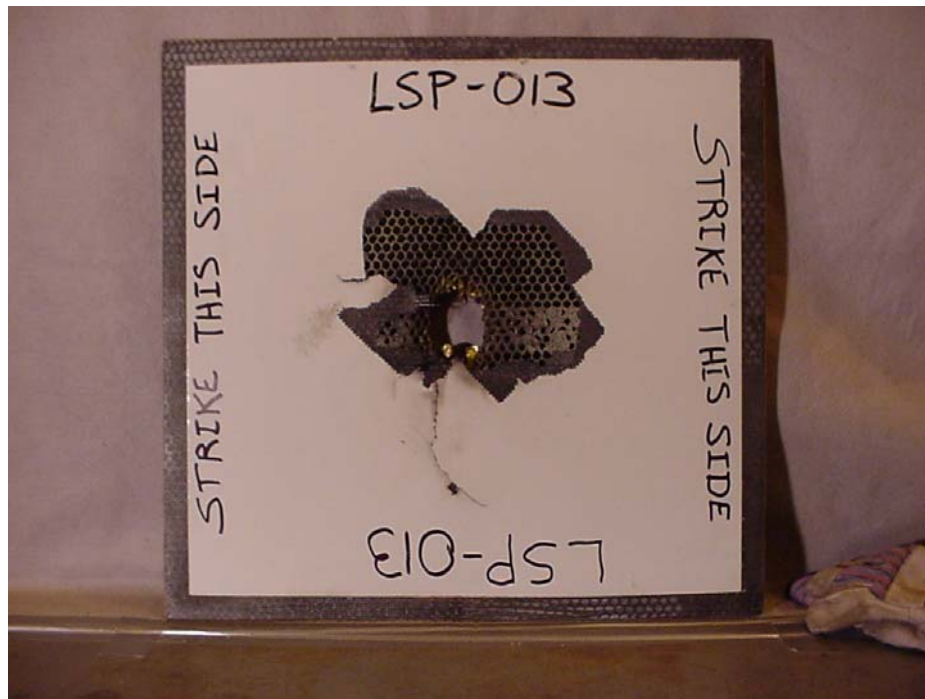
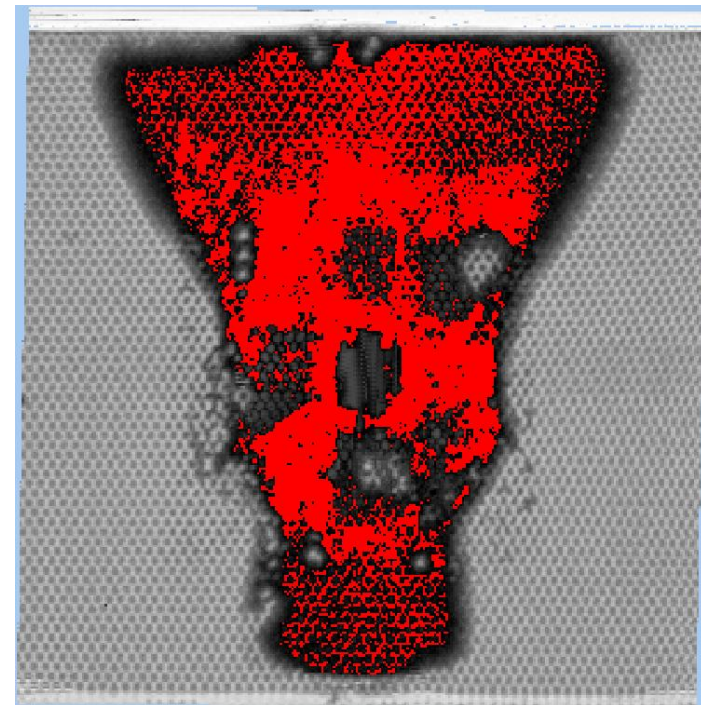
12-14 inch DIA, panel split, large area
- visual

Damage area entire panel destroyed –
Validated by TTU

Visual damage of LSP-013, LSP-013 TTU scan on right

Note that NDI documented damage is much larger than visual damage on unprotected aluminum core panel

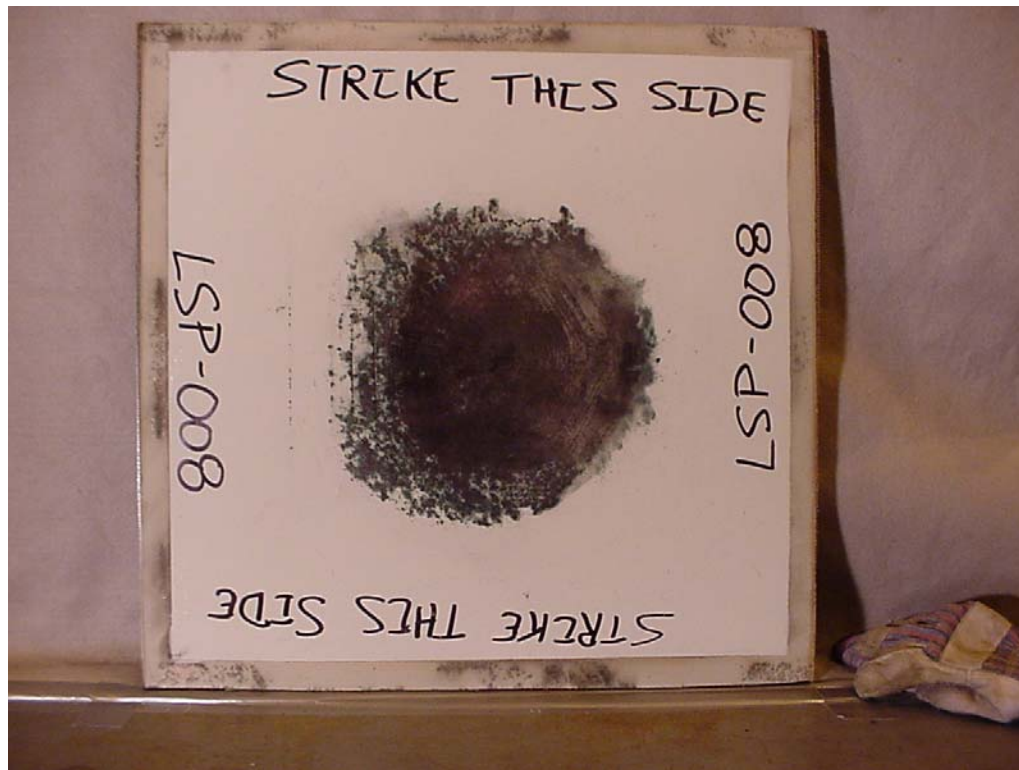
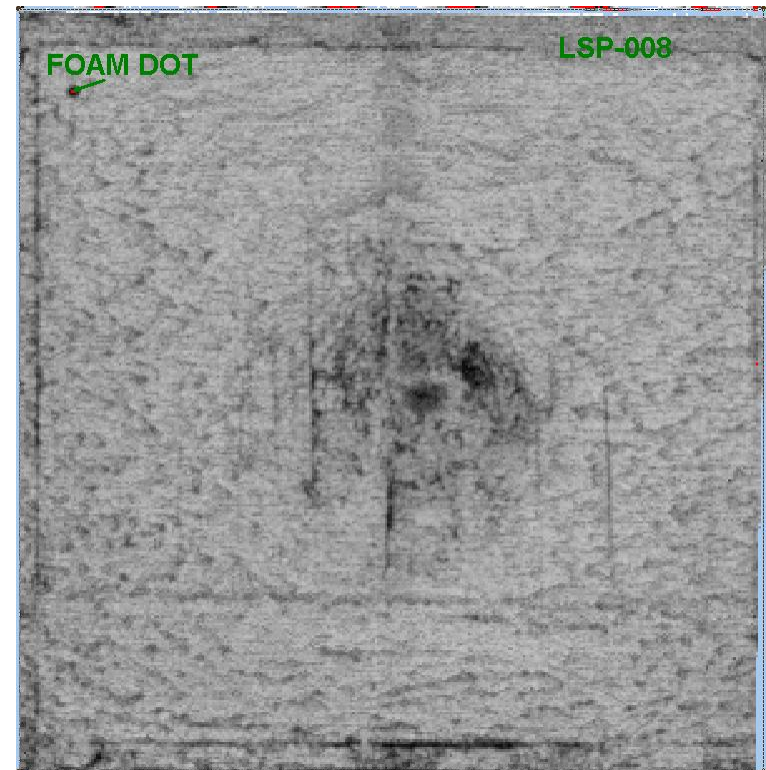
12-14 inch DIA, Outer 1-2 plies
- visual

Damage area 11 inch DIA 1-2 ply–
Validated by TTU

Visual damage of LSP-008, LSP-008 TTU scan on right

Note that NDI documented damage is much larger than visual damage on copper mesh protected panel,
Attenuation “streaks” running vertical will have to be addressed in repair.....

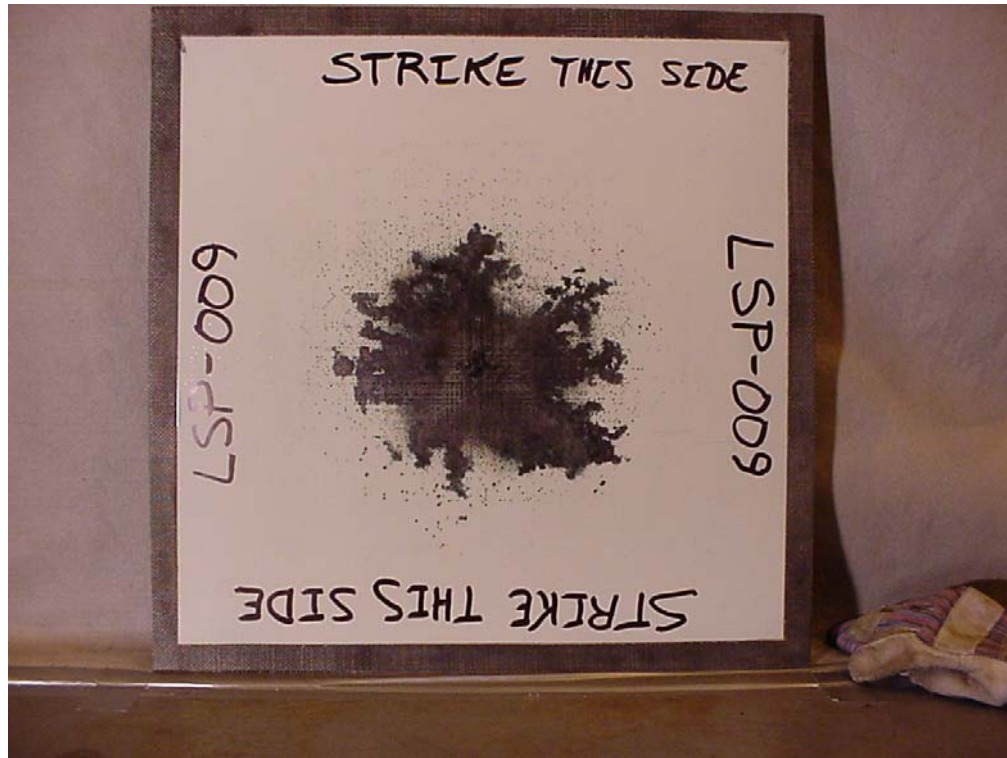
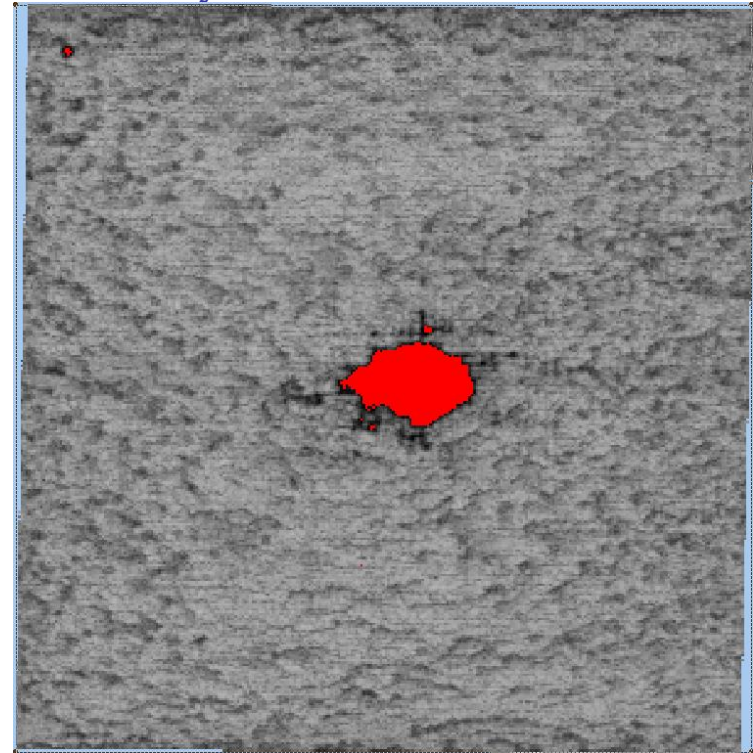
9-11 inch DIA, Outer 1-2 plies
- visual

Damage area 9 inch DIA 1 ply– dis-bonded
From core at center 4-5 inch DIA
Validated by TTU

Visual damage of LSP-009, LSP-009 TTU scan on right

Note that NDI documented damage is “deeper into the thickness” than visual damage on Phos-Bronze protected panel.....note spotted attenuation representing “detonation chord” effect....

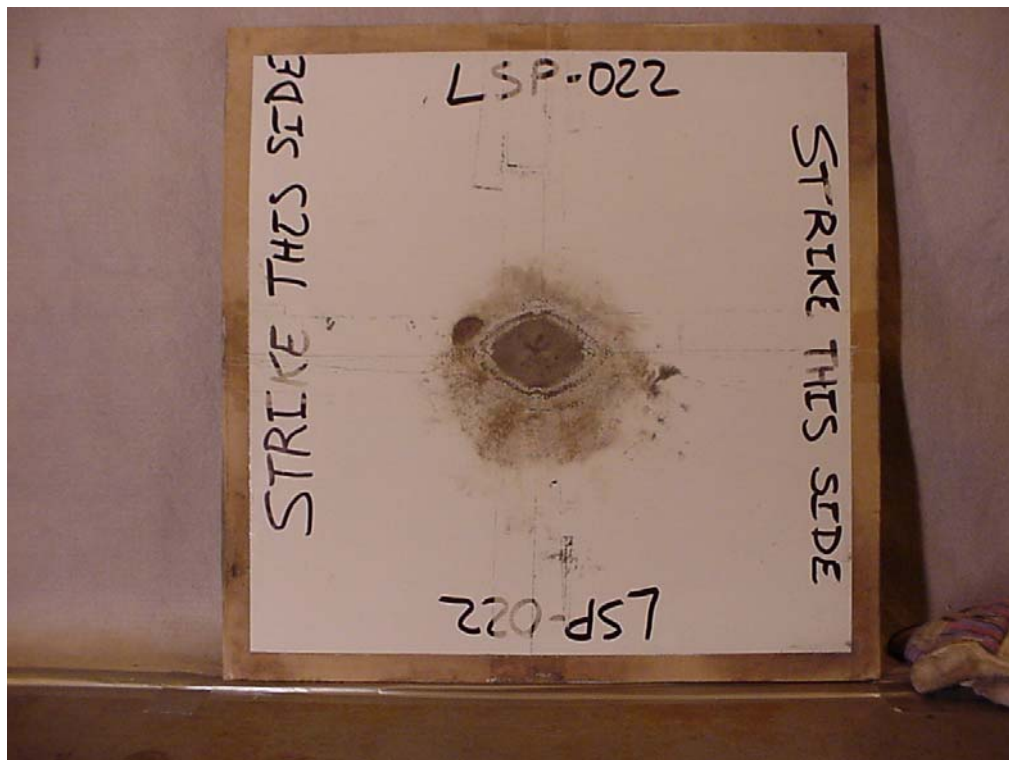
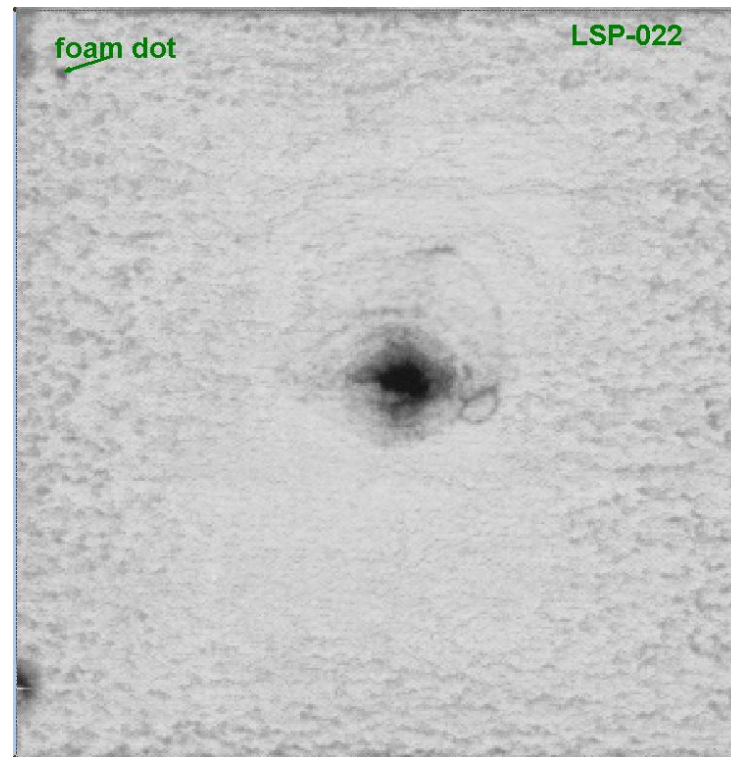
3-4 inch DIA, mesh only
- visual

Damage area 2 inch DIA, mesh only-
Validated by TTU

Visual damage of LSP-022, LSP-022 TTU scan on right

Note that NDI documented damage is less than visual damage on Al mesh protected 0.50 inch thick panel.....

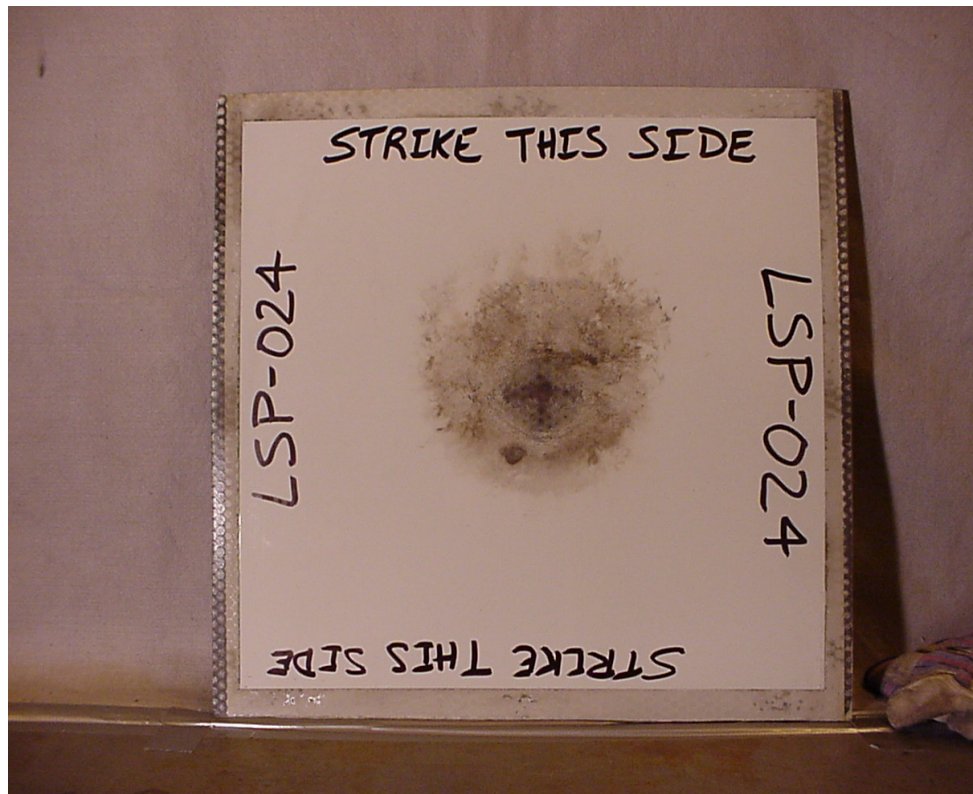
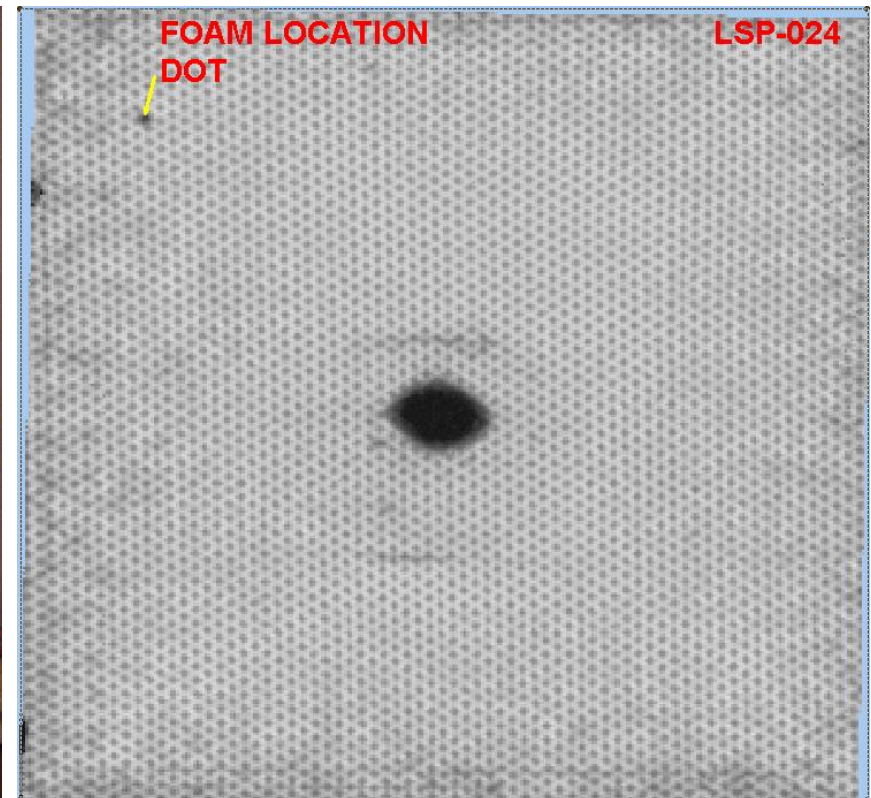
3/8 HRP (0.5 inch thk) 3-4 inch DIA, mesh only
Al Mesh - visual
S-2 Glass

Damage area 2 inch DIA, mesh only-
Validated by TTU

Visual damage of LSP-024, LSP-024 TTU scan on right

Note that NDI documented damage is less than visual damage on Al mesh protected 0.50 inch thick panel.....

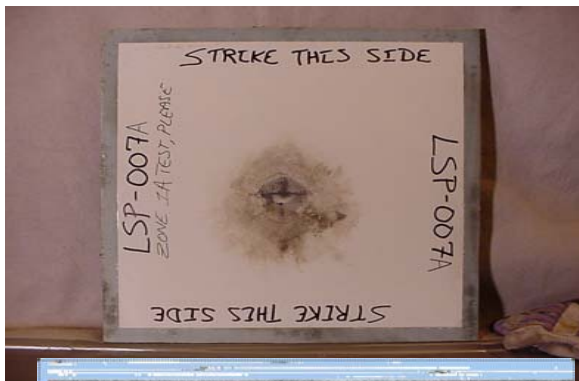
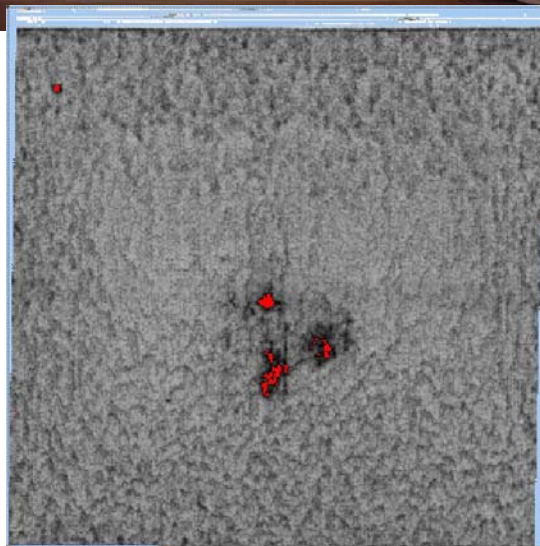
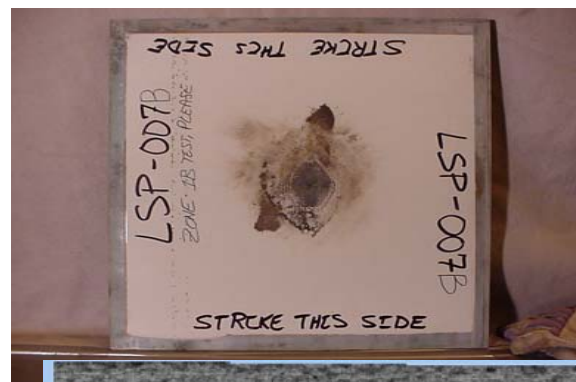
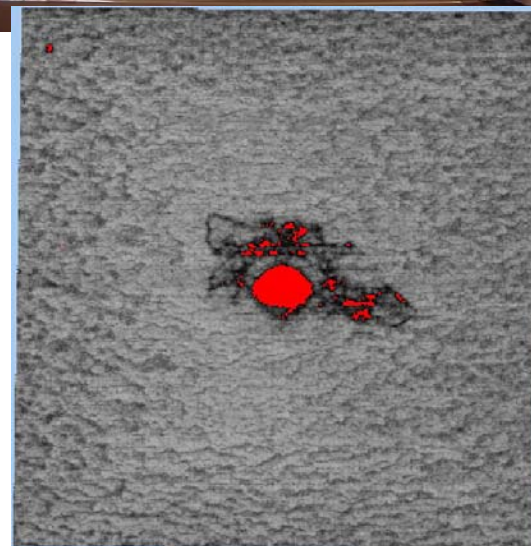
3-4 inch damage, mesh only - visual

1-2 inch locations – validated by TTU

5-6 inch damage, mesh only - visual

2-3 inch DIA locations – validated by TTU

Zone 1A on left, Zone 1B on right, panel 007 using aluminum mesh protection

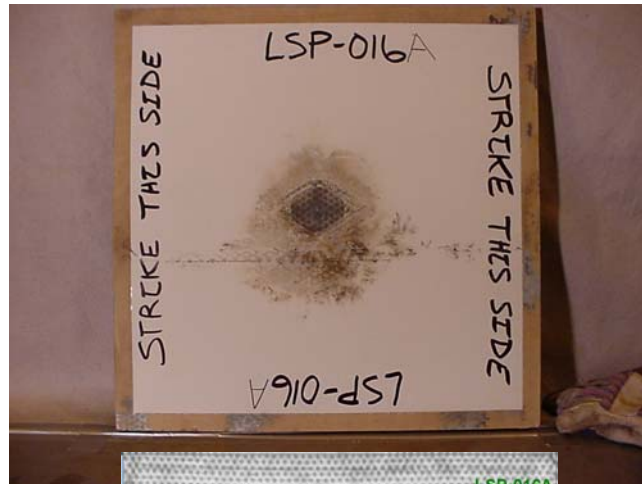
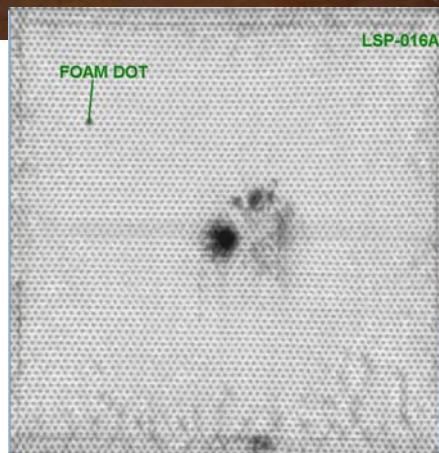
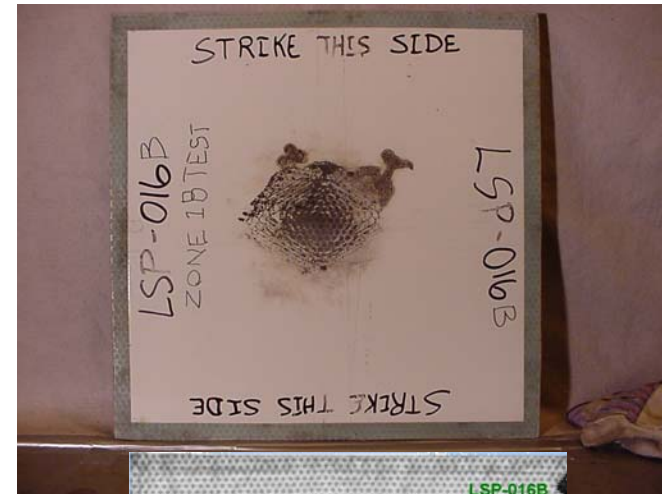
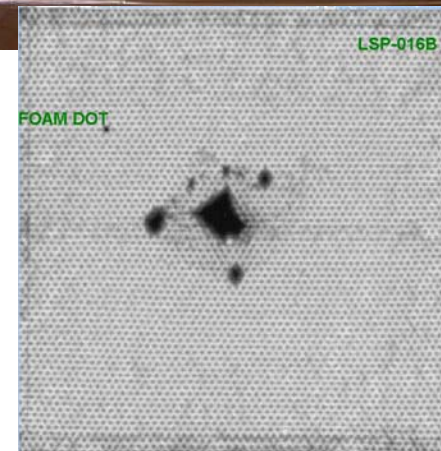
3-4 inch damage, mesh only

1-2 inch locations – validated by TTU

5-6 inch damage, mesh only

2-3 inch DIA locations – validated by TTU

Zone 1A on left, Zone 1B on right, panel 016 using aluminum mesh protection

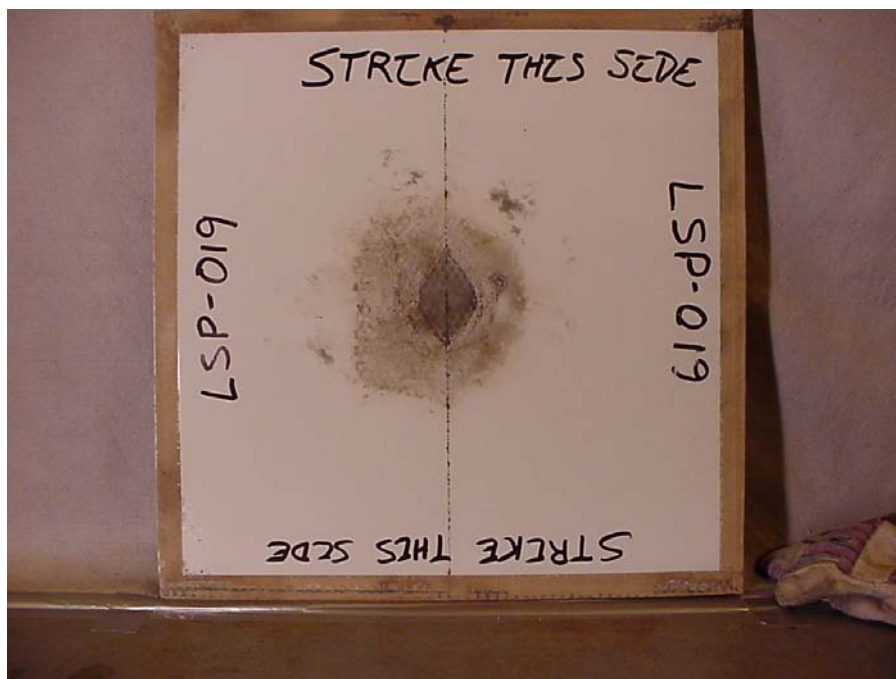
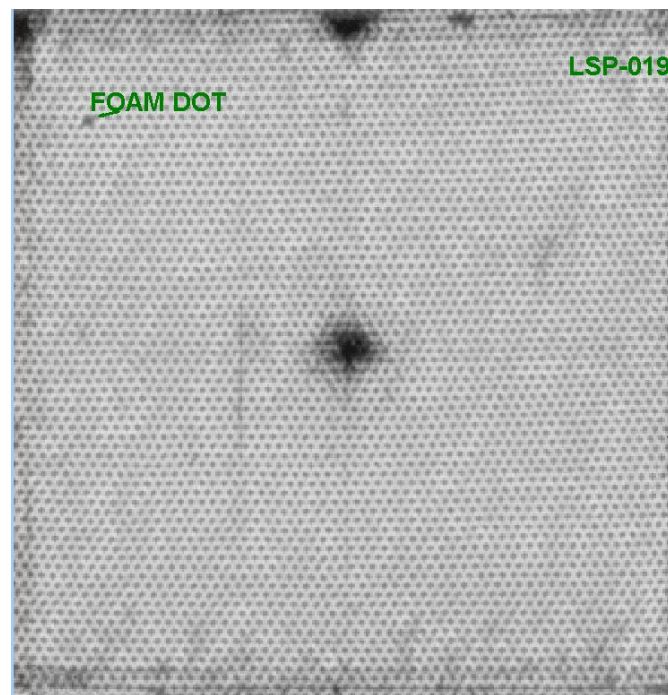
3-4 inch DIA, mesh only
- visual

Damage area 1-1.5 inch DIA, mesh only-
Validated by TTU

Visual damage of LSP-019, LSP-019 TTU scan on right

Note that NDI documented damage is the least amount, all panels, for this configuration.....
