Lufthansa Perspectives on Safe Composite Maintenance Practices

Damages on composite components

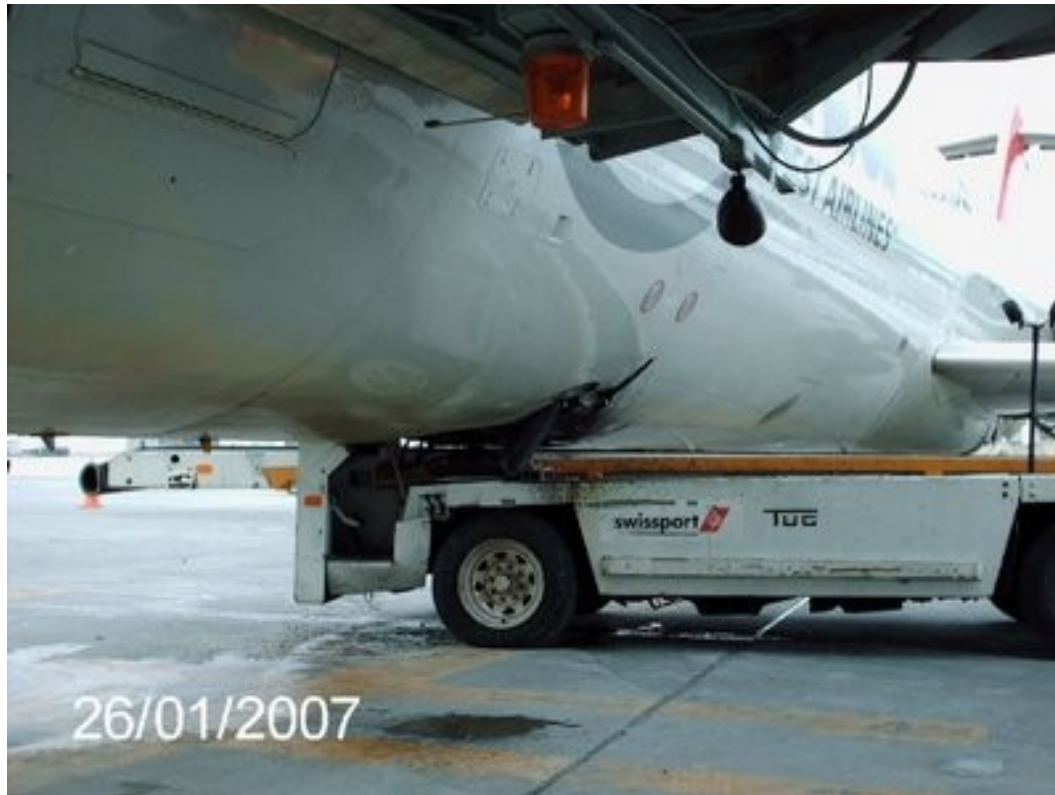
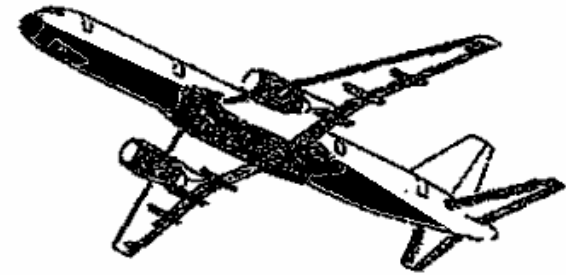
Foreign Object Damage (FOD) ground service vehicles

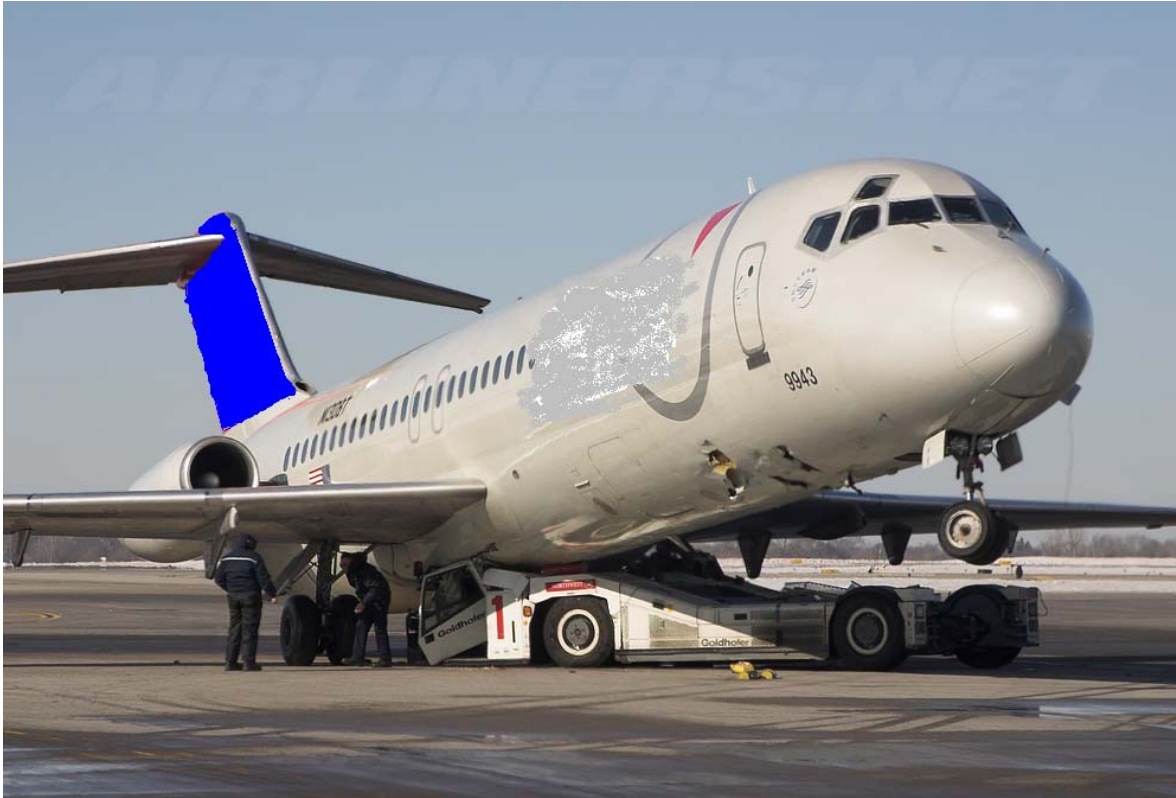
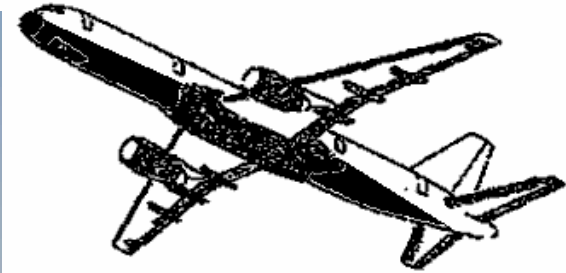
Foreign Object Damage (FOD) ground service vehicles

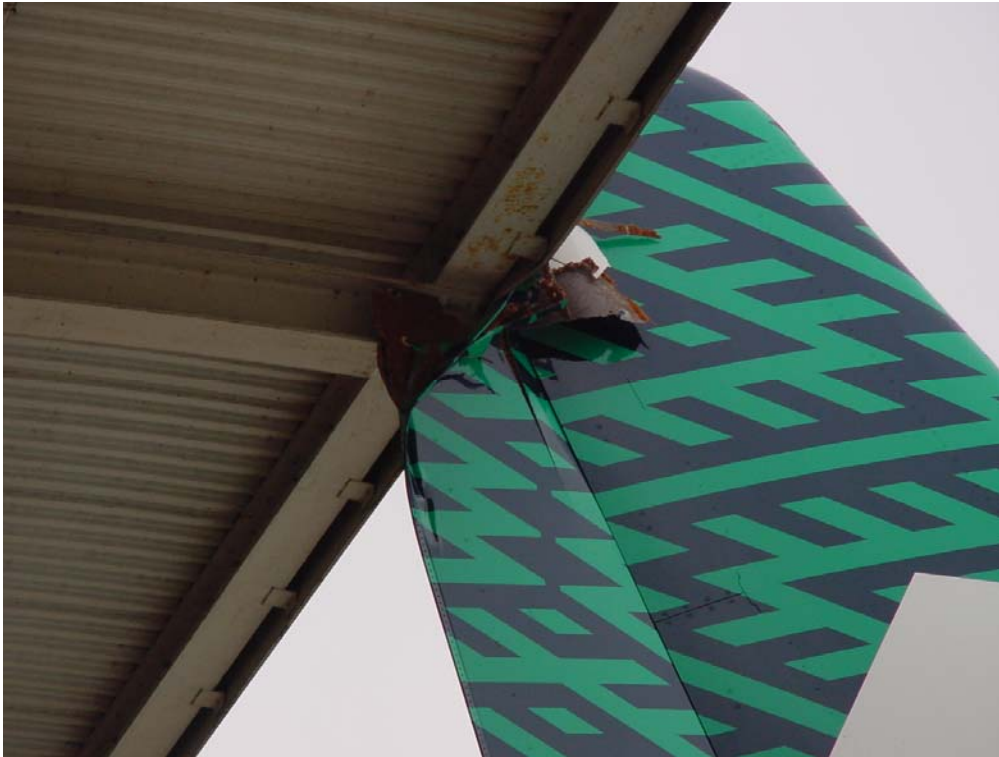
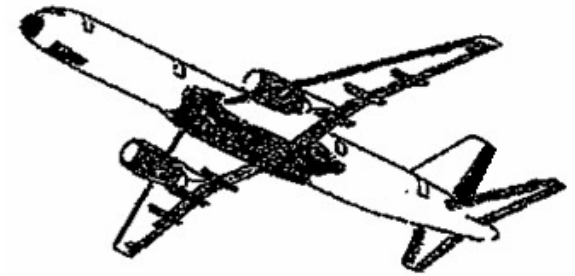
Foreign Object Damage (FOD) towing damage

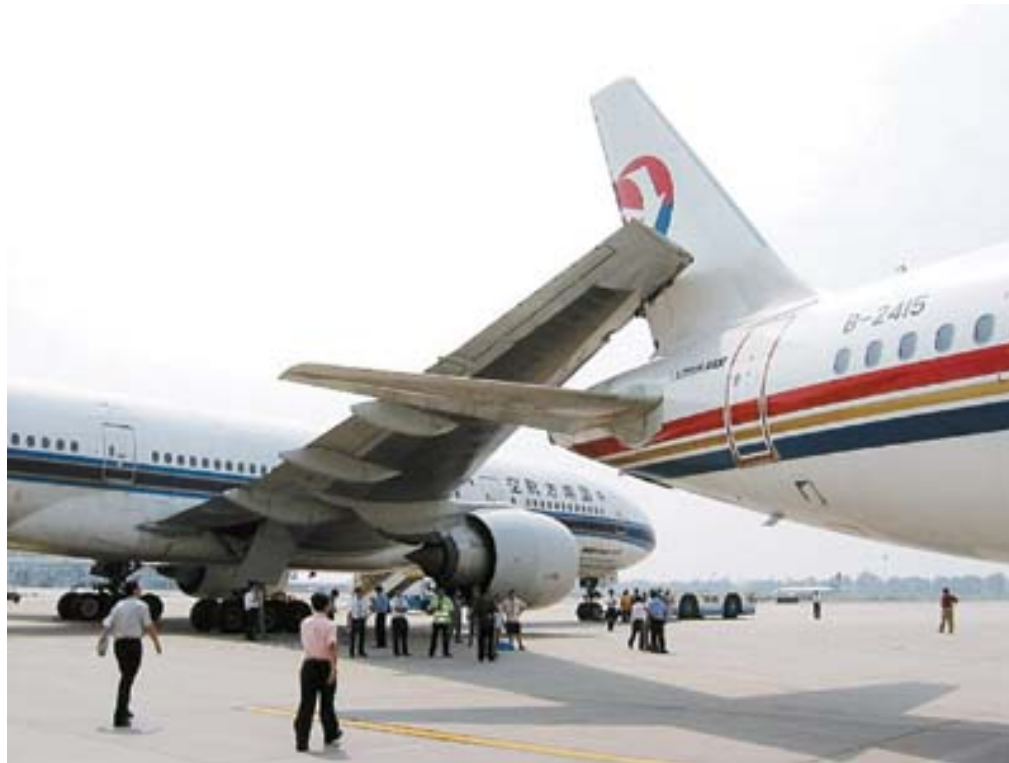
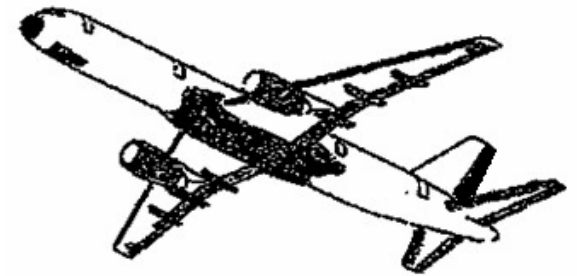
Foreign Object Damage (FOD) towing damage

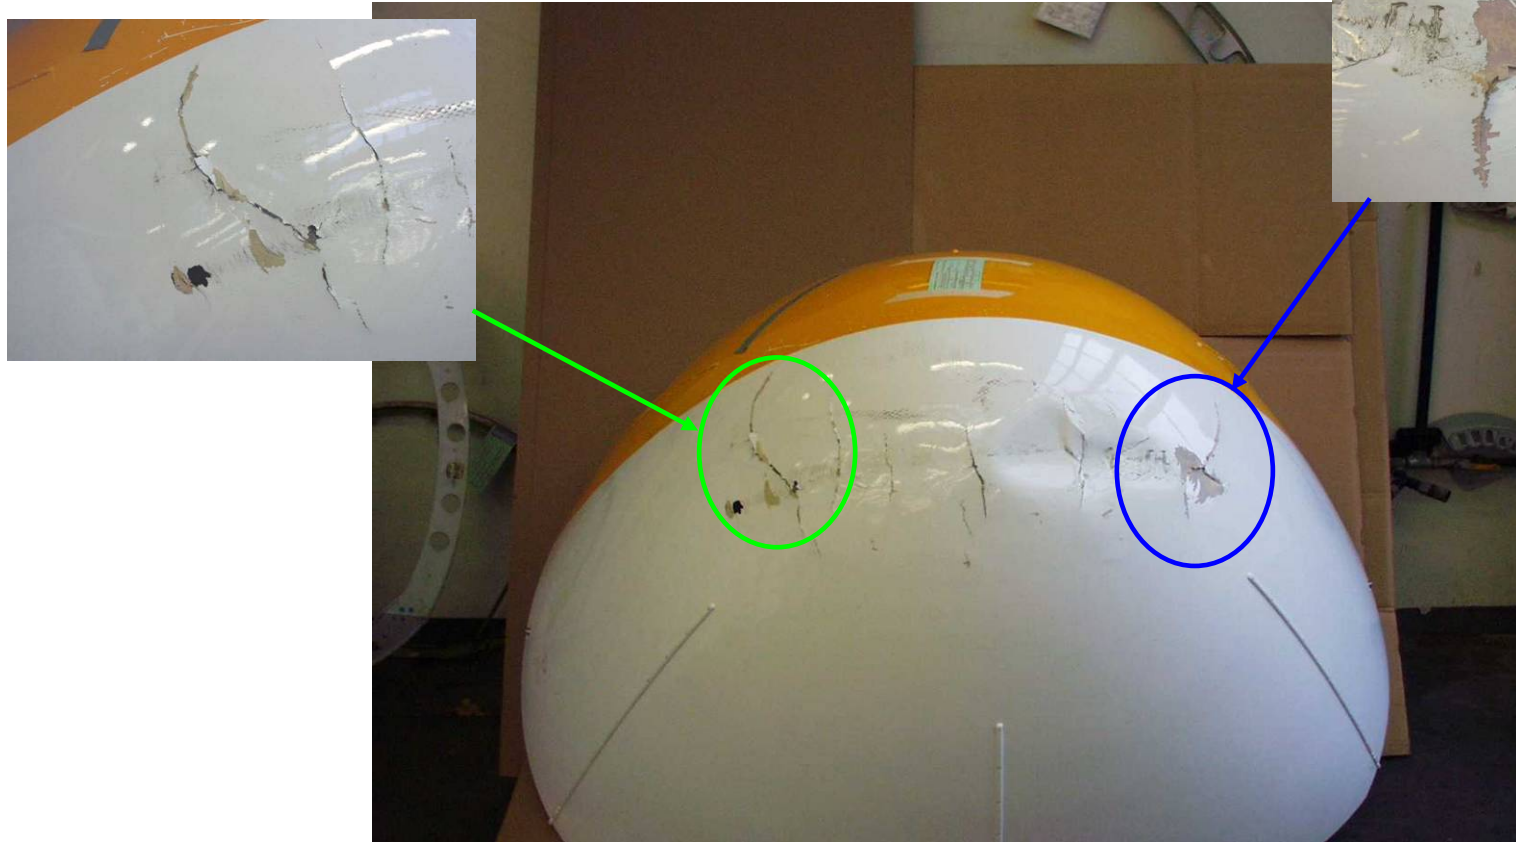
Foreign Object Damage (FOD) docking damage

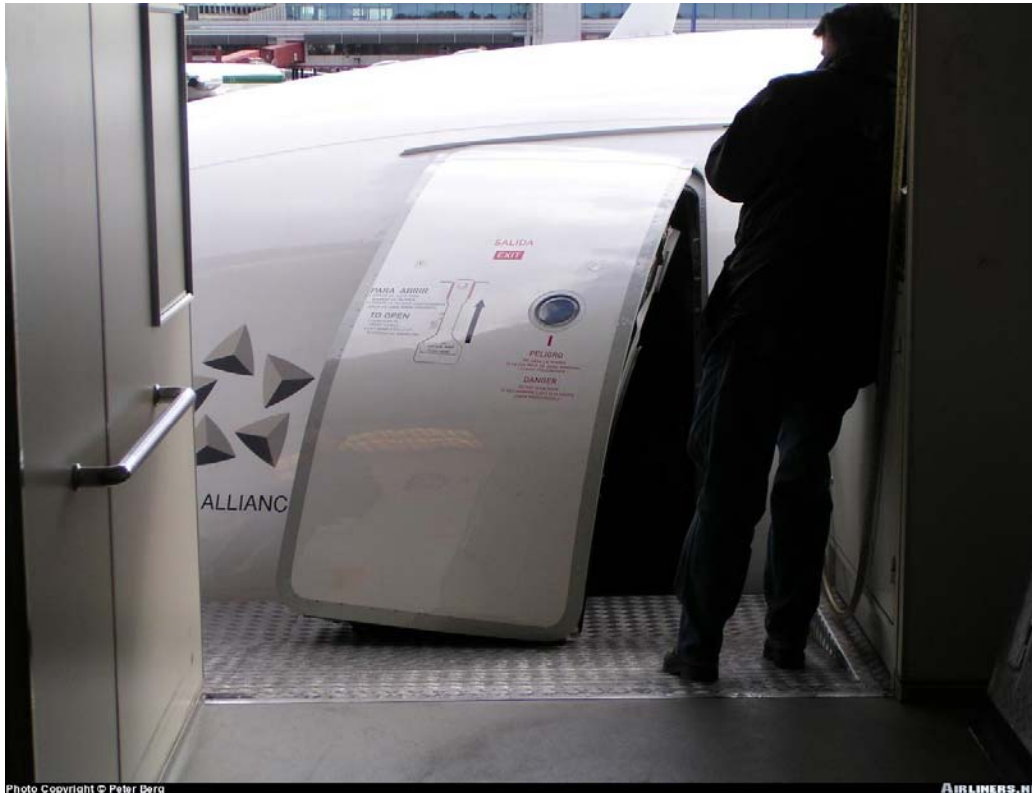
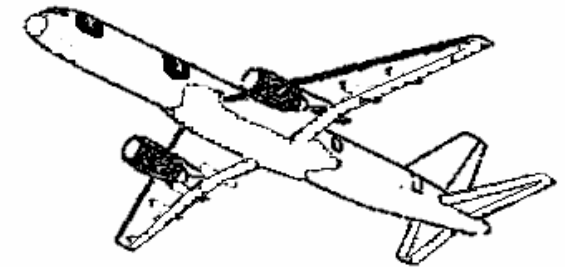
Foreign Object Damage (FOD) Passenger fly bridge

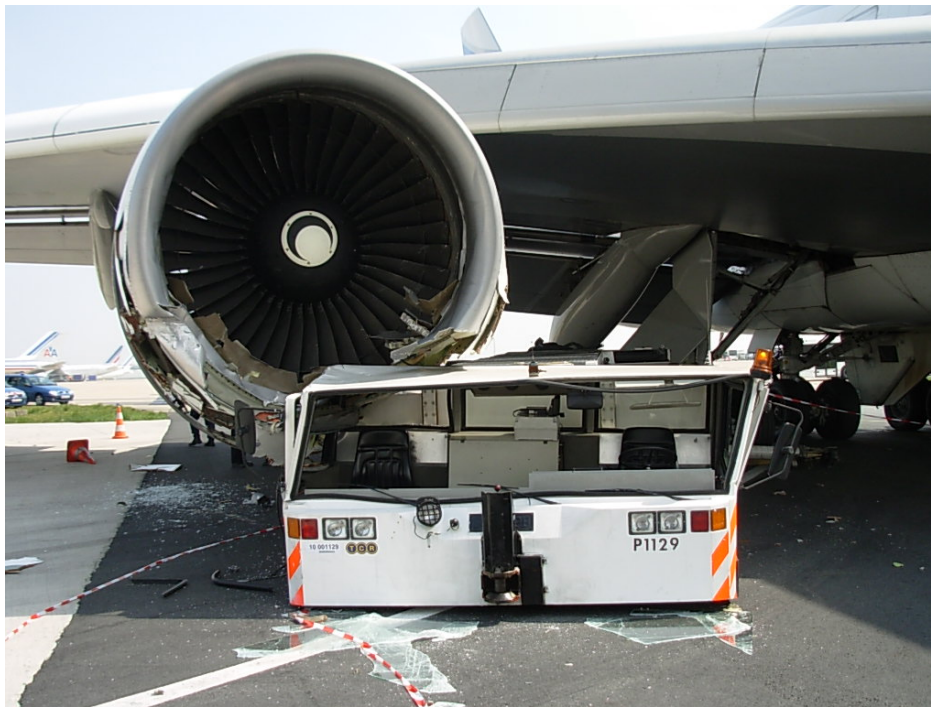
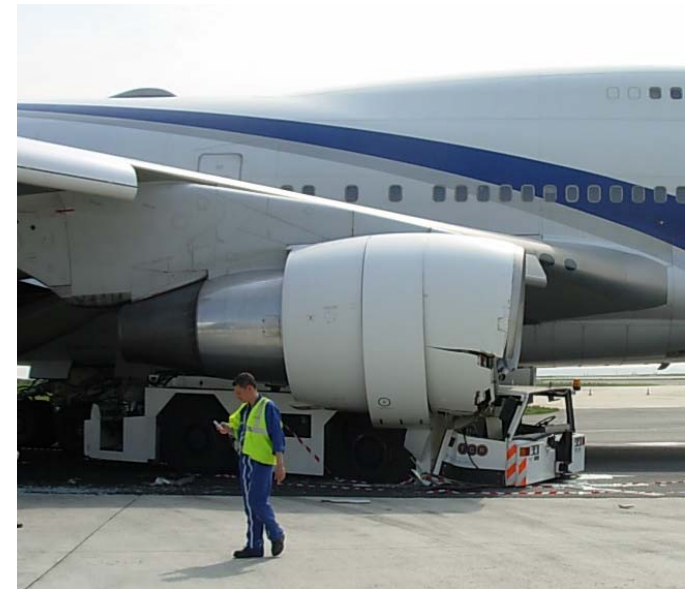
Foreign Object Damage (FOD) ground service vehicles

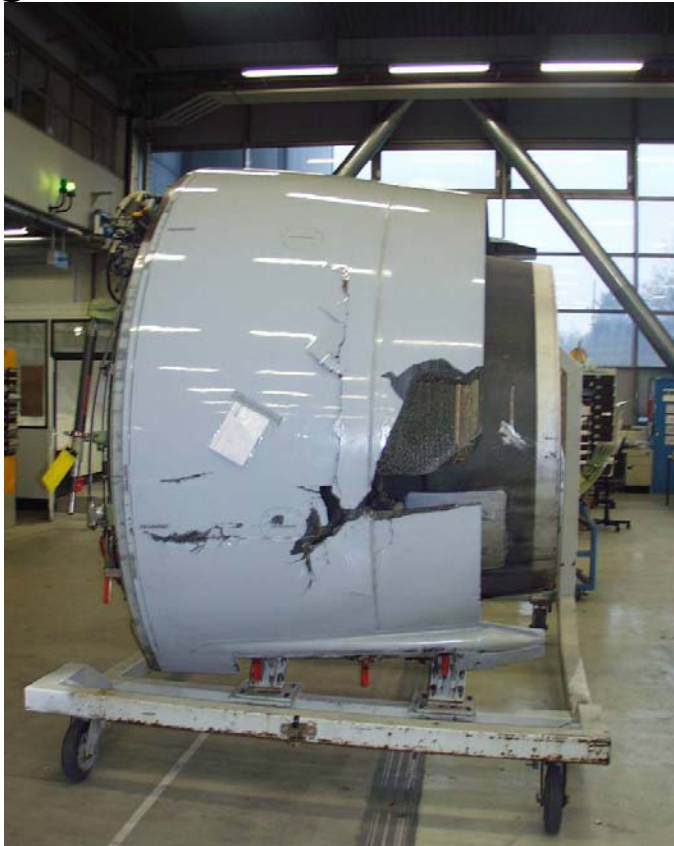
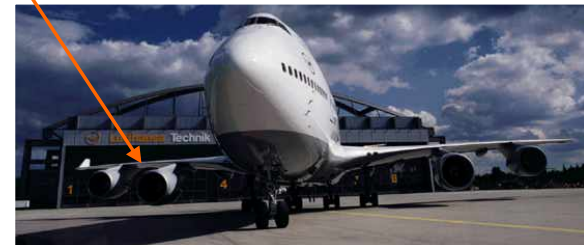
Reverser
translating sleeve

Foreign Object Damage (FOD) ground service vehicles

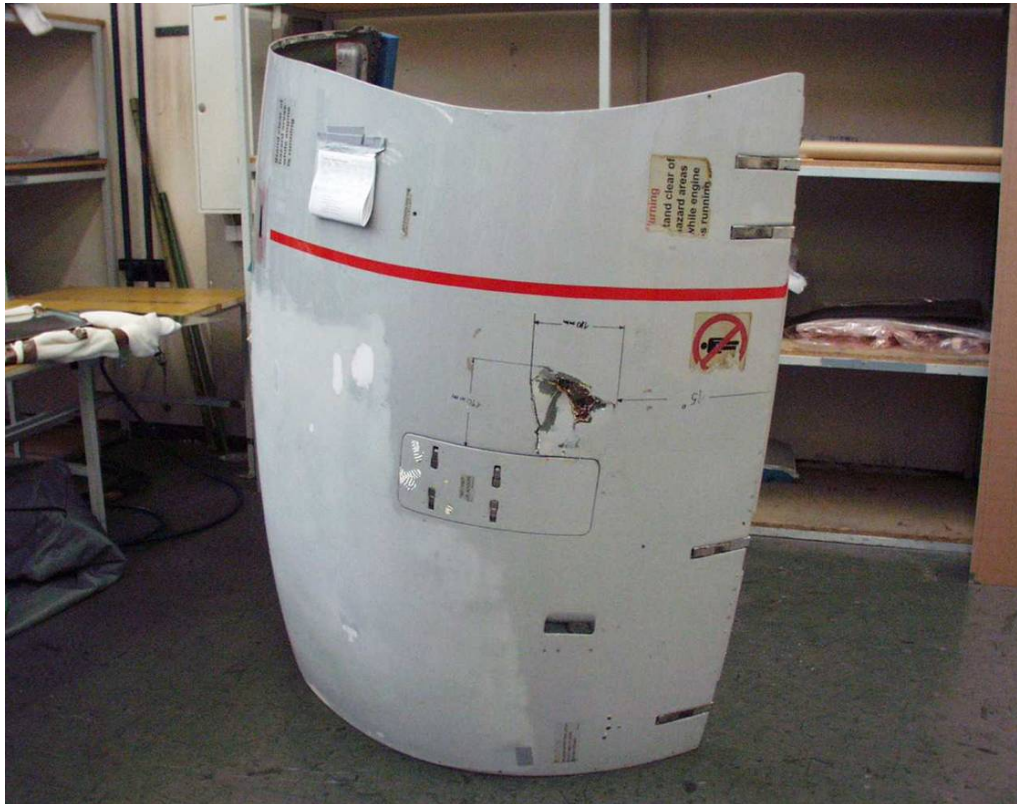
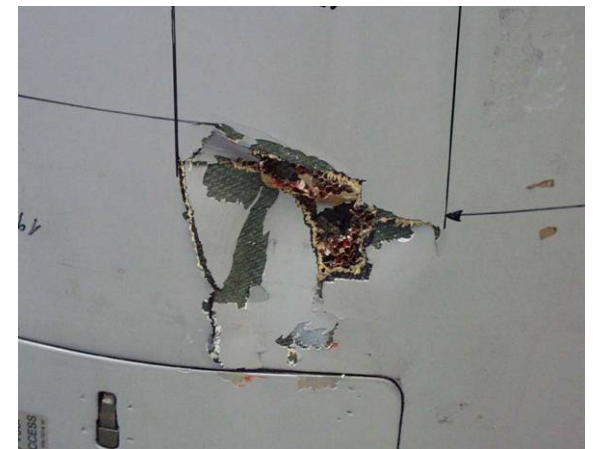
Foreign Object Damage (FOD) ground service vehicles

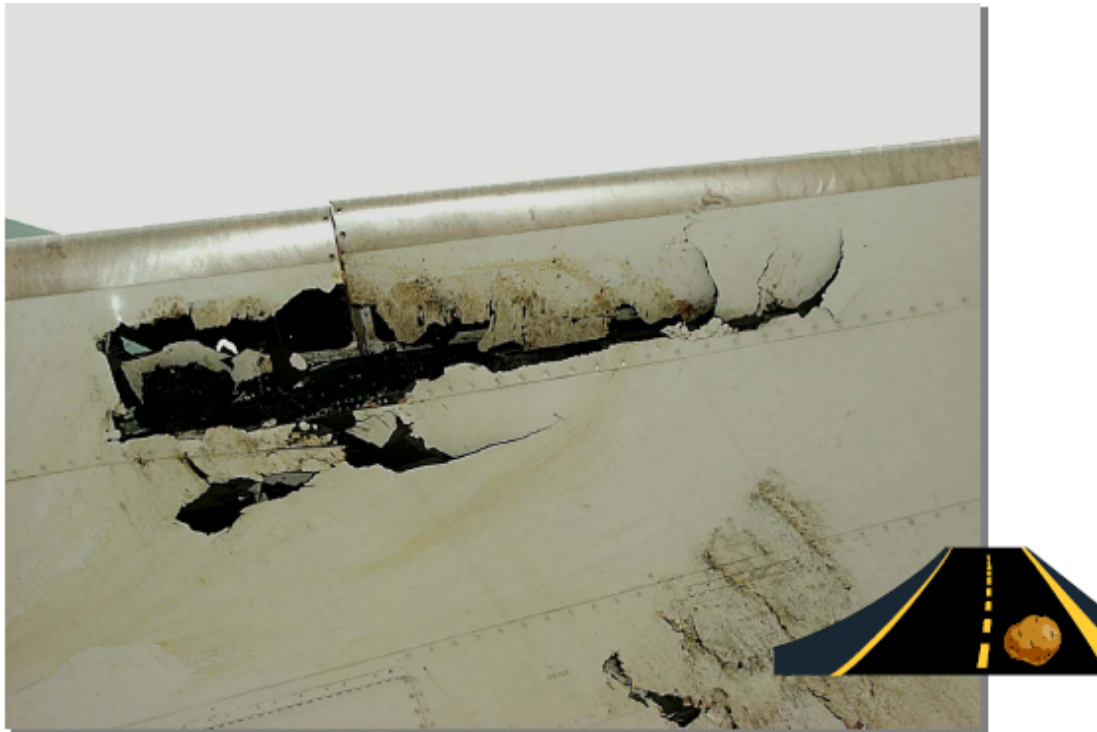
runway debris - damage on horizontal stabilizer

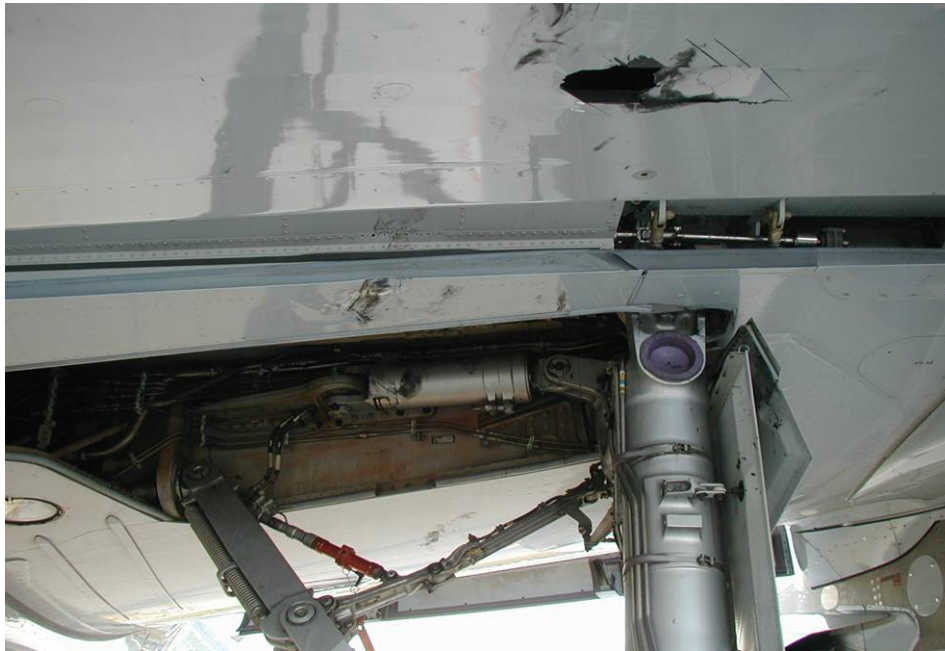
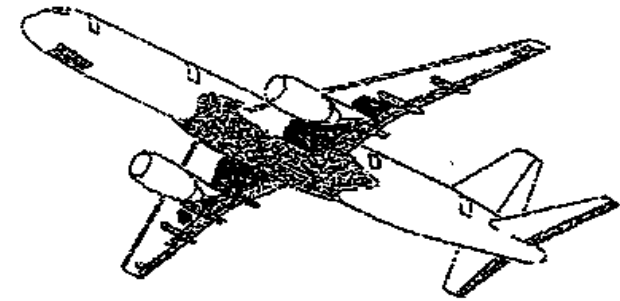
Foreign Object Damage (FOD) tire separation

Parts of a tire or debris on the runway may damage composite structures heavily.

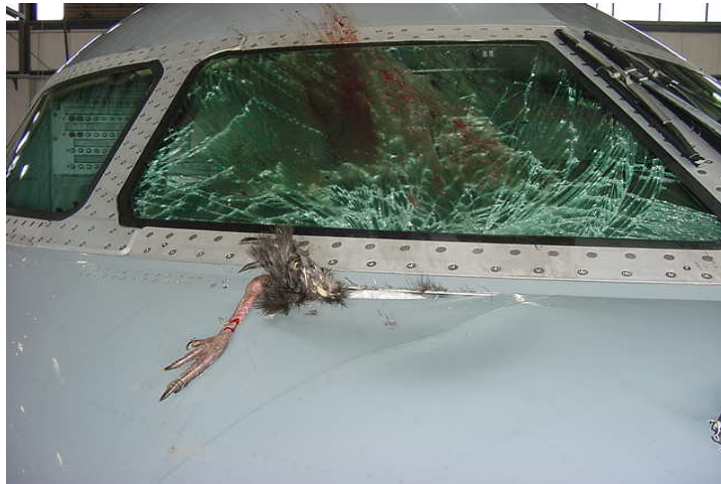
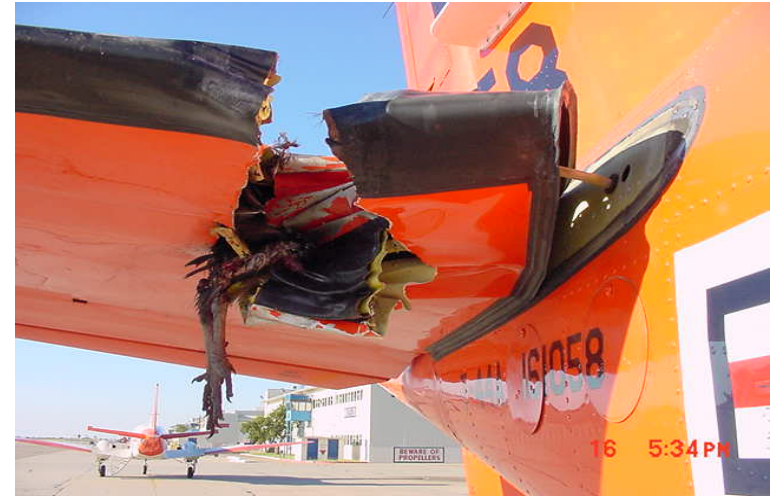
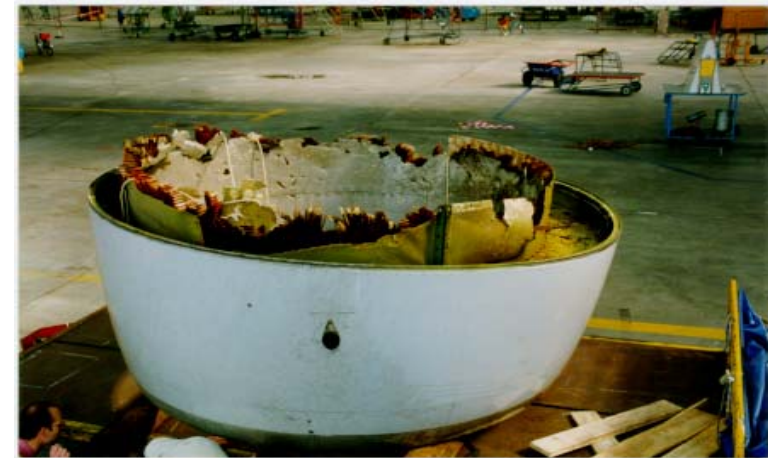
Foreign Object Damage (FOD) bird strike

Bird strike results in heavy structural damages. Affected areas are radomes, engines and leading edges.

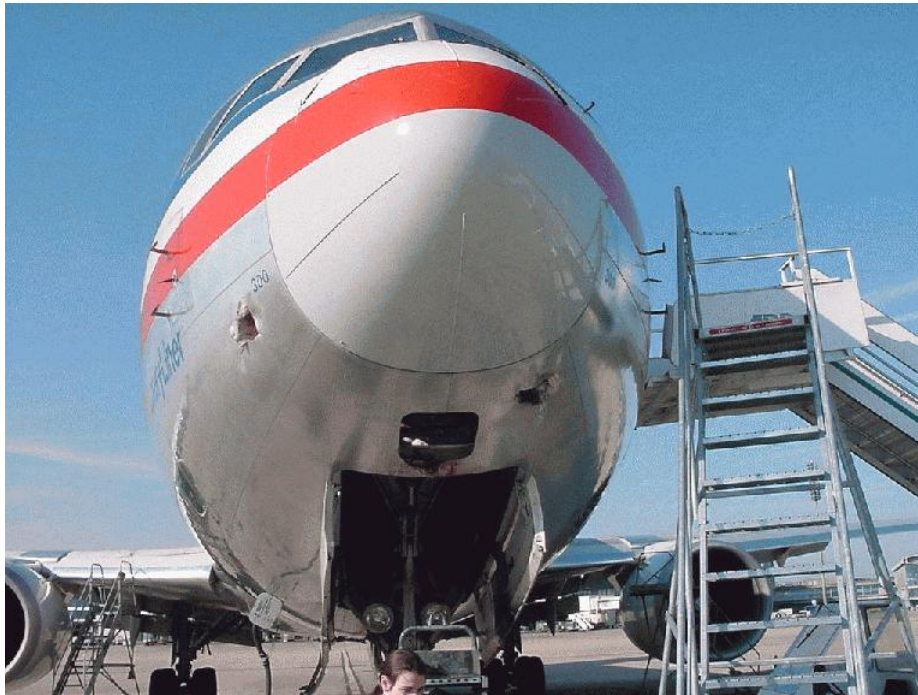
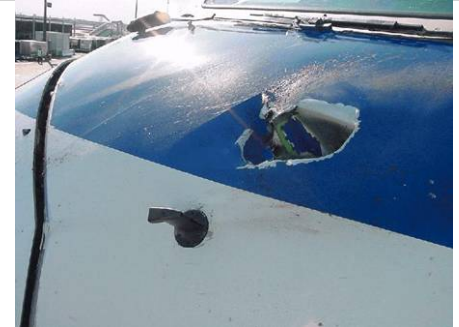
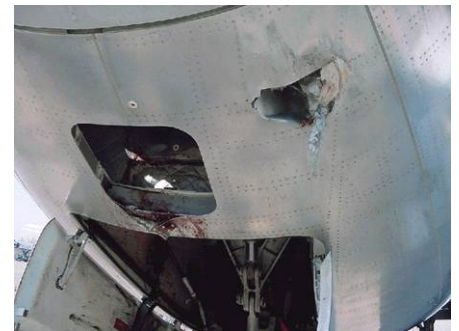
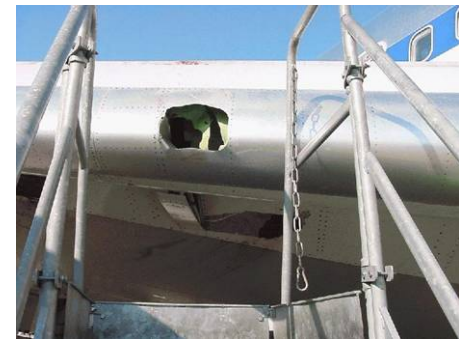
Foreign Object Damage (FOD) bird strike

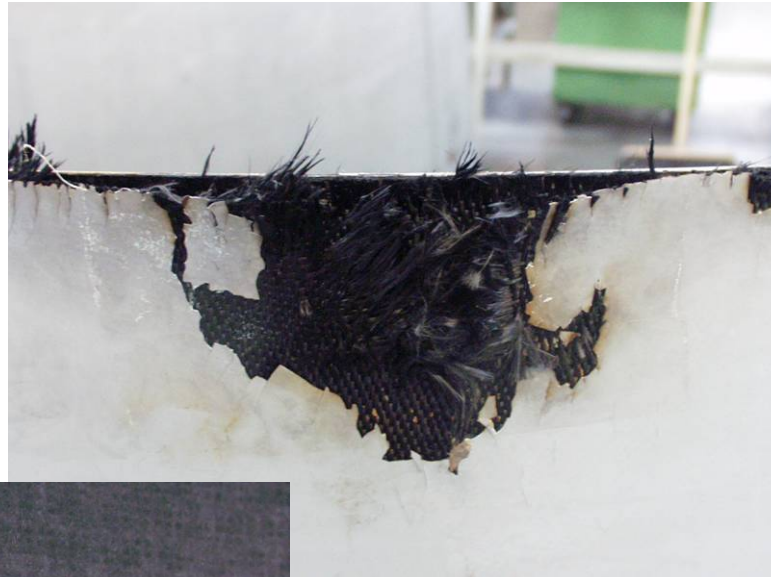
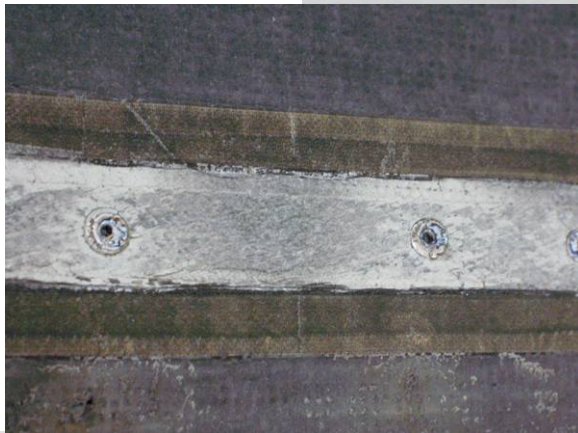
Lightning strike on a CF6-80 translating cowling

Composite materials are electric conductors. Because of thermal overload and/or sparking, adjacent fasteners have to be changed after lightning damage.

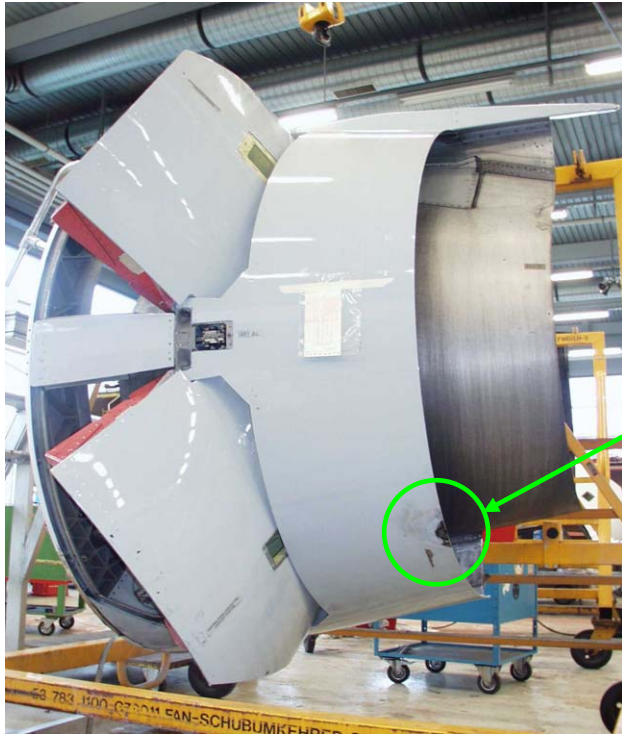
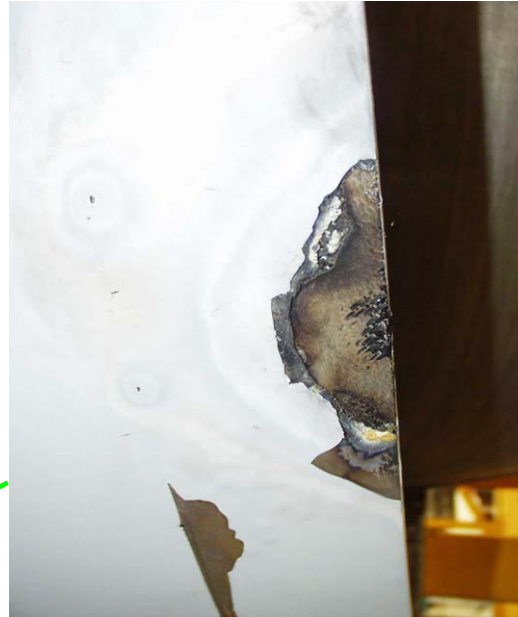
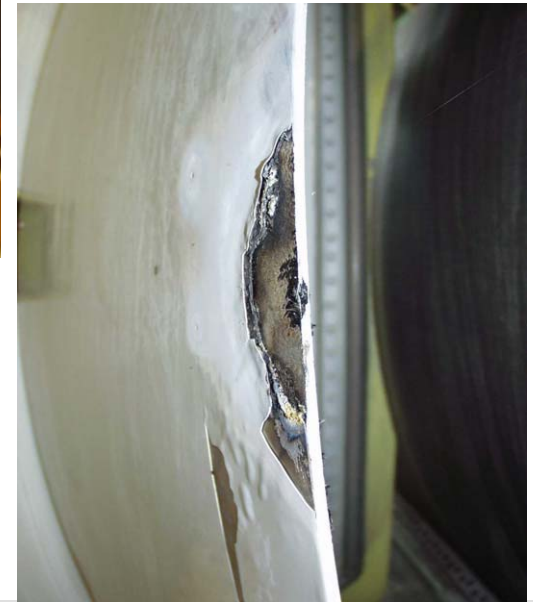
Lightning strike on CFM56-5A
Fan Reverser

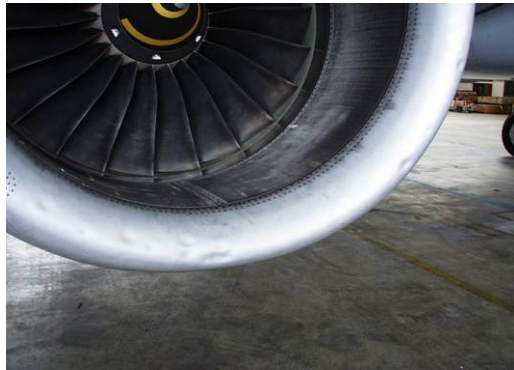
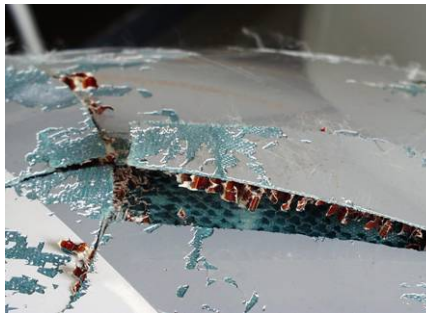
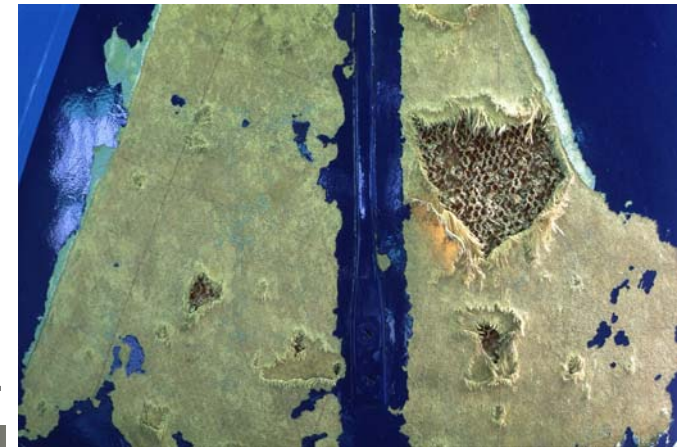
Hailstorm damage often occurs on leading edges, engine nose cowl and radome areas.

Hailstorm damage is frequently more difficult to detect on composite structures.

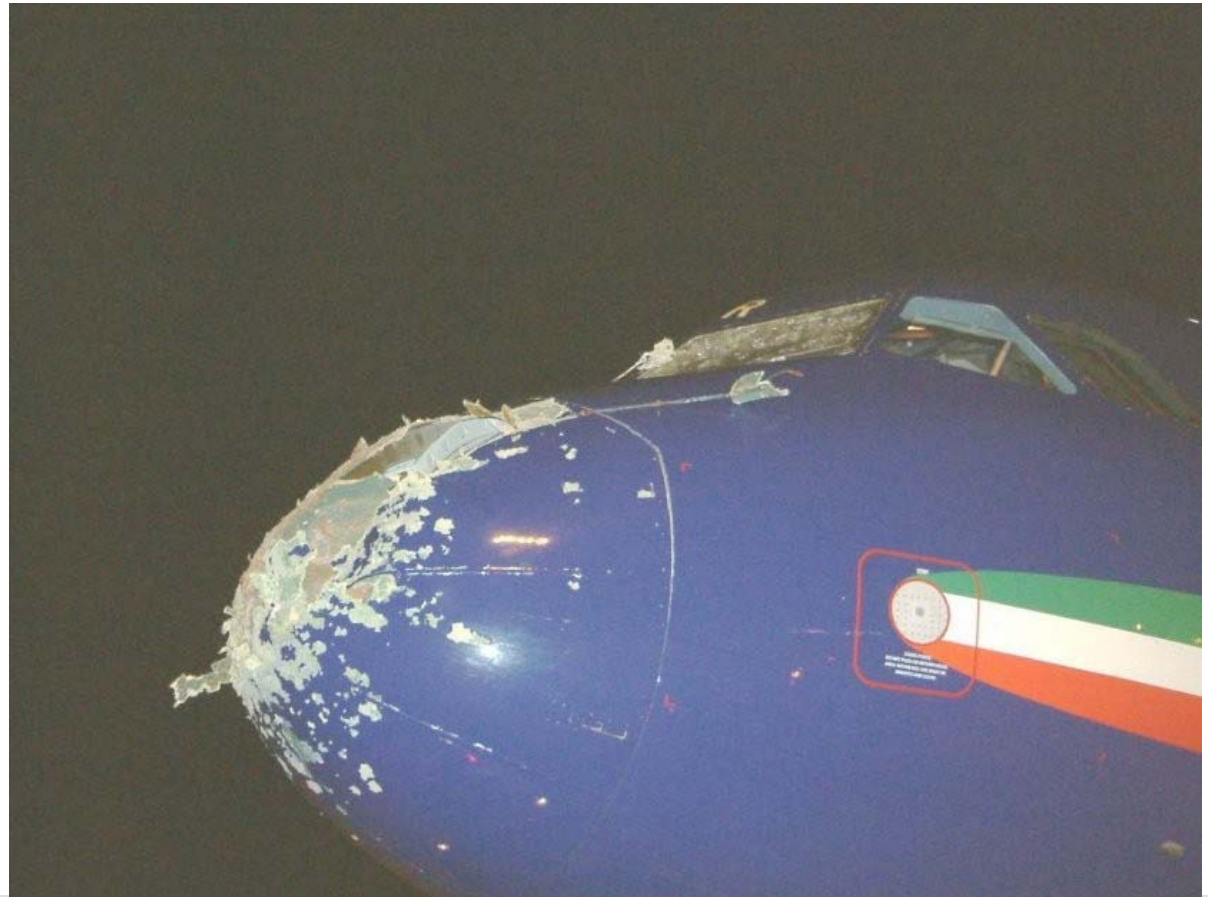
Foreign Object Damage (FOD) hailstorm

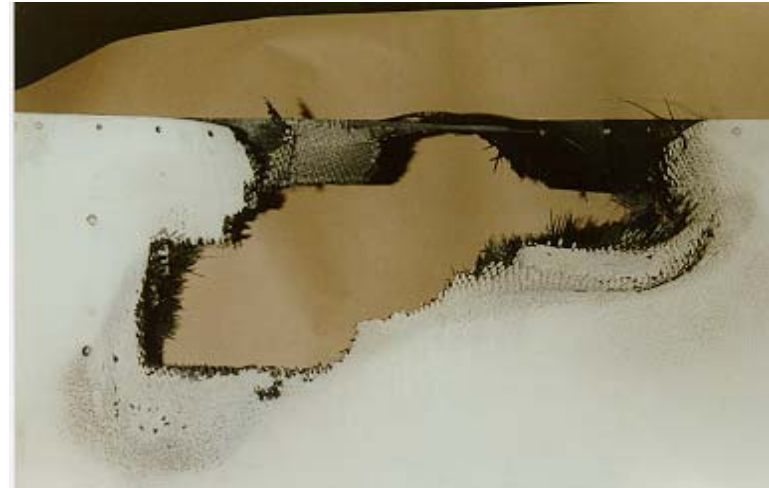
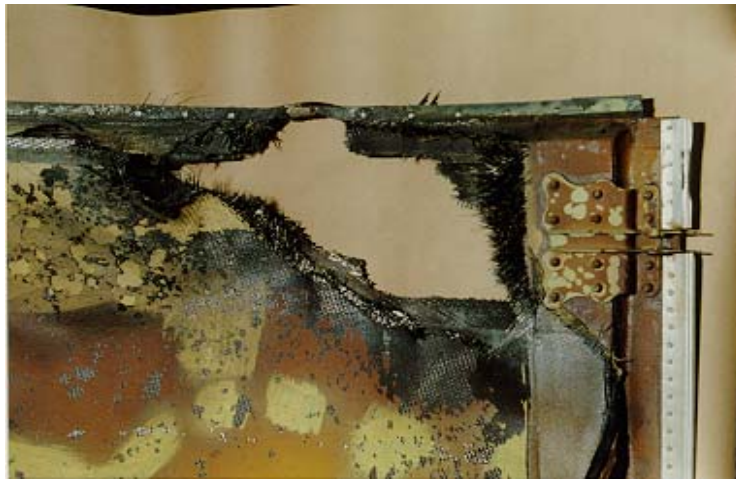
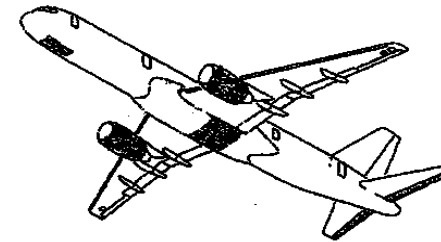
Fan cowl overheat damage resulted from failed anti-ice duct clamp

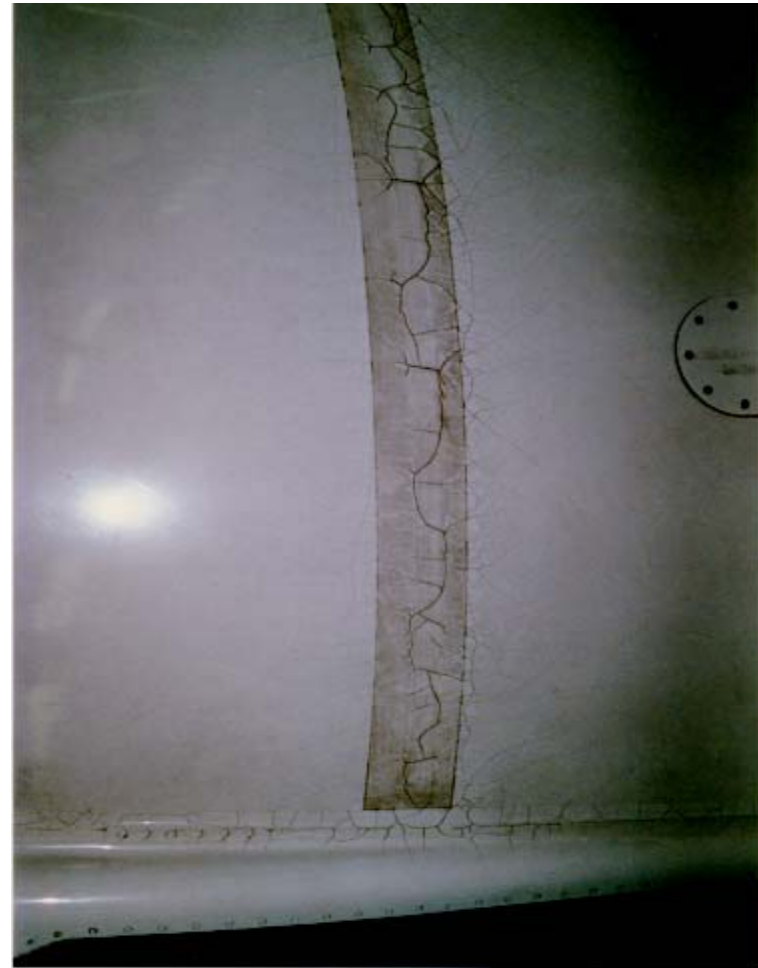
Cracks in the surface protection coat suggest structural damages which could result in a premature removal of the component.

Source of the cracks is not yet completely identified, but can be related to the excessive filler thickness or to a change in the paint flexibility by a chemical interaction with the composite resin hardener.

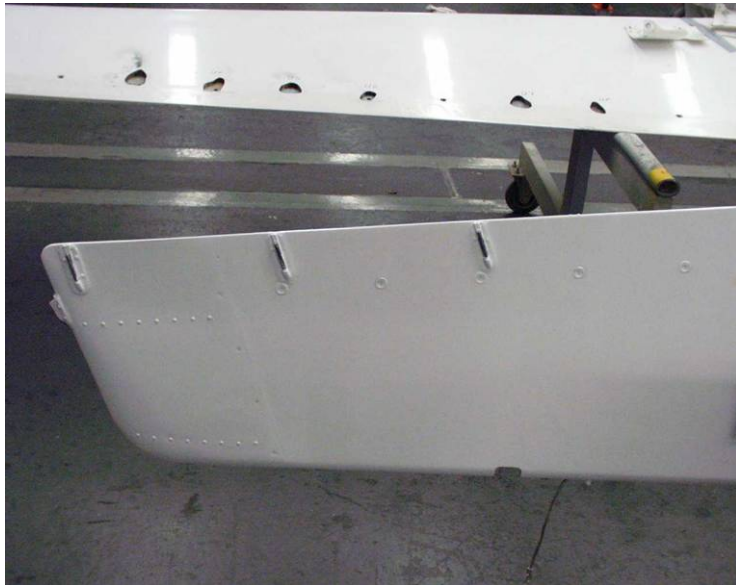
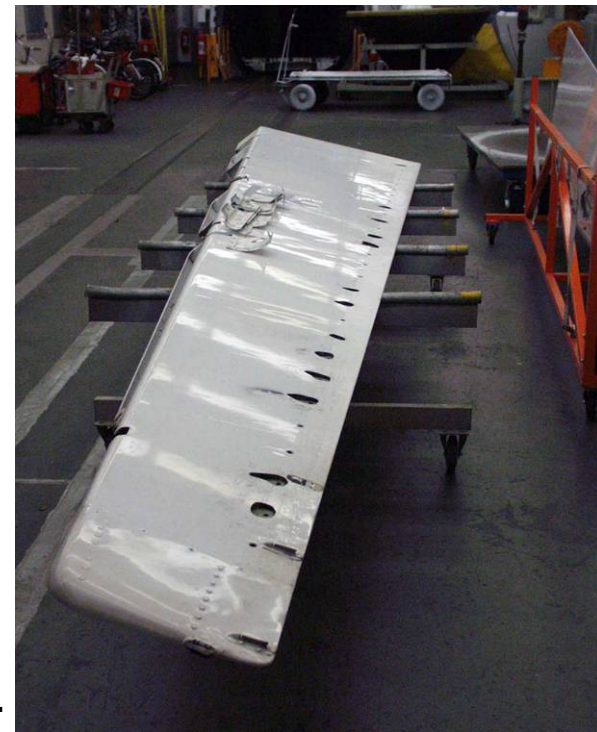
Fluid contamination water in an elevator

Water enters the elevator honeycomb core through fastener holes due to component „breathing“.

Repairs are difficult and time consuming.

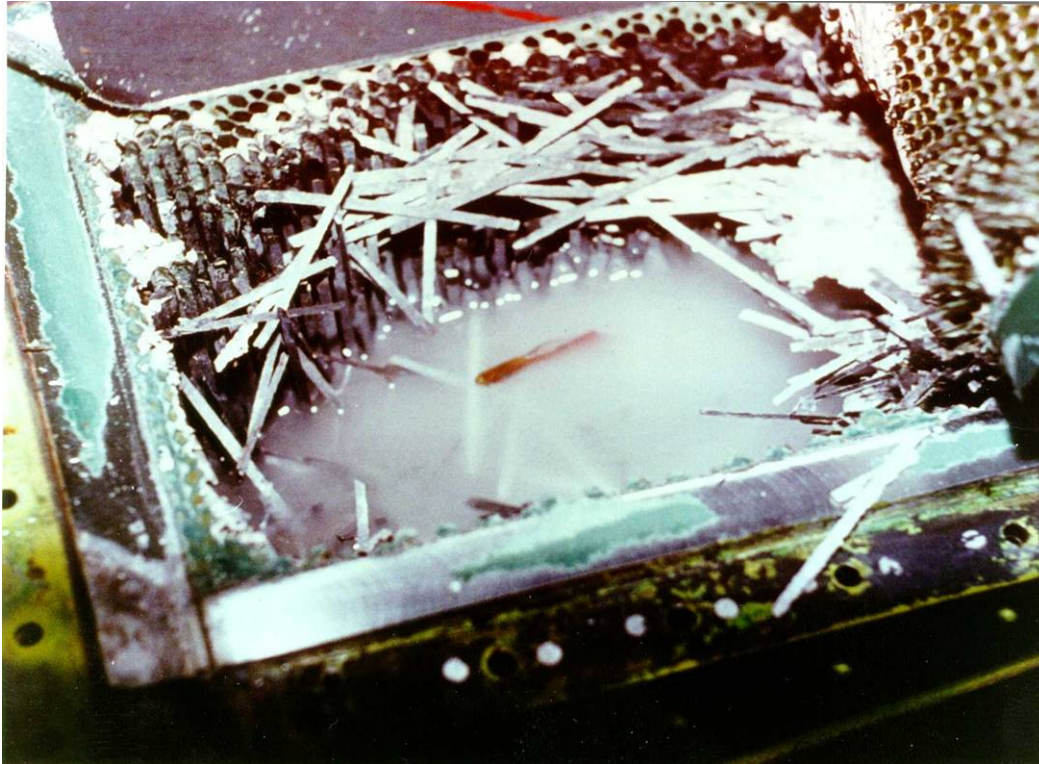
Fish is still swimming !

General problem on many honeycomb sandwich components

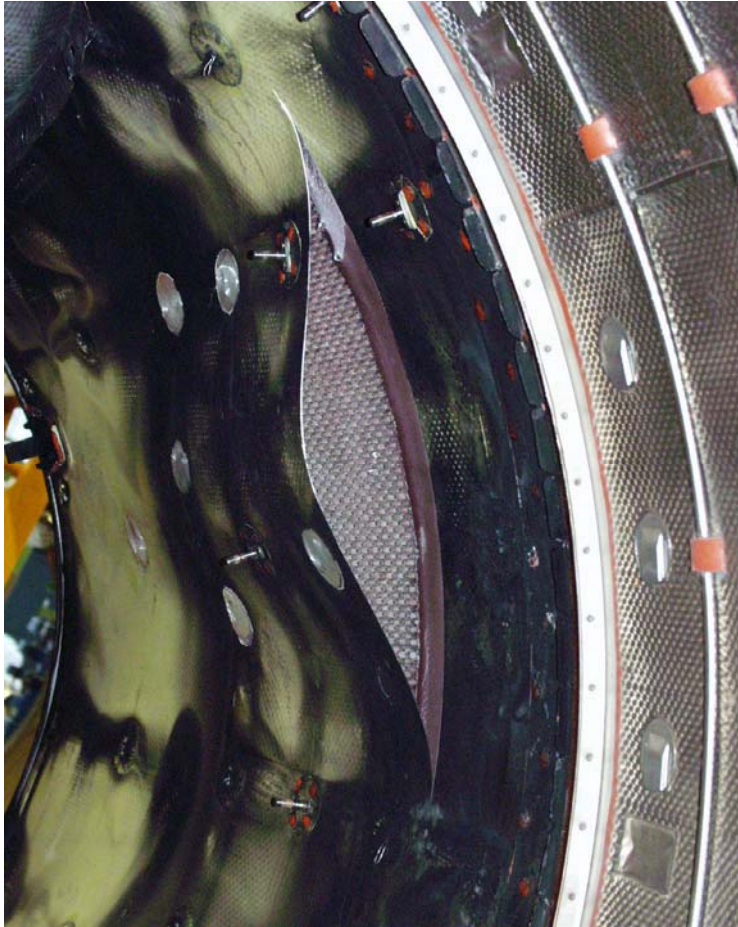
Surface treatment on honeycomb foil leads to poor bonding properties

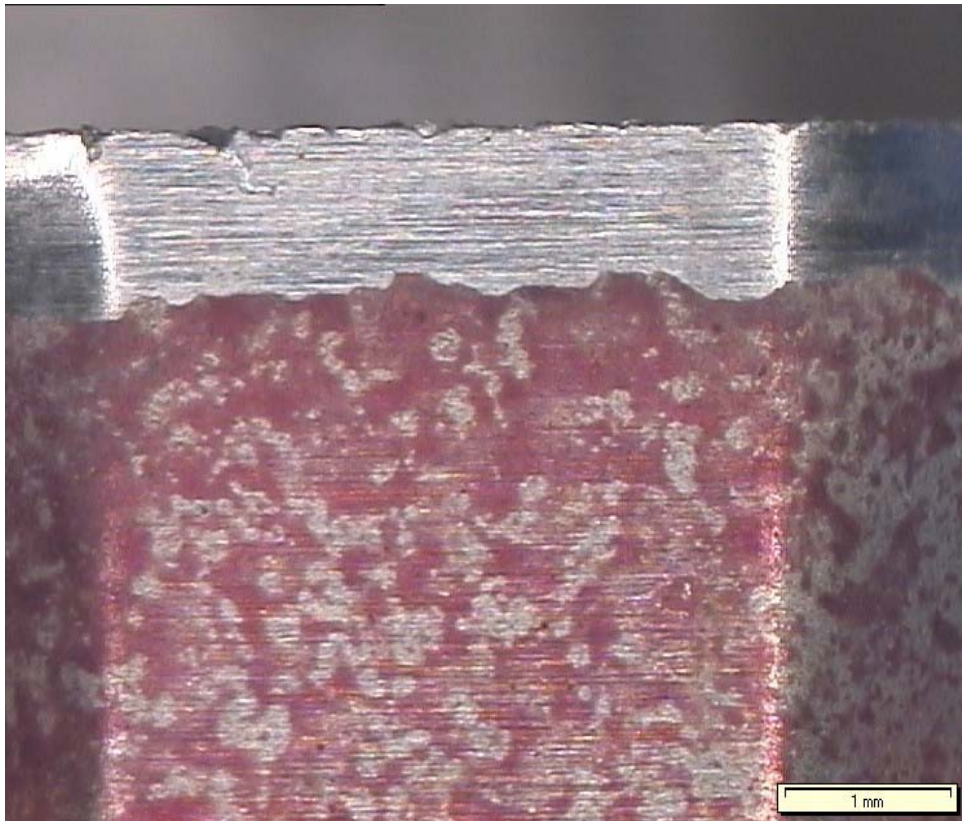
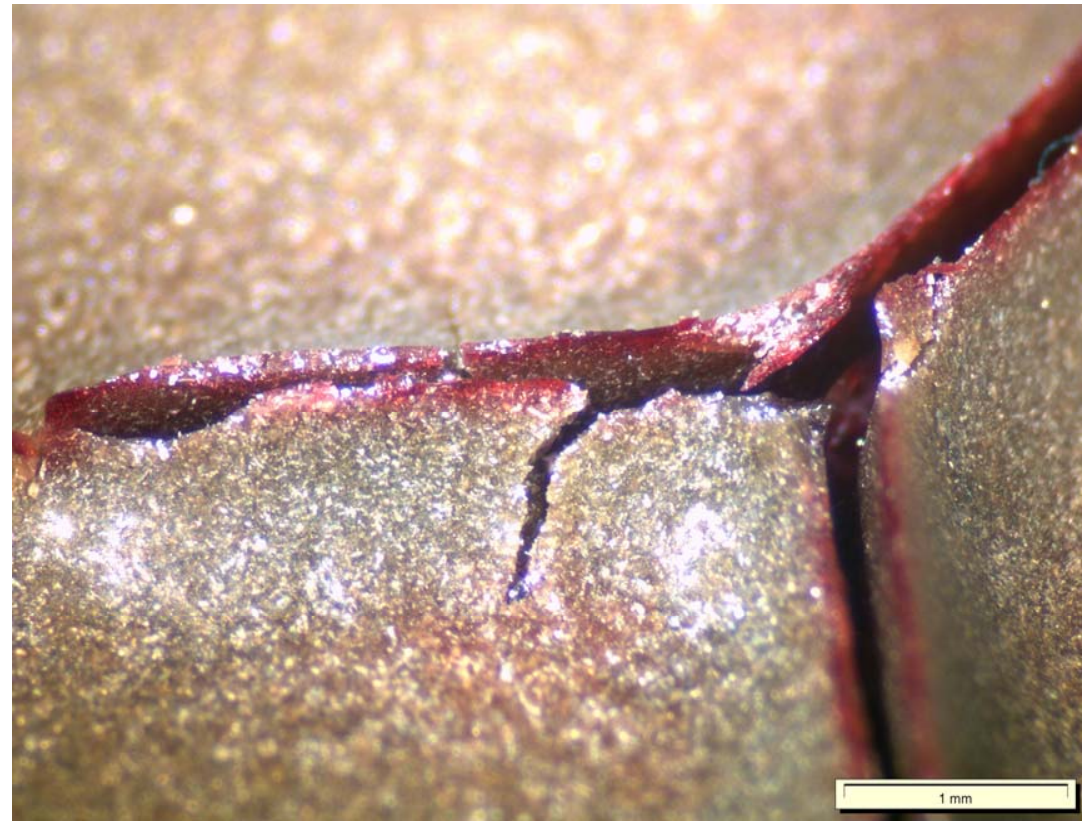
Surface treatment on honeycomb foil leads to poor bonding properties
