Lufthansa Perspectives on Safe Composite Maintenance Practices

Damages on composite components

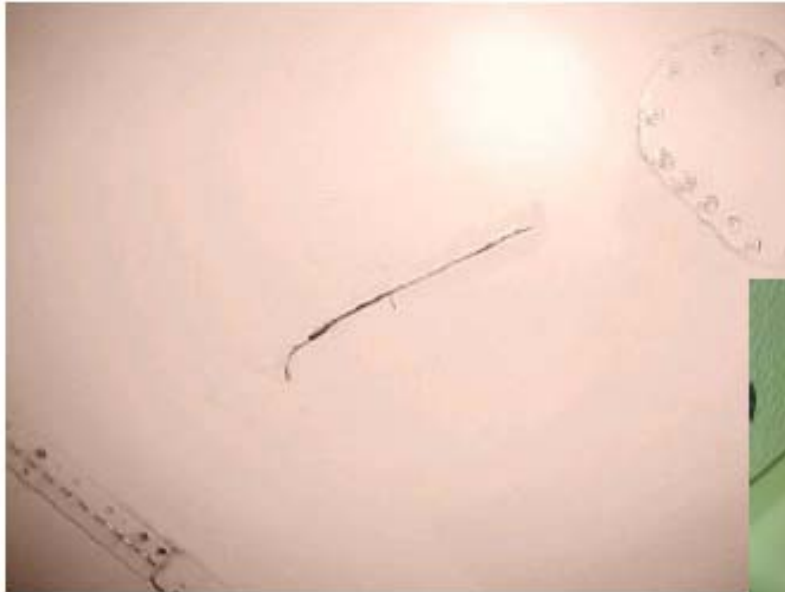
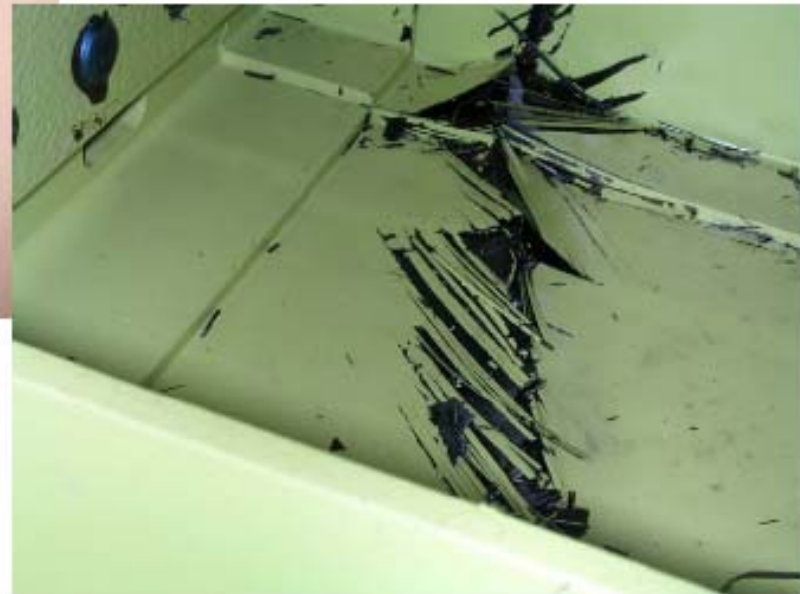
Visible damage on outside surface

Total damage on inner side of structure
