Service Experience With Early BCA Composite Applications

CACRC Workshop
May 9, 2007

Background **ACEE** 737 Composite HS Program

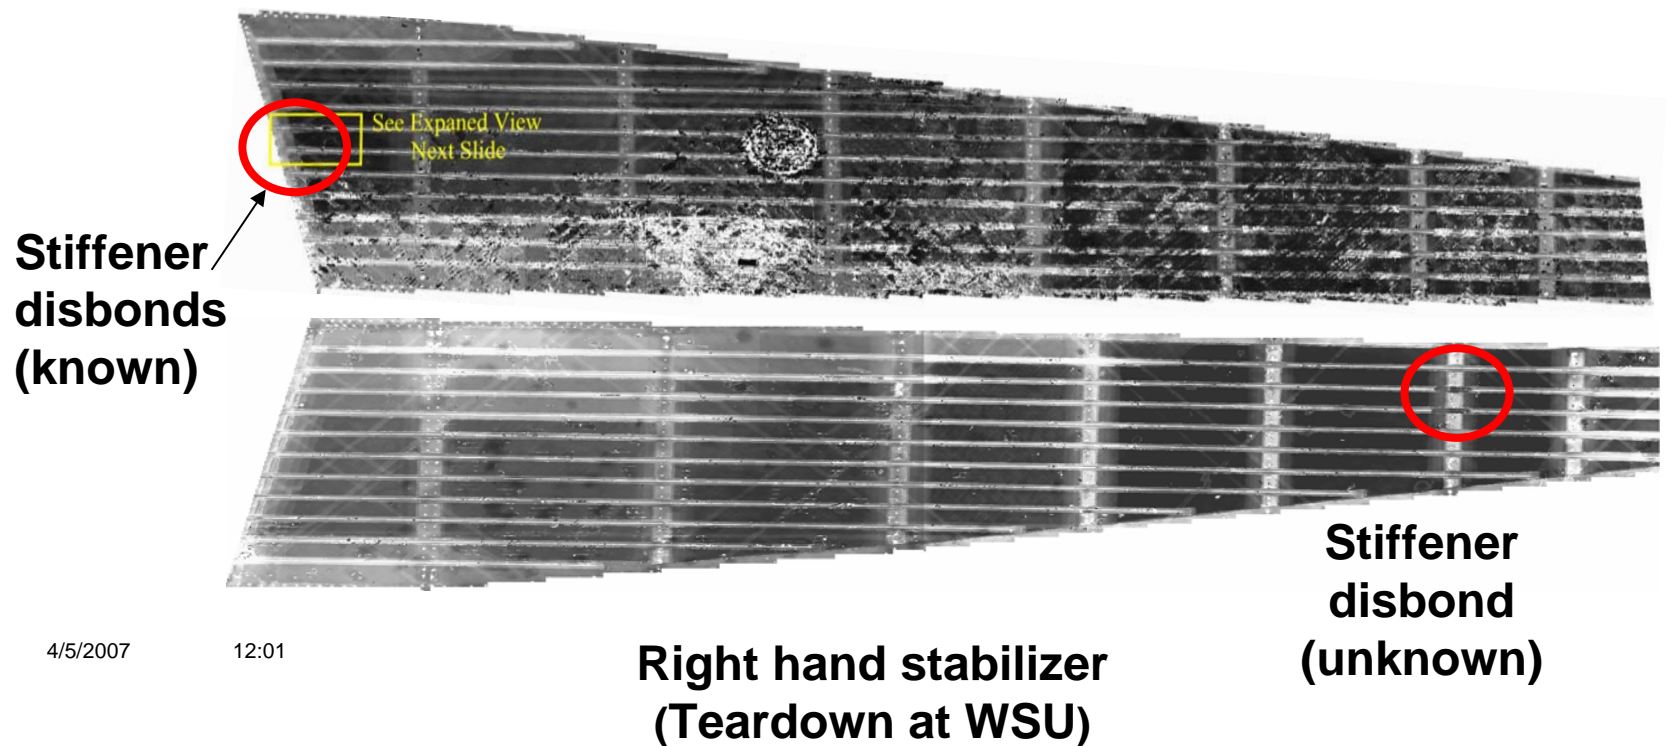
Production NDI Results

- **NDI with thickness mapping scan revealed stiffener disbonds**
 - **Known disbonds confirmed, other anomalies identified**

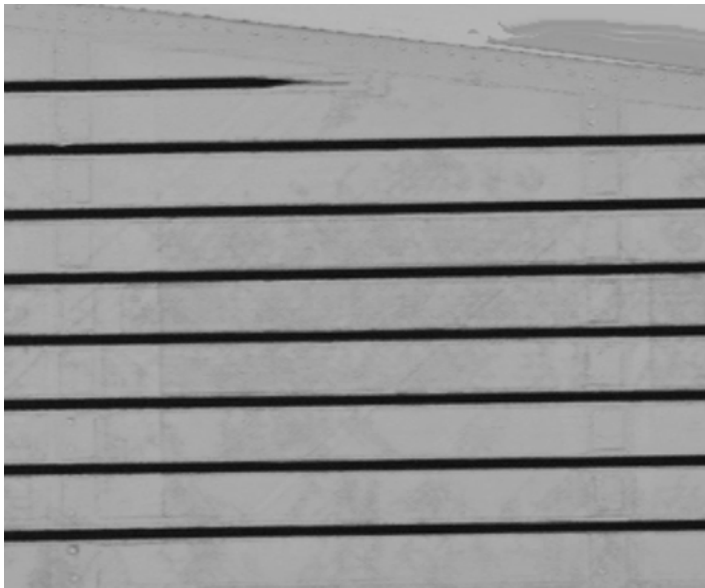
1980's Sensitivity

- NDI has become more sensitive, standards more rigorous
- Today's materials and manufacturing processes can produce laminates with far less porosity levels

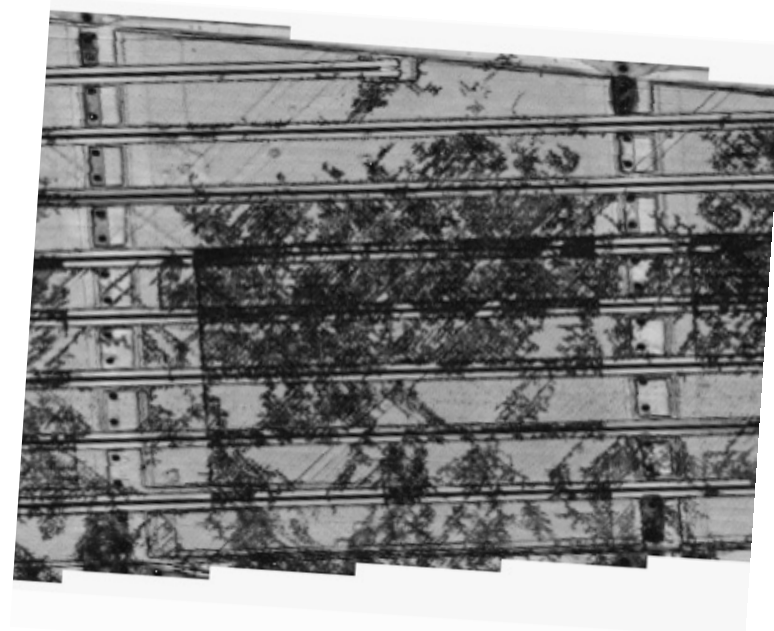
Today's Sensitivity

(scans show same structure but different sensitivity level)

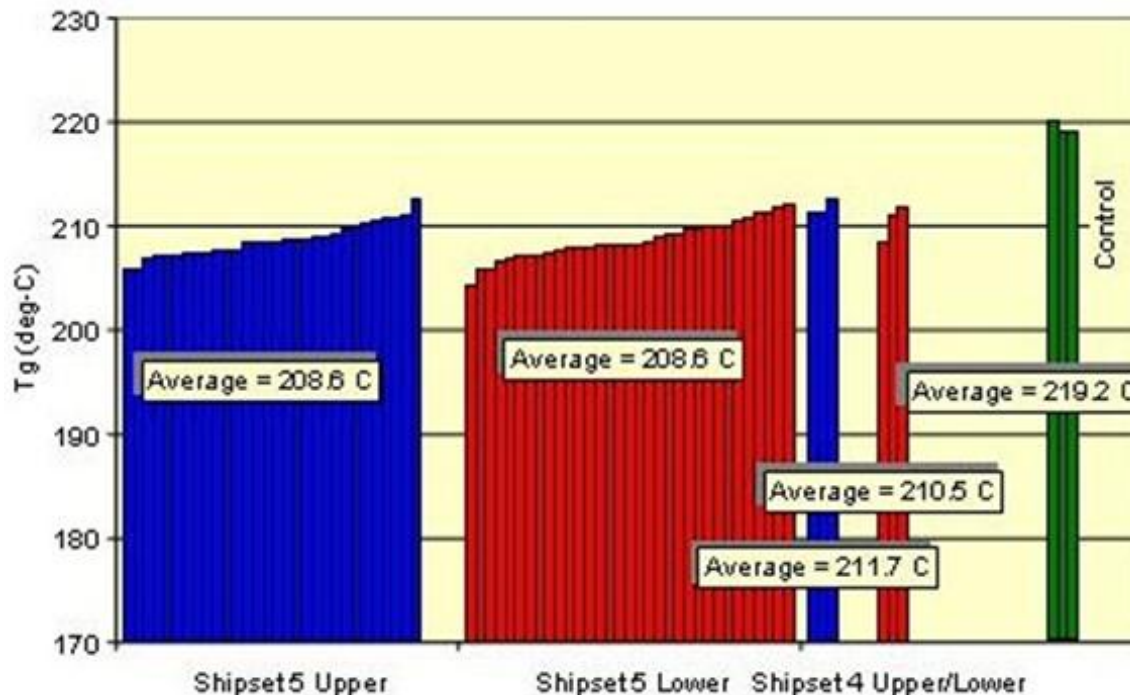
Physical Test Results (T_g)

- T_g values consistent but lower than limited “Quasi-Control” obtained from secondarily bonded spar
- NIAR results similar to slightly lower
- T_g remains significantly above service temperature

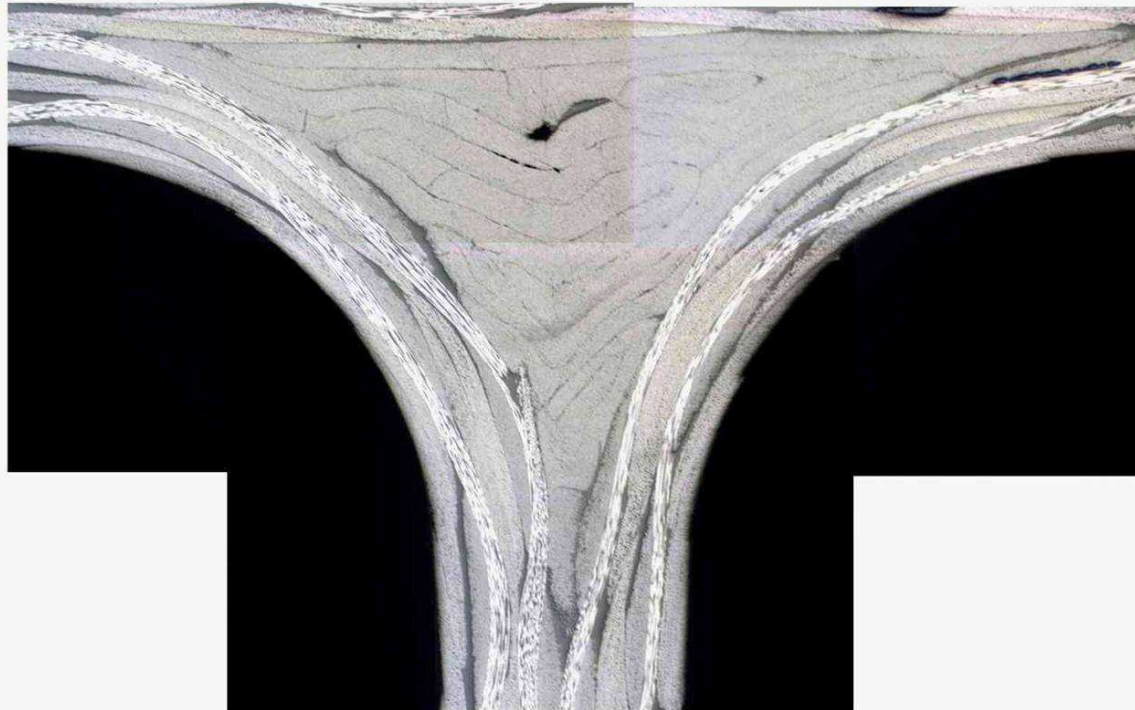
Physical Test Results

- Upper skin stringer showing noodle region
- Good compaction / low porosity
- Some microcracking evident; microcracks concentrated in resin rich & resin starved areas

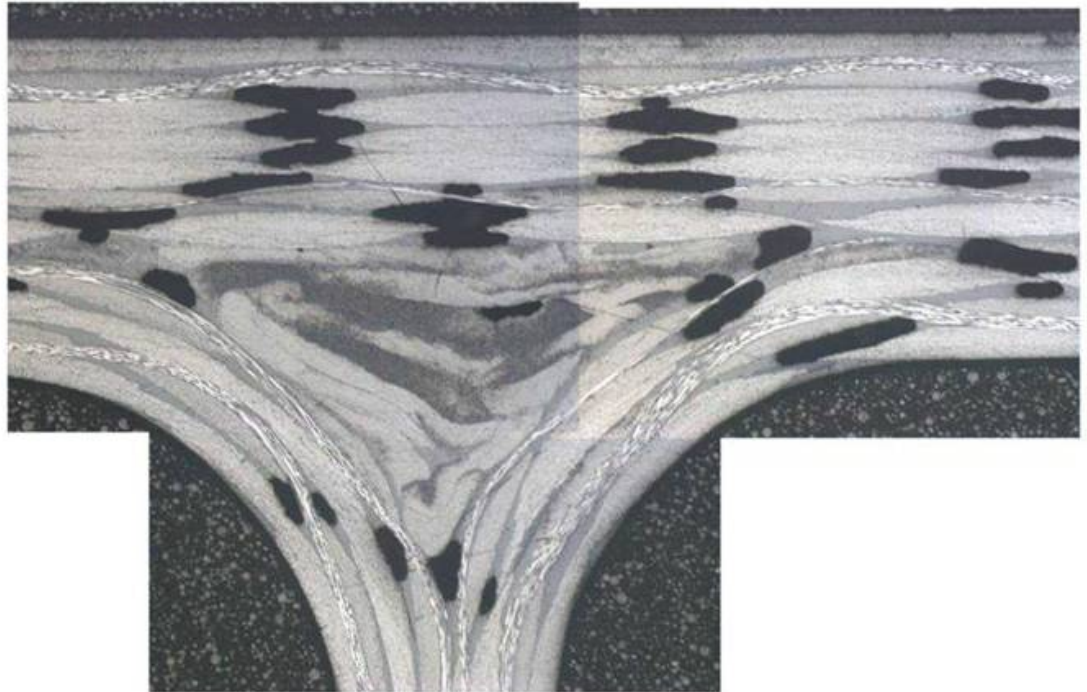
Physical Test Results (Microscopy)

- Upper skin/stringer region taken in area of high attenuation
- Up to 5+% porosity noted in Boeing teardown; similar results reported from NIAR teardown

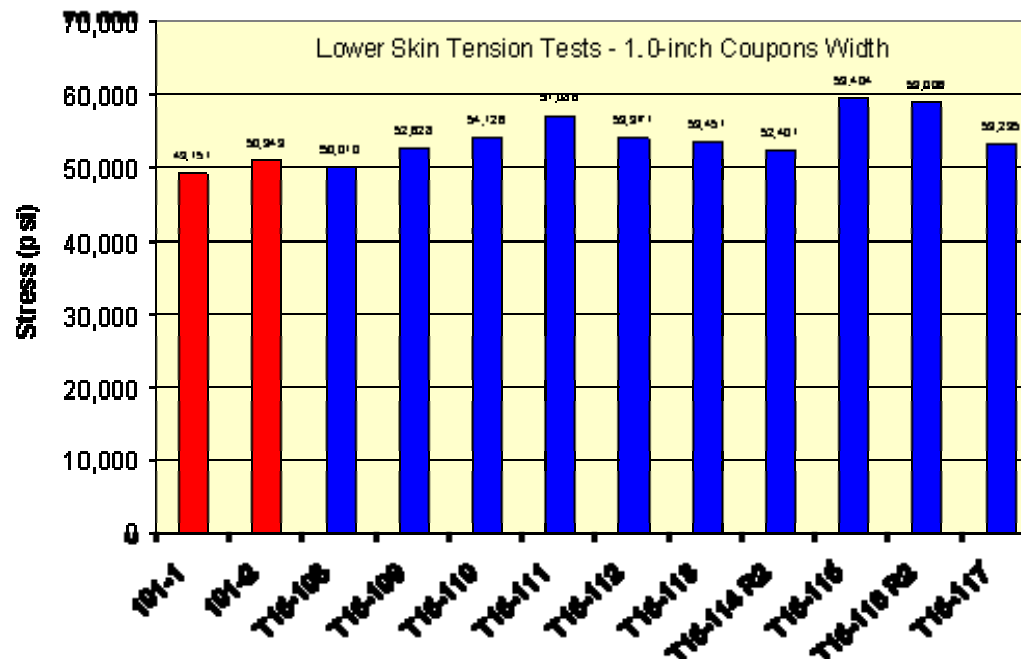
Mechanical Test Results (Tension)

- 70 specimens from upper and lower skins of two stabilizer articles
- No significant degradation
- Shipset 4 equivalent to shipset 5
- Specimen curvature had little effect

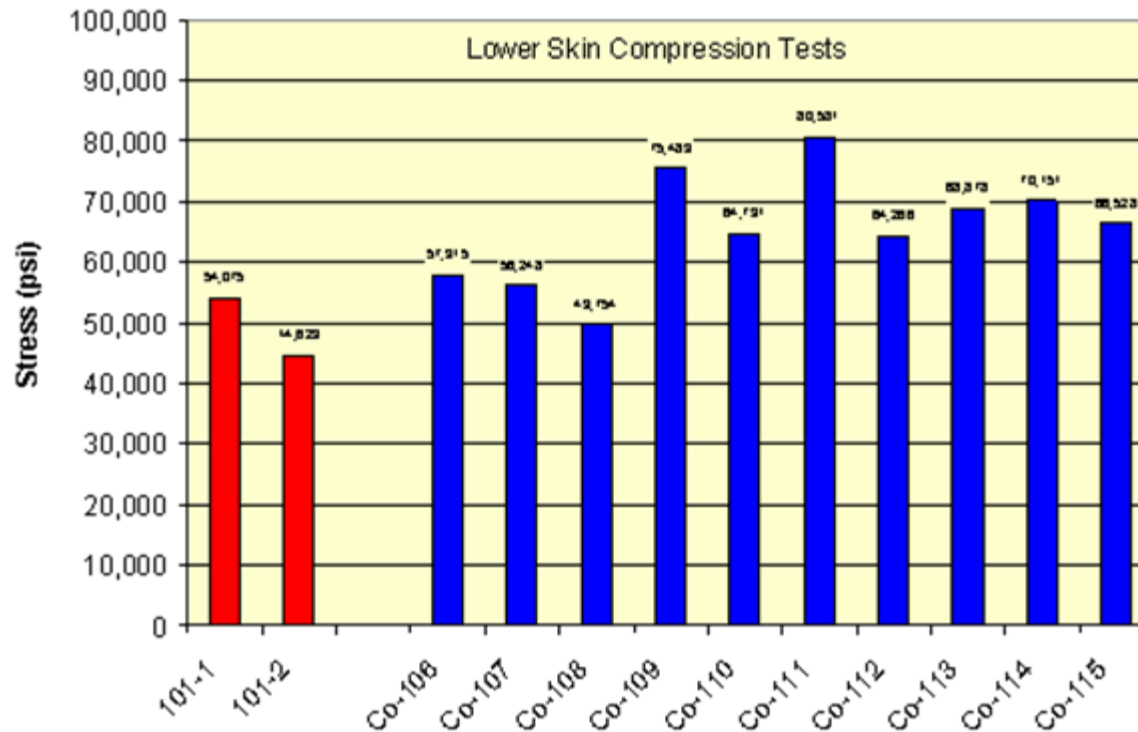
Mechanical Test Results (Compression)

- 70 specimens from upper and lower skins of two stabilizer articles
- High scatter but no significant degradation / residuals higher than baseline for all regions / Shipset 4 equivalent to Shipset 5
- Scatter believed related to level of porosity

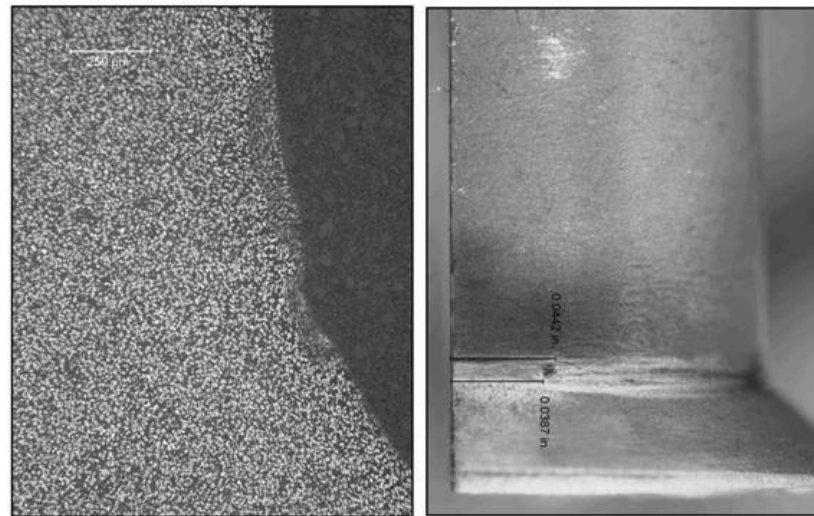
- No evidence of lightning induced fastener pitting even though the teardown article leading edge & tip showed evidence of having been struck

Mechanically induced fastener pit found on teardown article fastener – no evidence of lightning induced damage
