Presented by  
Dr Roland Thévenin  
Senior Expert Composite  
Structure Conformance

# ***Airbus Composite Structures***

## ***Perspectives on safe maintenance practice***

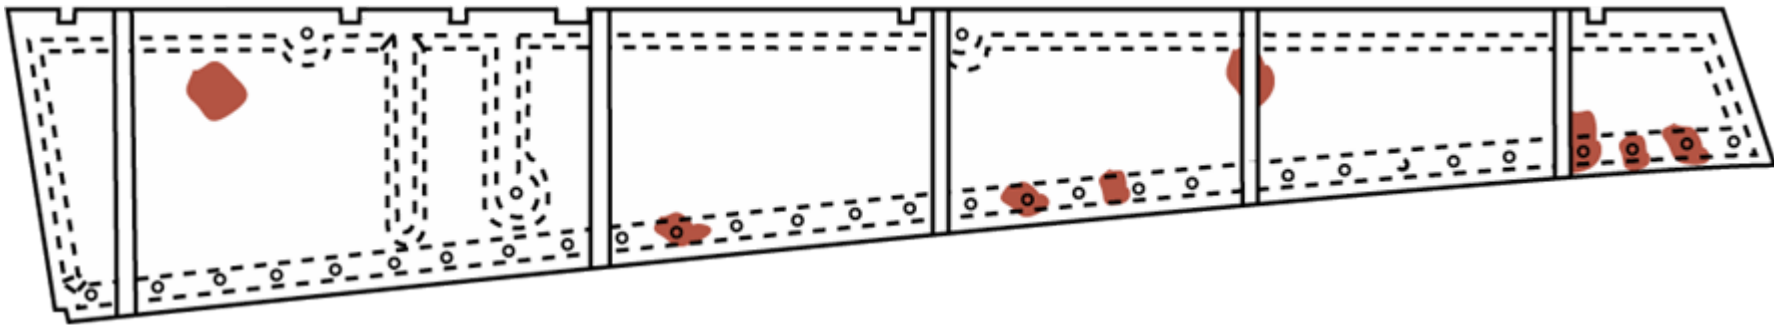
- **Upper panel**
  - Inspection by thermography

- Affected areas
  - Trailing edge inserts
  - Bonding straps
  - Panel surface

- **It is a combination of several parameters**
  - ▶ Structure: Discontinuity or/and Porosity of the Skin
  - ▶ Environment: Heat and Humidity
  - ▶ A/C performance: Flight profile
- ▶ All when combined together in a critical way, present for the panel risk of : ***Water Ingress***
- **Which Lead in most of the case to:**
  - ▶ Deterioration on the honeycomb / skin bonding line
  - ▶ Delamination
  - ▶ Weight increase

- By adding one adhesive film
- Systematic Water Leak Test

- 1 time thermography inspection mandatory at 10 Years
- Re-protection with 1 additional layer of pore filler and new paint
- All completed in 2002

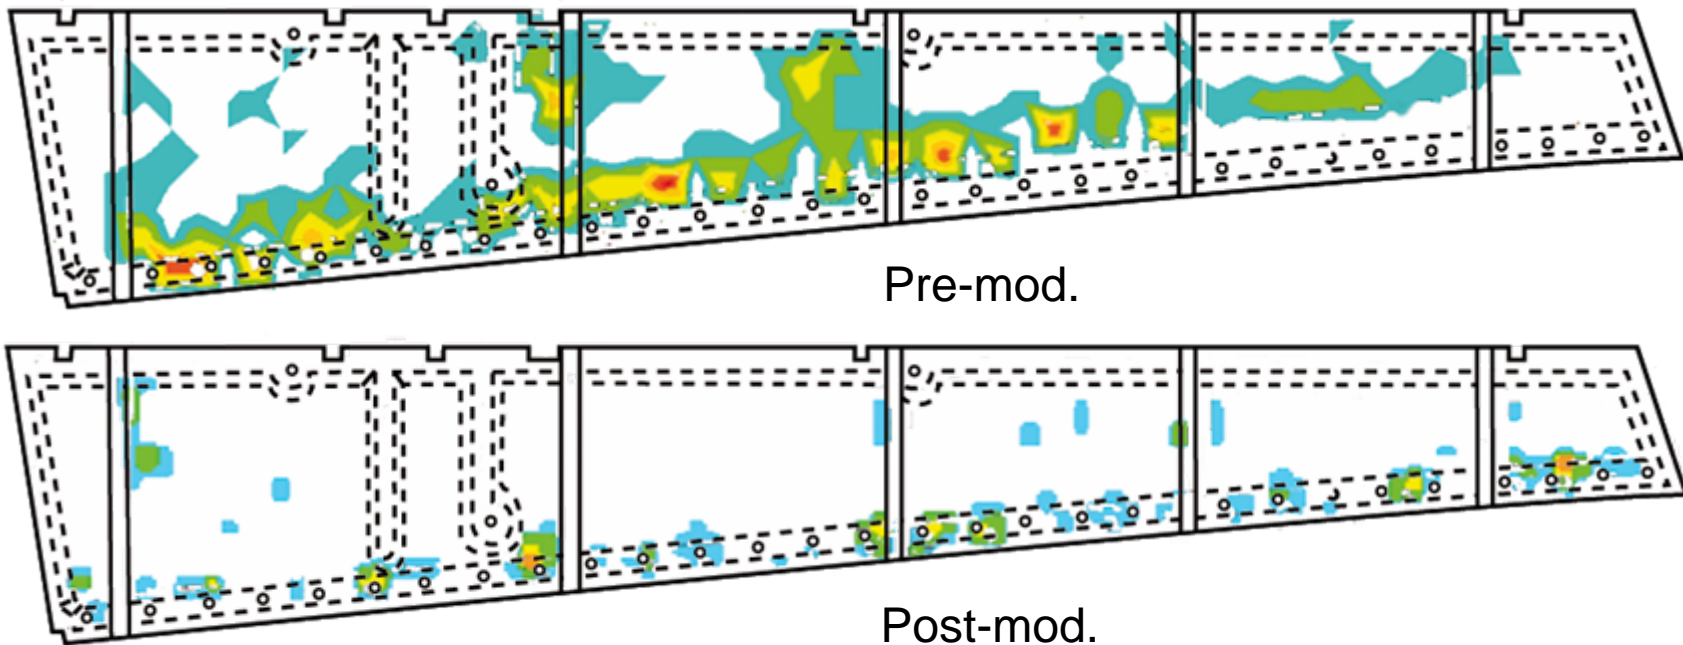
- Sampling of 22 elevators in each configuration

- **Post-mod / Post-SB elevators are also affected at lower extent**
  - ▶ Trailing edge inserts
  - ▶ Bondings straps
  - ▶ Panel surface

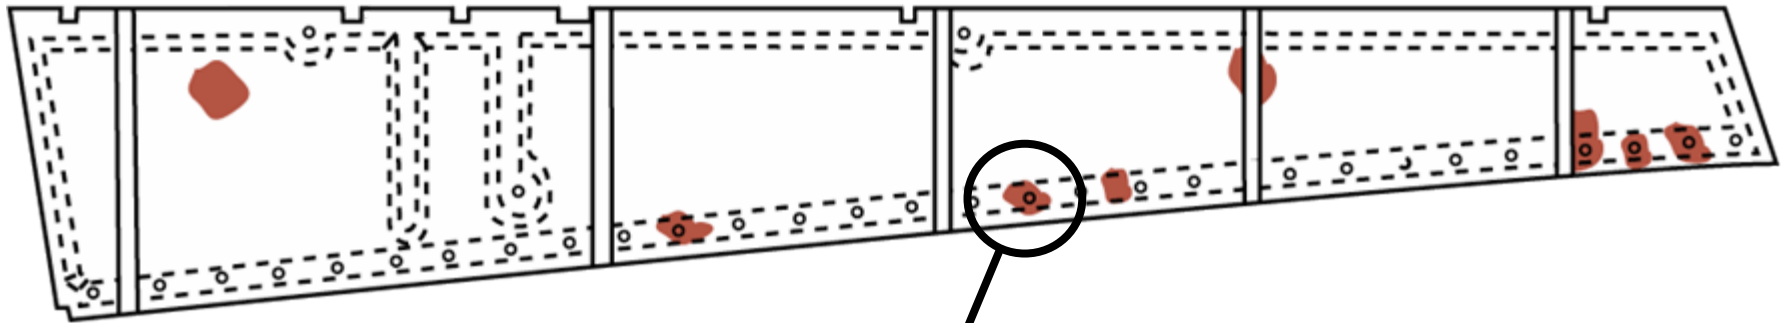
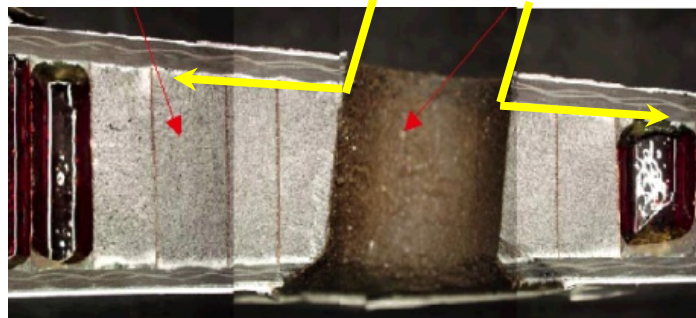
- Trailing edge inserts

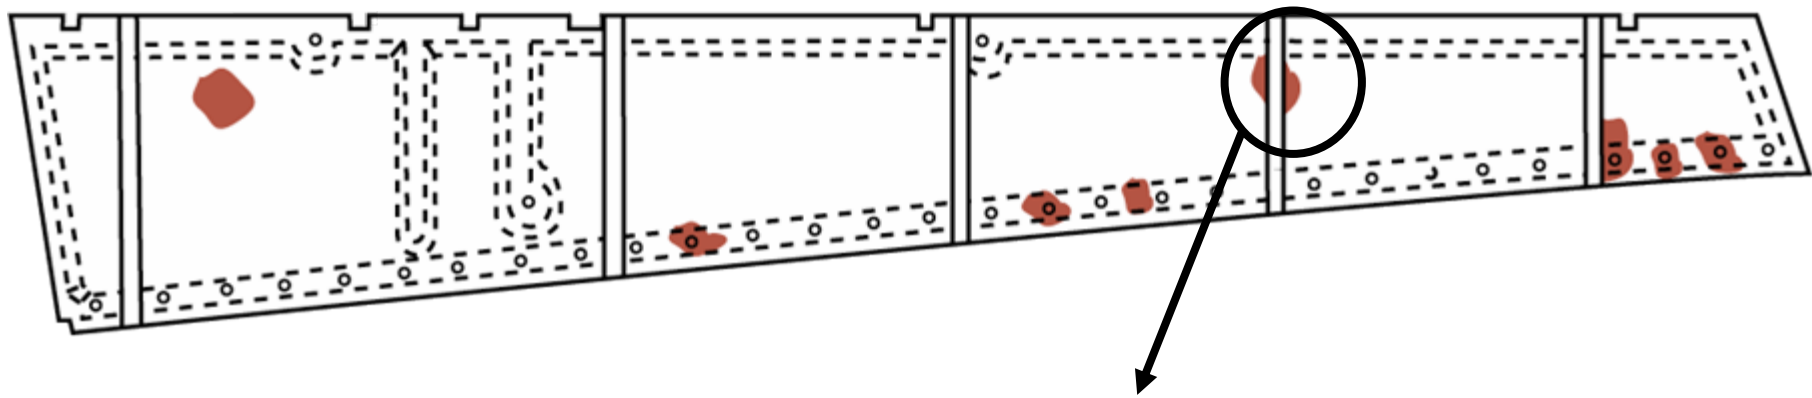
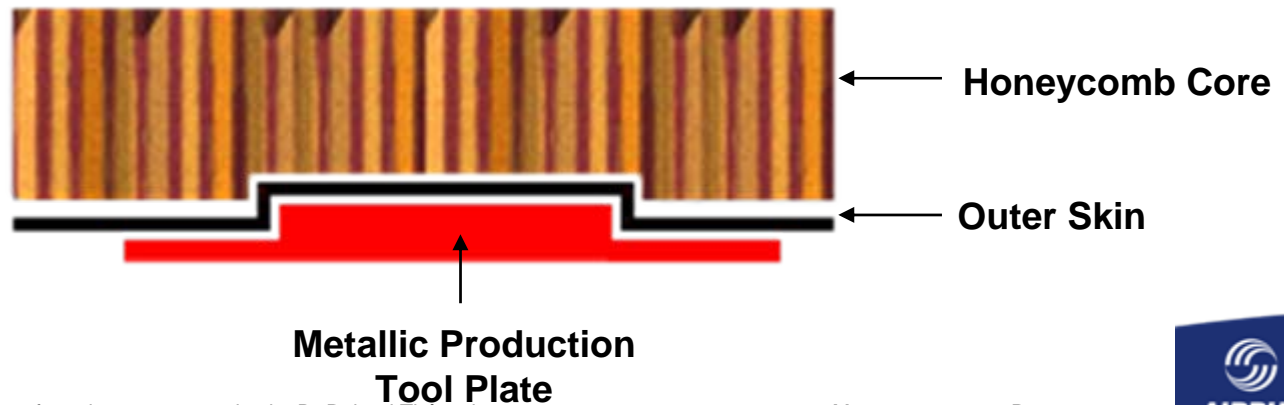
- Bonding straps replaced by mesh

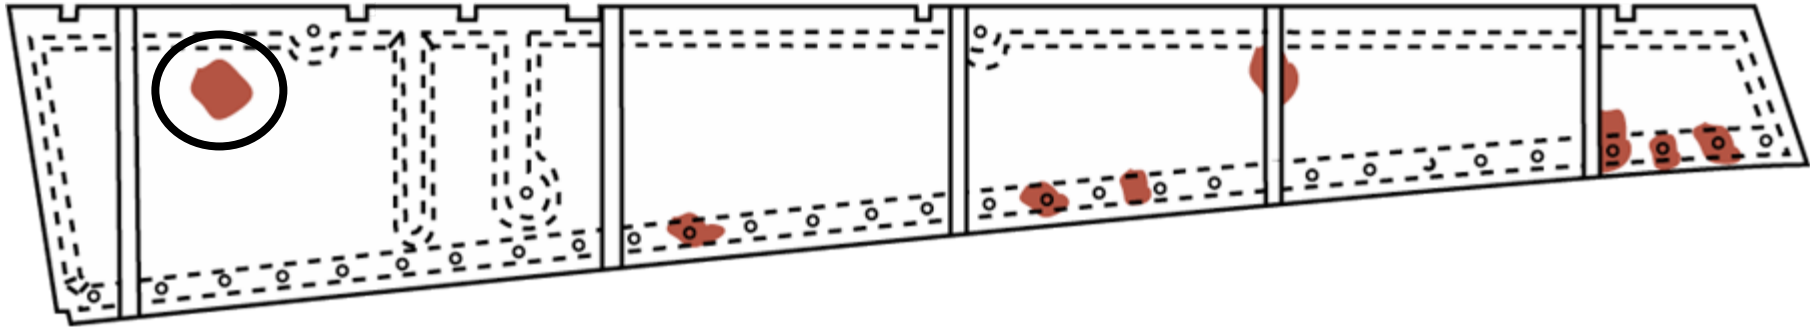
- Panel surface

- Origin:
  - Porosity from production
  - Unrepaired paint or structural damage
- Improvement:
  - New prepreg used in production with higher resin rate
  - Glass honeycomb replaced by Nomex
  - Low resin flow control

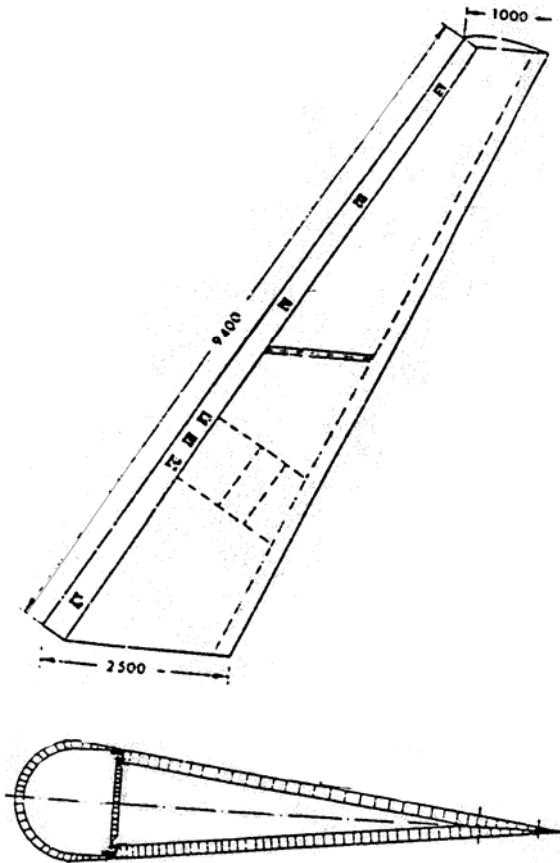
### •In-service damage

- ▶ Large skin-core disbonding
- ▶ Due to the Aramid layer between the core and the carbon fiber skin (poor resin adhesion on Aramid)
- ▶ Production modification 5844 replaced the Aramid with Glass layer

- ▶ All affected rudders replaced (80)

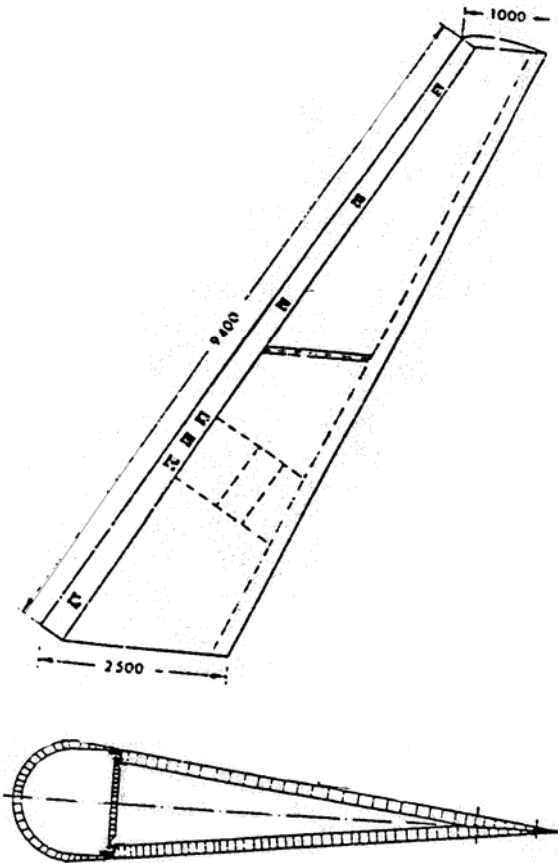
### •In-service damage

- ▶ Skin-core disbonding in the bottom area
- ▶ Due to the attachment of the Front Spar through the honeycomb.

- ▶ AOT has been launched to inspect any damage and the status of the structure (contamination...) Production modification 8827 has modify the attachment

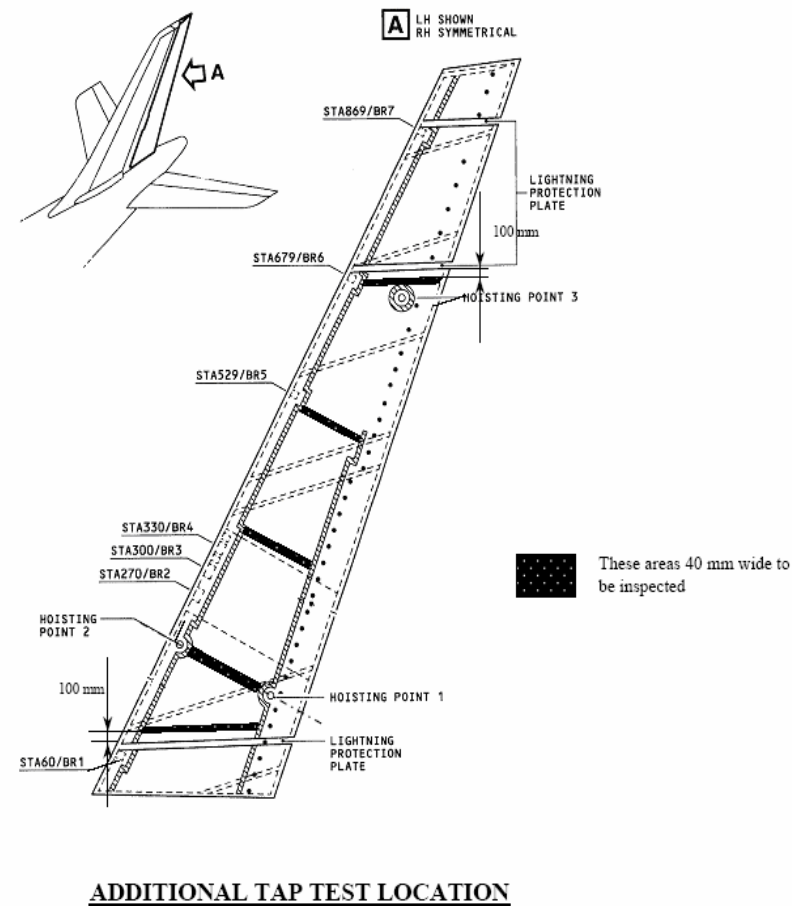
- **Precautionary inspection AOT#1**
  - ▶ Precautionary fleet wide inspection of in-service rudders launched post even
    - AOT's 55A6035 and 55A2035 dated 17-Mar-05
    - About 400 similar P/N rudders (pre mod 8827)
    - Detailed visual inspection plus a tap testing of specific areas
  - ▶ Inspection was based on existing 5Y MPD and AMM tasks
    - Most of findings would have been captured during regular maintenance

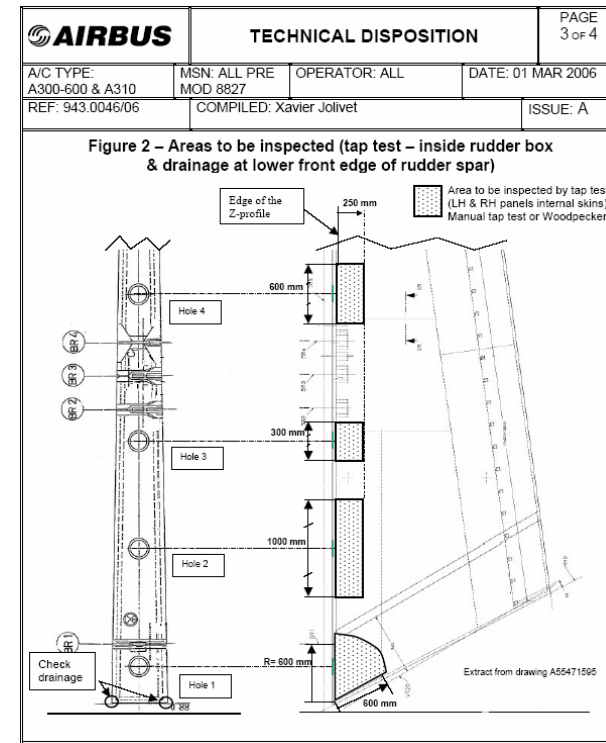
- ▶ Issued after rudder inner skin disbond finding
- ▶ Limited to pre-mod 8827 rudders
- ▶ AOT Inspection for:
  - correct drainage condition (visual)
  - fluid contamination traces (visual)
  - Inner skin disbond (tap test)
- ▶ **Results:**
  - No significant finding (few drains blocked and/or fluid stains, no tap test finding)

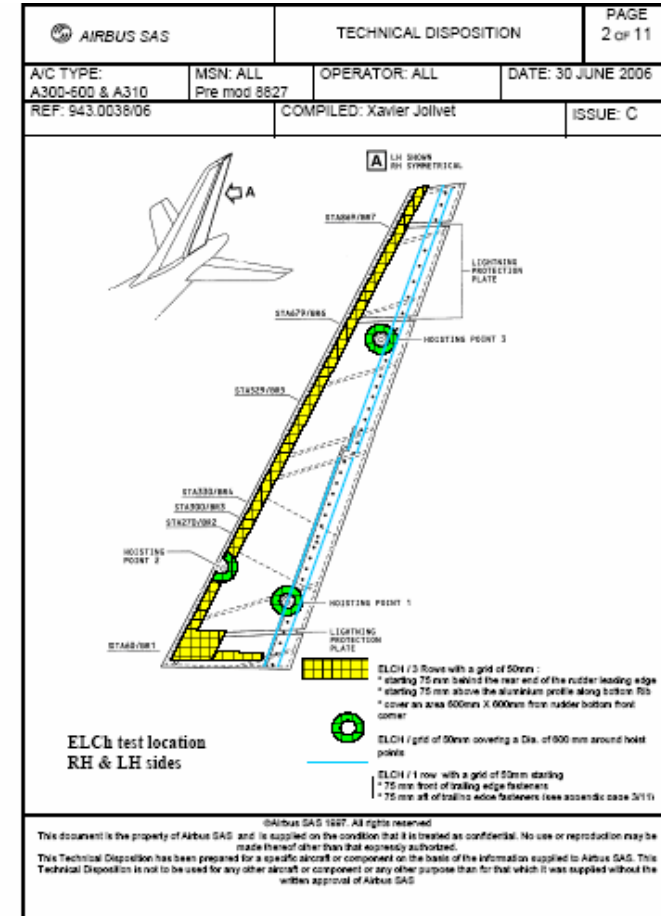
- ▶ 2nd campaign in 2006 (5 airlines):

- ▶ Complete Panel borders
- ▶ Trailing edge screws
- ▶ hoist point surround

- 12 aircraft inspected / no finding
