GE90 Fan Blade Service Experience and Repair

FAA/EASA/Industry Composite
Damage Tolerance and
Maintenance Workshop

May 10, 2007

GE90 Composite Fan Blade

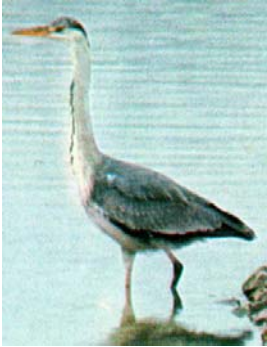
“Single” Bird Ingestion Event October 4, 1998

- Thrust level ... takeoff
- Aircraft speed ... V1 (~150 kts)
- Bird species ... Gray Heron
 - Weight ... ~3 lbs+
- Engine condition ... serviceable

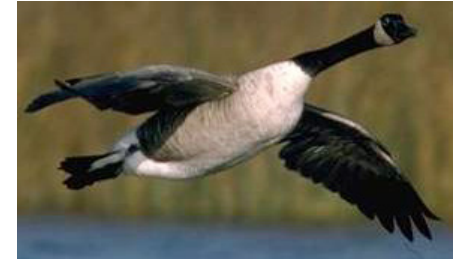
“Multiple” Bird Ingestion Event September 9, 2002

- Aircraft ... on approach
- Airspeed ... ~200 knots
- Ingestion ... both engines
- Bird species ... Canadian Goose
 - Weight ... ~8 lbs
- Engine condition ... serviceable

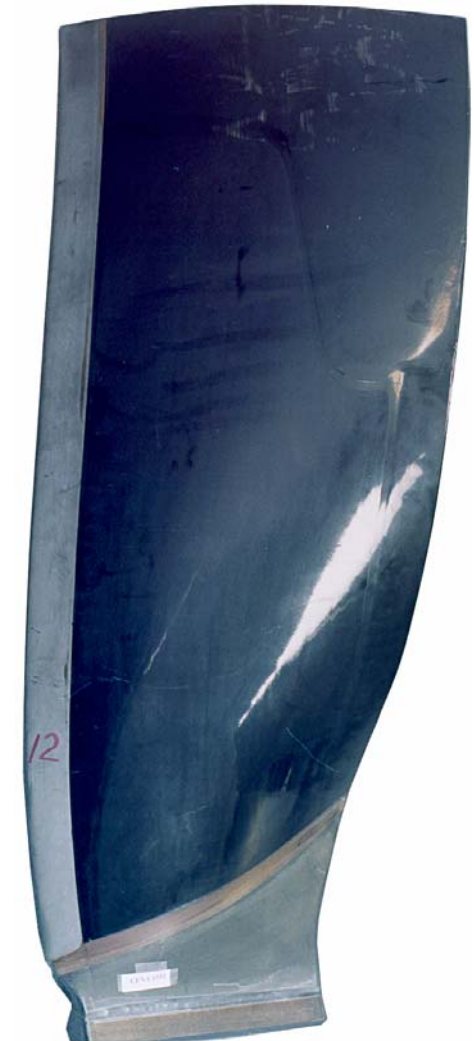
Serial No. ... CFNA 0804

Fan Blade Erosion and Wear Assessment

- Leading edge guard ... small amount observed directly on nose - quantification showed small erosion depth
- Tip region ... no erosion
- Trailing edge region ... no erosion
- Airfoil ... pressure side
 - * Polyurethane surface ... Some erosion observed
 - * Surface adjacent to leading edge guard ... some paint peeling

- Dovetail pressure faces ... no significant wear
- Platform wear strips ... Some local wear observed
