JAL Perspective on Application & Field Experiences for Composite Structure

3rd FAA/EASA Industry Composite Damage
Tolerance and maintenance Workshop

Jun Yamanaka
Japan Airlines
Engineering Department
June 4th, 2009

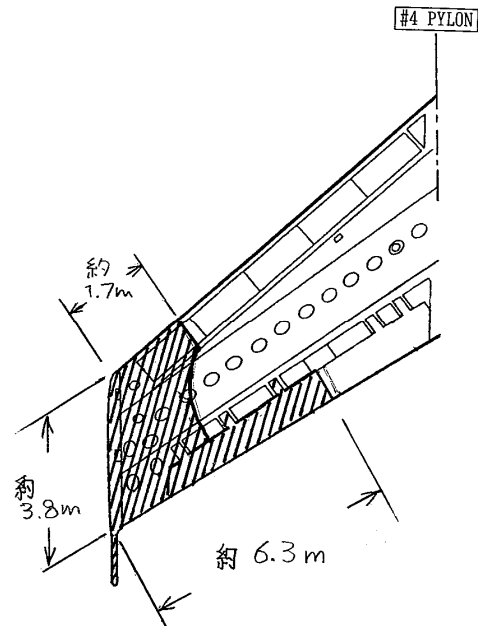
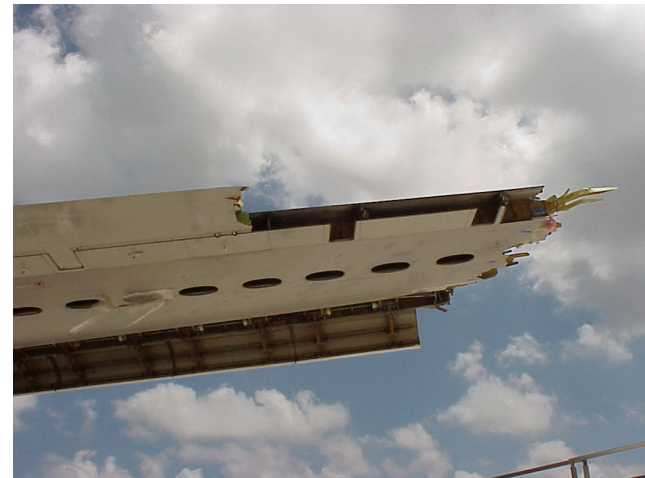
Wing tip was hit with light pole.

The wing main box, wing tip structure, leading edge flap and aileron got severe damage.

■ The repair took almost 3.5 months

Cut and splice the wing skins, spars and stringers. All repair were “Bolted” repair.

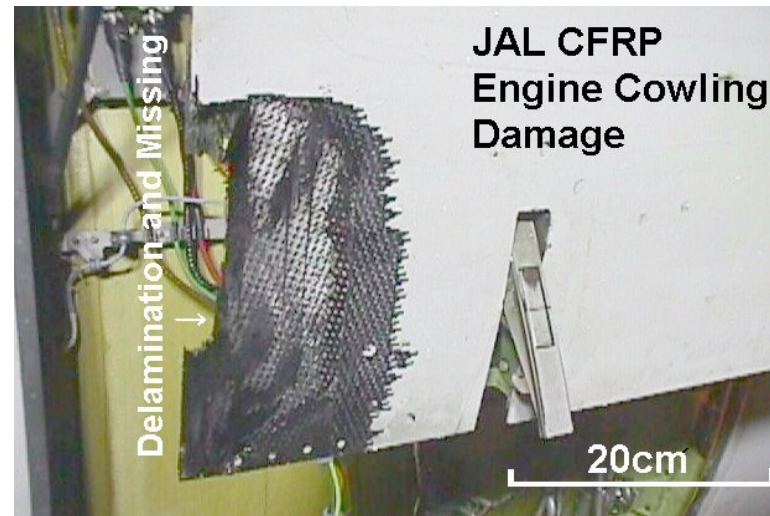
Lightning hit damage occurred on the engine cowling. Heat damage with disbond was found.

The cowling was replaced.

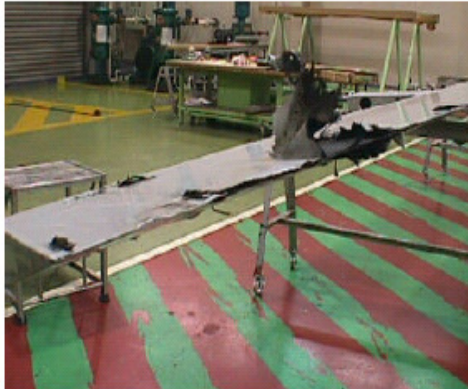
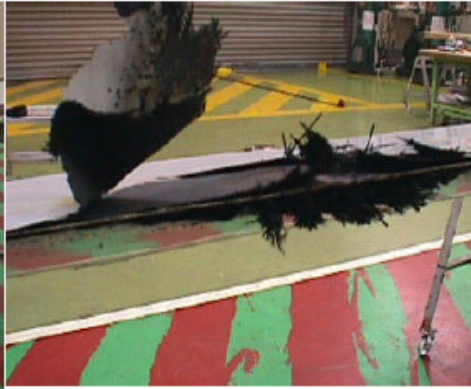
Damage Status – Lower Surface

Heavy Damage with Crack, Delamination & Resin Burn-Off – Skin Plies (12" x 40")
Missing – Discharger, Discharger Base & Insert

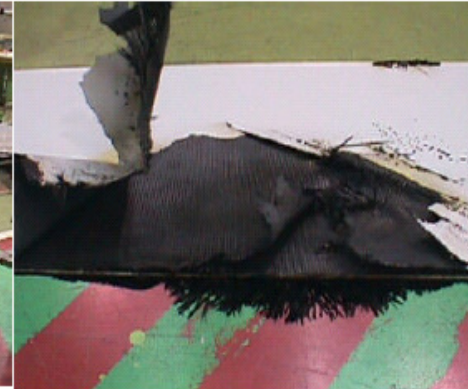
Lightning hit damage occurred on the outboard aileron.
Heat damage with large disbond was found.

The aileron was replaced.

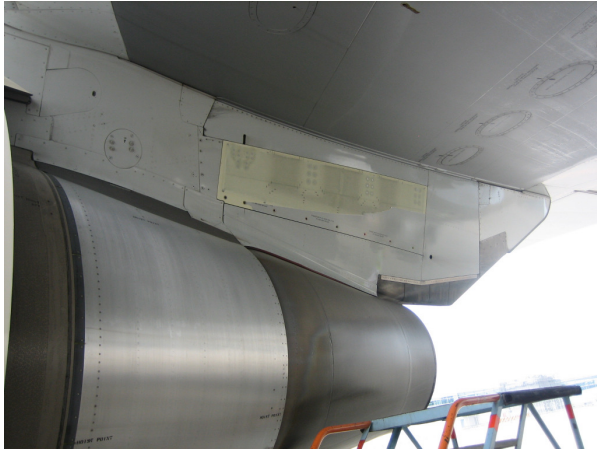
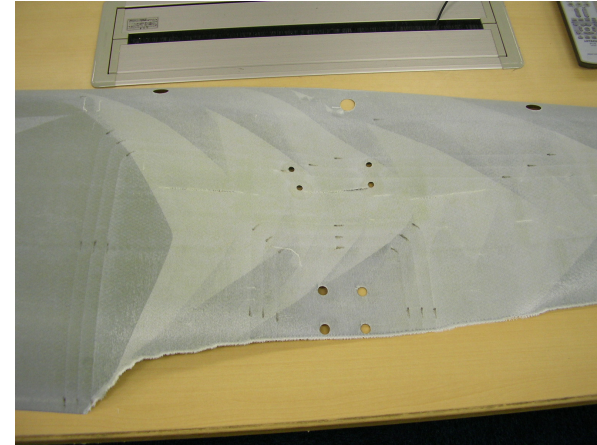
Large peel off skin of glass fiber honeycomb

During the turn around, the pylon aft fairing glass fiber honeycomb skin was found peeled off. The most outer glass fiber ply disbonded and departed from the airplane.

No other damage was found in the honeycomb.

The root cause of the disbond was considered to be a poor edge protection design of the skin.

The skin edge erosion lead the airflow to peel off skin ply.

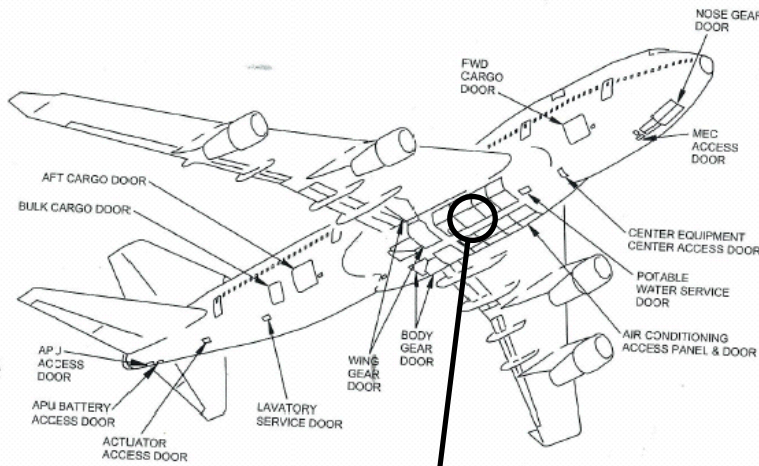
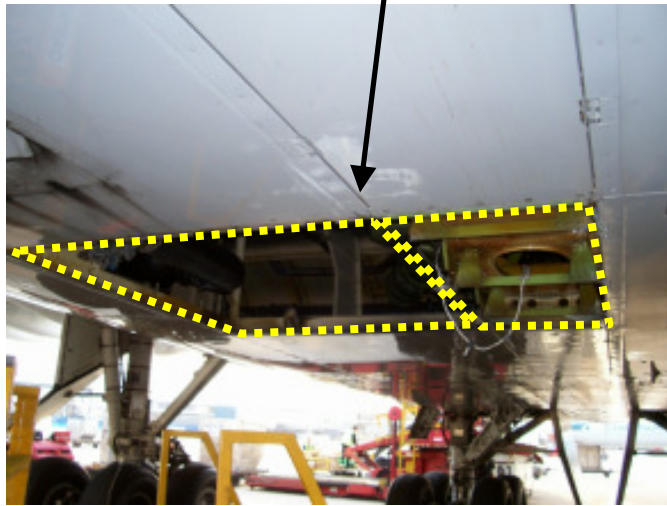
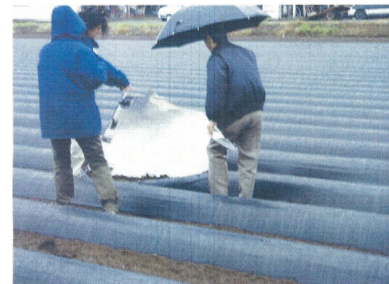
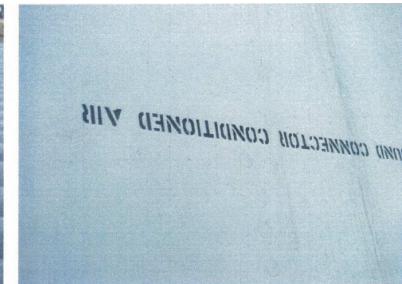
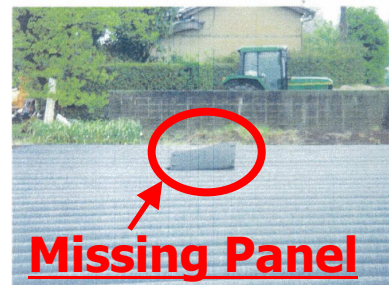
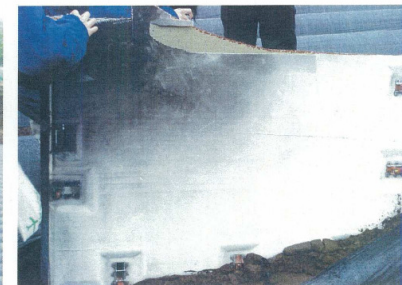
Air-con Bay ACC Panel Missing

- The Panel fell down in a farmer's field near houses.
