Lufthansa Technik

**Lufthansa Perspective on Applications &
Field Experiences for Composite
Airframe Structures**

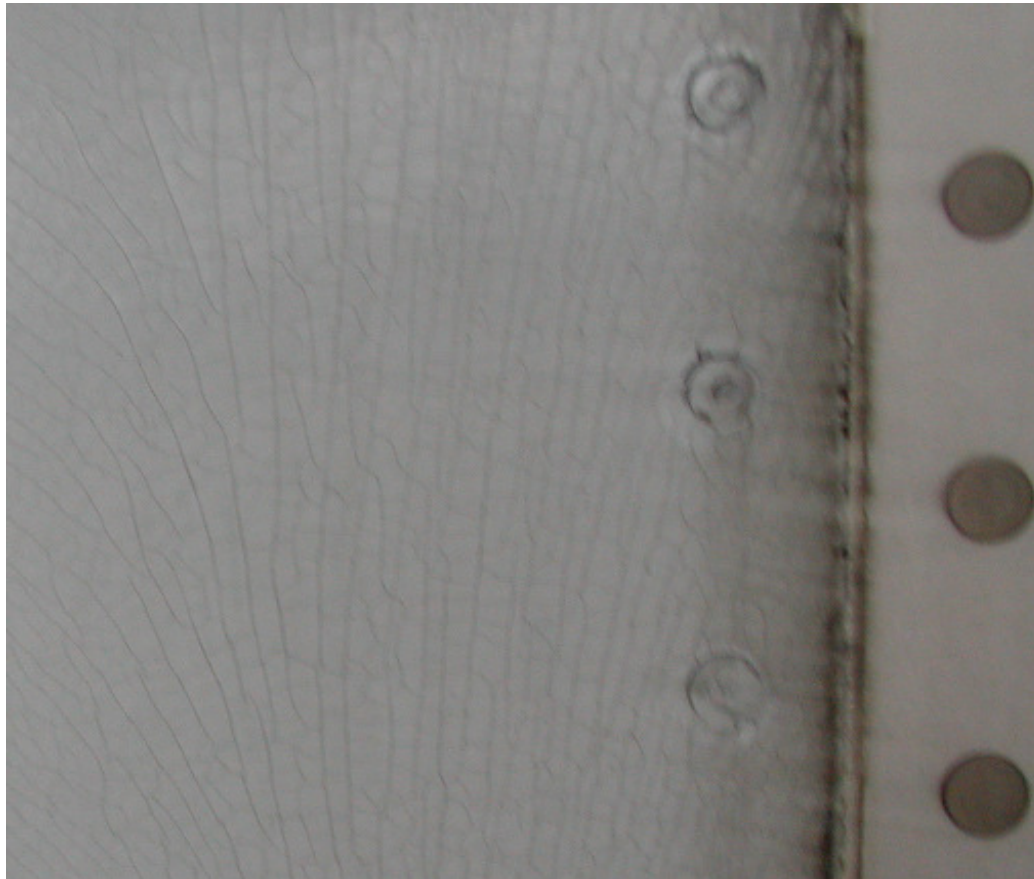
“Mud cracking”
appearance after 3 to 4
years service exposure on
inlet cowl outer barrel

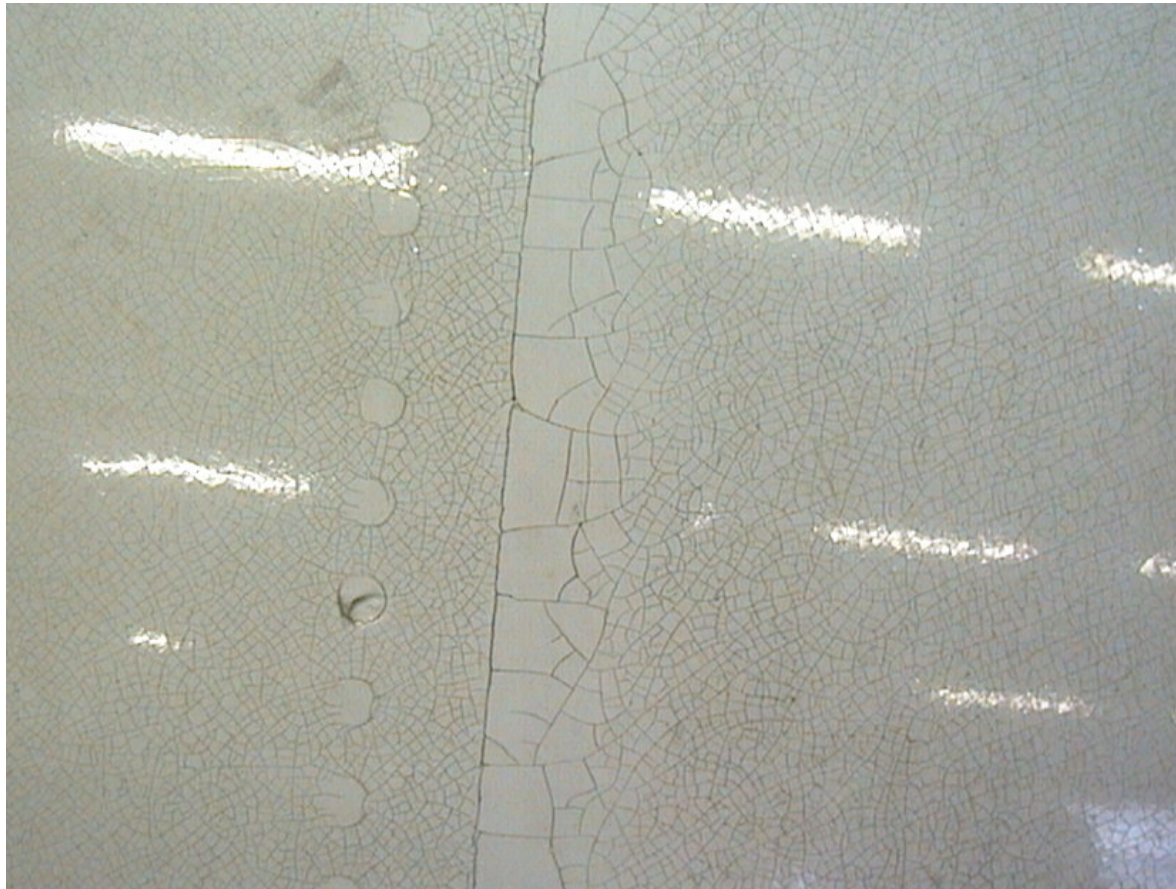
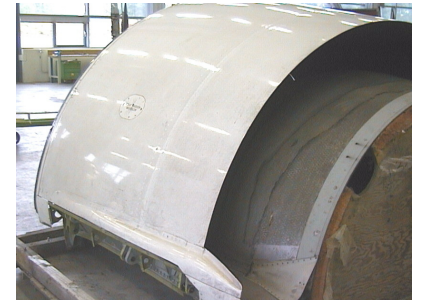
Another example of “mud cracking” appearance on a fan reverser sleeve.

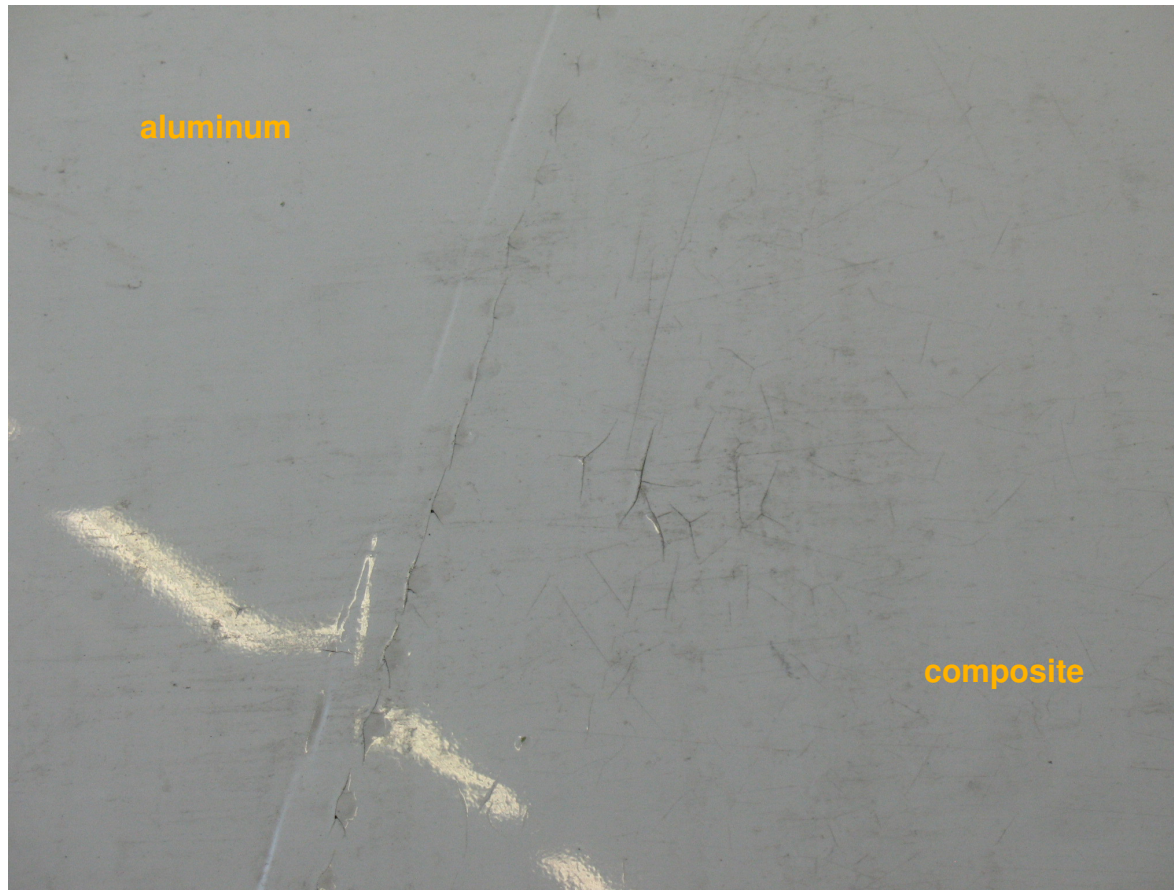
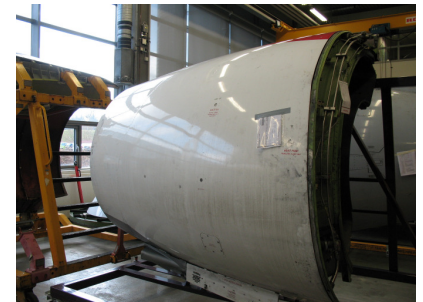
Comparison of paint performance on aluminum (left, paint in acceptable condition) and composite (right, paint cracked) substrate of a fan reverser sleeve

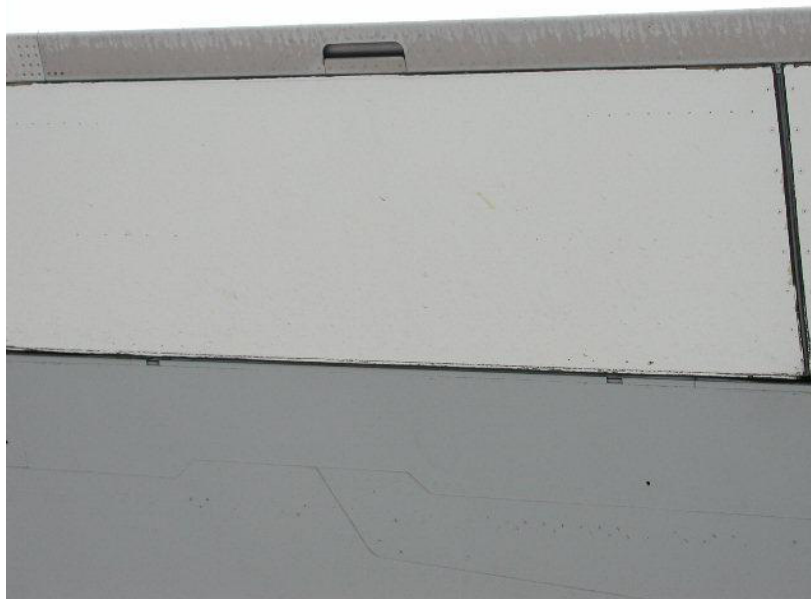
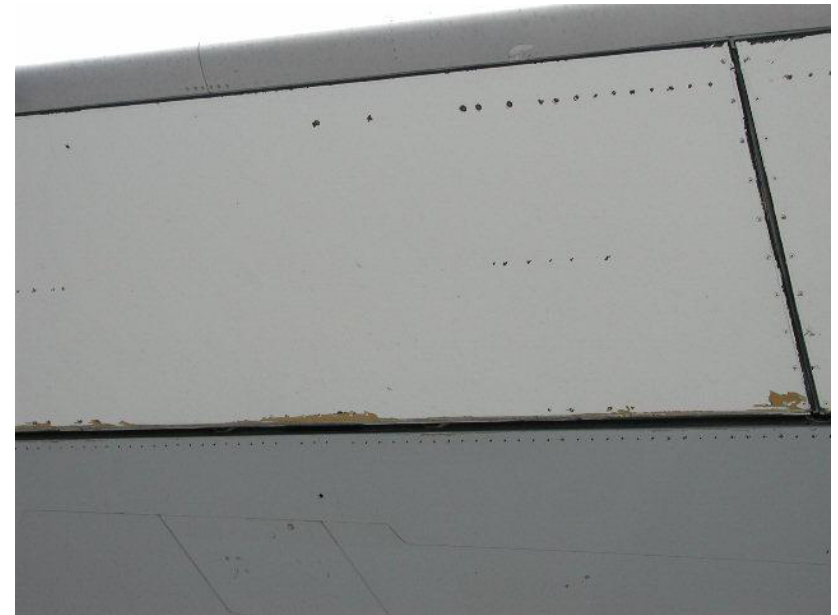
Chamber flaps painted with and without flexible primer after 18 month operation

Results showed significant influence of primer

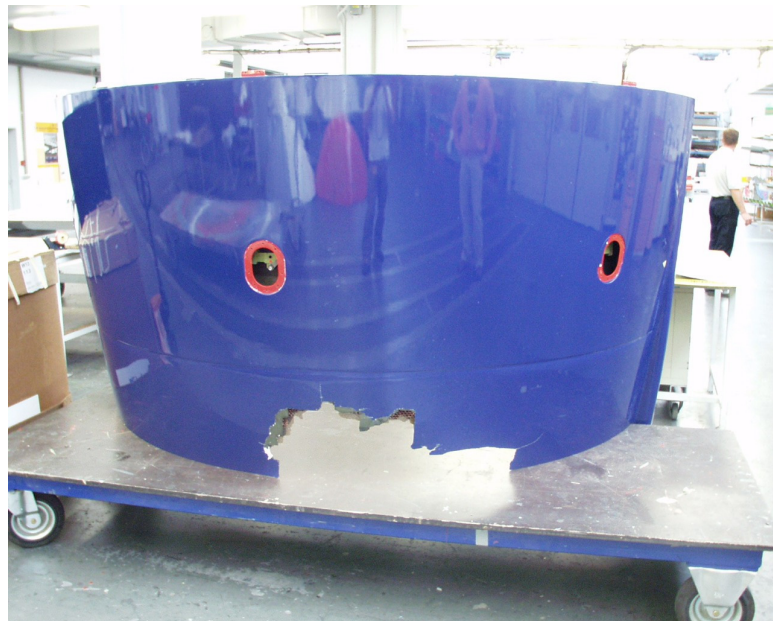
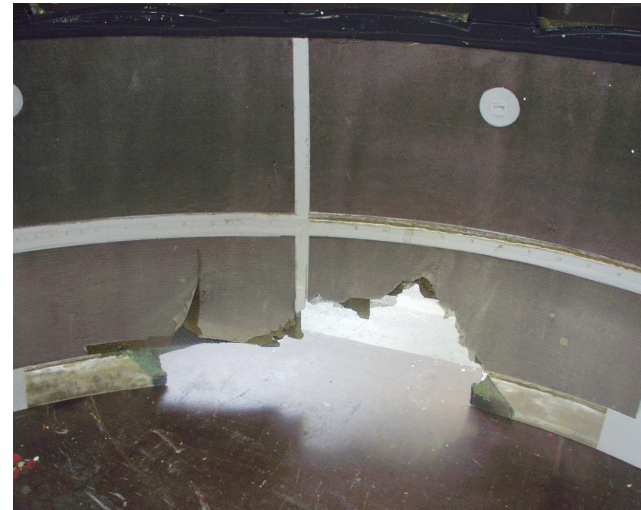
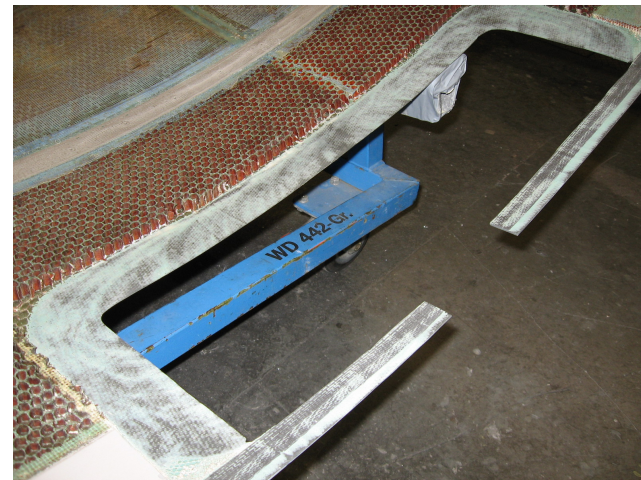
- CF6-80 Thrust Reverser Translating Cowl
- Sandwich Panel made of Honeycomb + CFPF Skins
- Damage caused by blocker door release

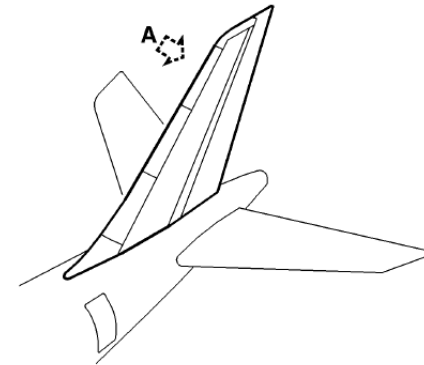
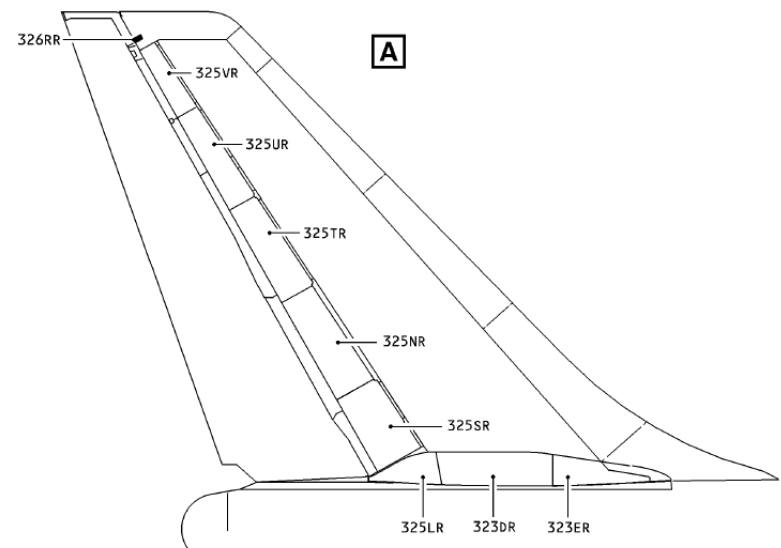
- During D-Check of an Airbus A340, a damaged stringer in the Vertical Stabilizer has been found during re-installation of the fairing between fuselage and the VS
- The damage was a disbonded stringer flange in the region of a fastener used for the fairing attachment
- Reason for damage unclear

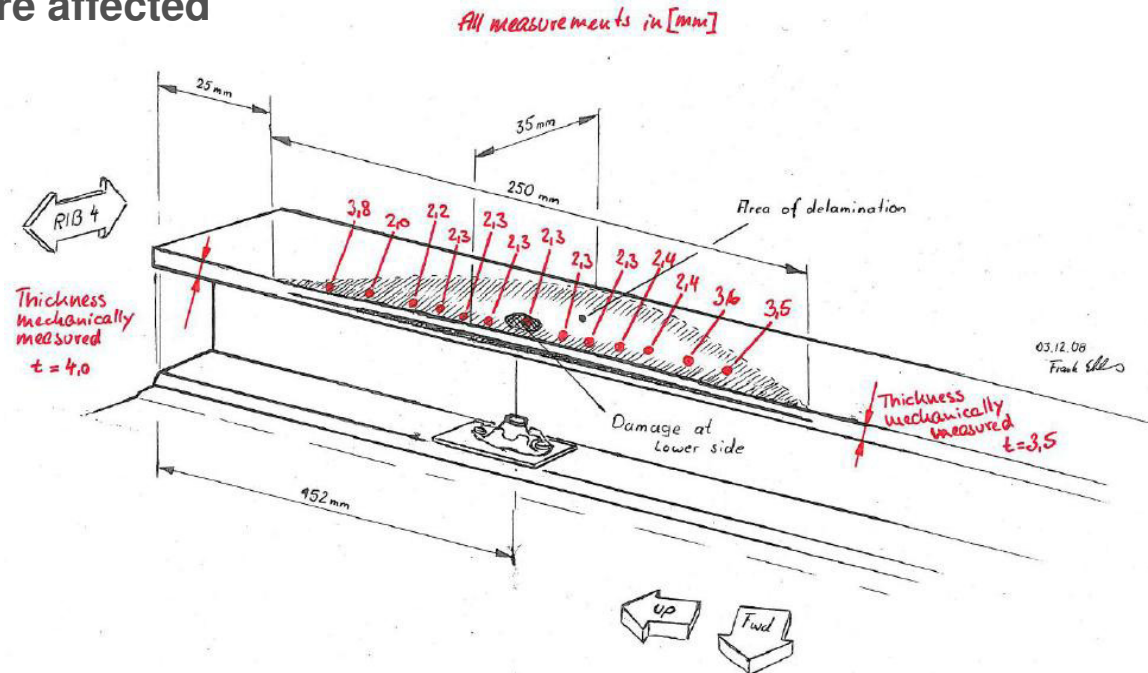
- In order to determine depth of the damage, an ultrasonic inspection of the flange was performed
- The measured values could not be definitely associated with expected CFRP layer thickness
- It was decided to mechanically remove the damage to clarify whether the tape layers were affected
