Presented by
Dr Roland Thévenin
Senior Expert Composite
Structure Conformance

FAA Workshop for Composite Damage Tolerance and Maintenance
June 4-5, 2009
Tokyo

Flight Control Sandwich Structures and Inspections

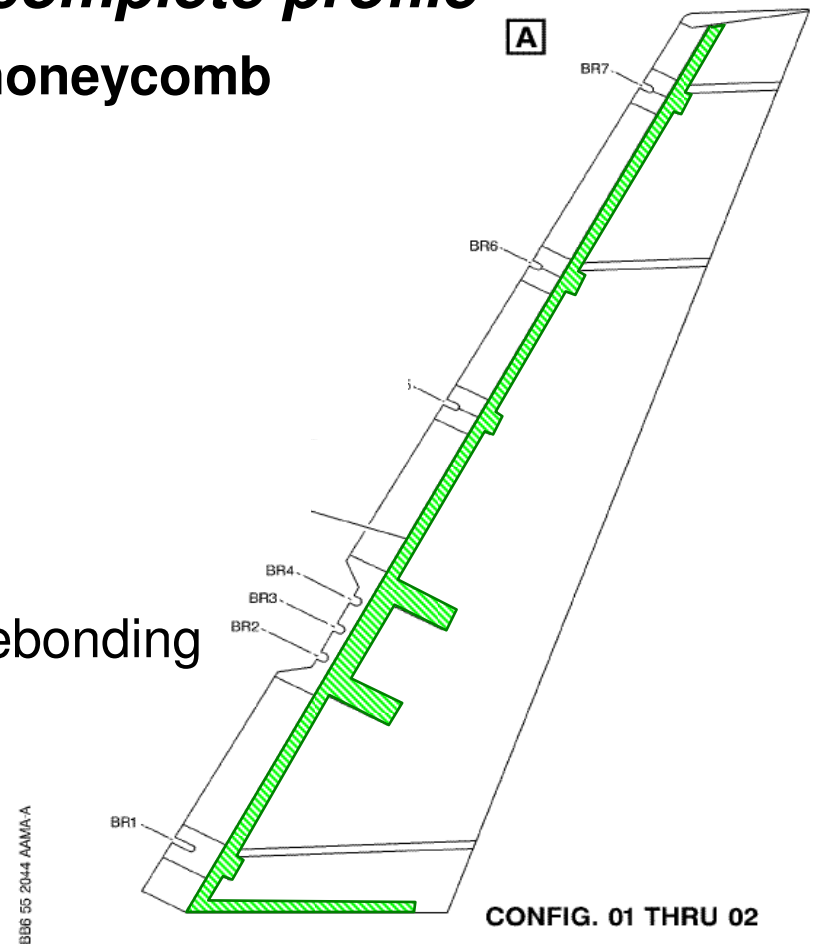
Z-profile area inspection along complete profile

▶ Check bonding of both skins / honeycomb

- ▶ Outer skin delamination
- ▶ crushed core
- ▶ inner/outer skin to core debonding
- ▶ water ingress

- ISBs issued end July 07
- AD 2007-0266 issued

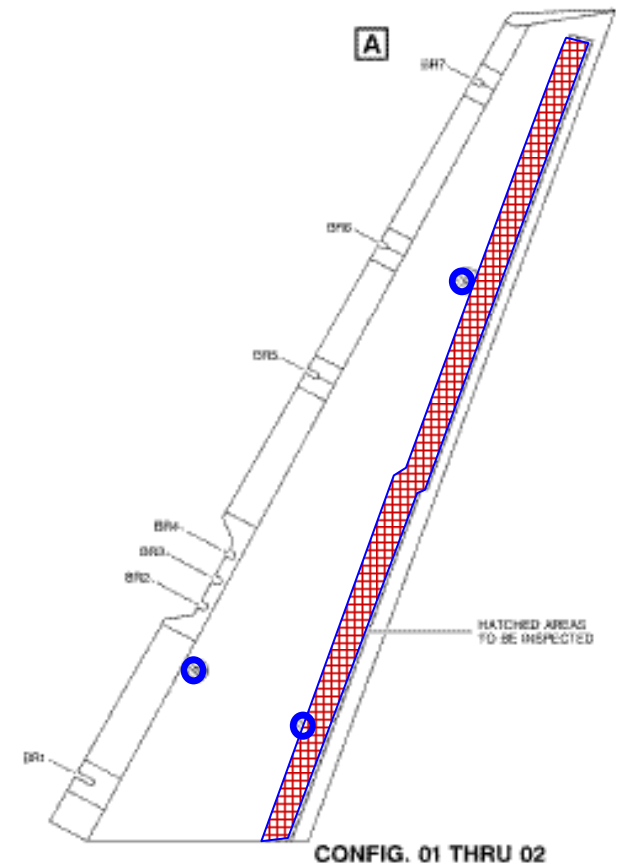
Hoist points & trailing edge screw areas inspection

- ▶ **Check for water contamination**
 - ISBs issued end July 07
 - AD 2007-0266 issued
 - New ‘combined’ ultrasonic & thermographic procedures

- Inspection method capability
 - Thermographic
 - ▶ Water ingress
 - Ultrasonic
 - ▶ Outer skin delamination
 - ▶ Crushed core, inner/outer skin to core debonding
 - ▶ Water ingress
