Field Experience – Lightning Strike Damage of ANA B767

June 4, 2009

ANA

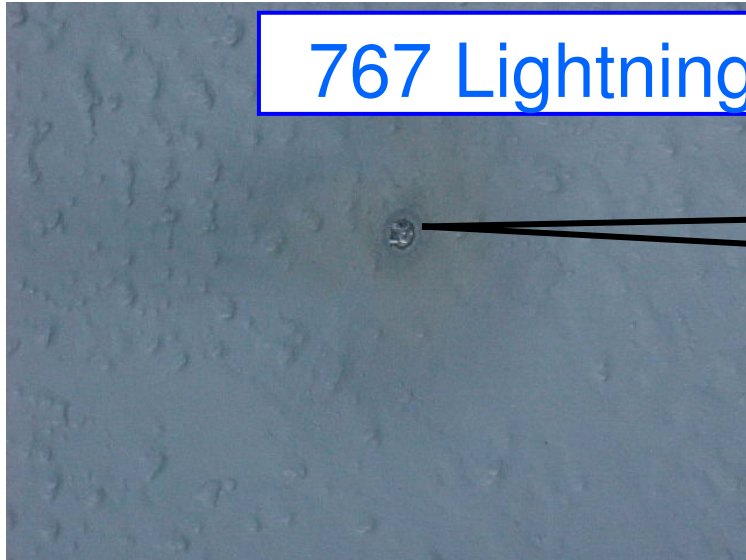
Melted Rivet

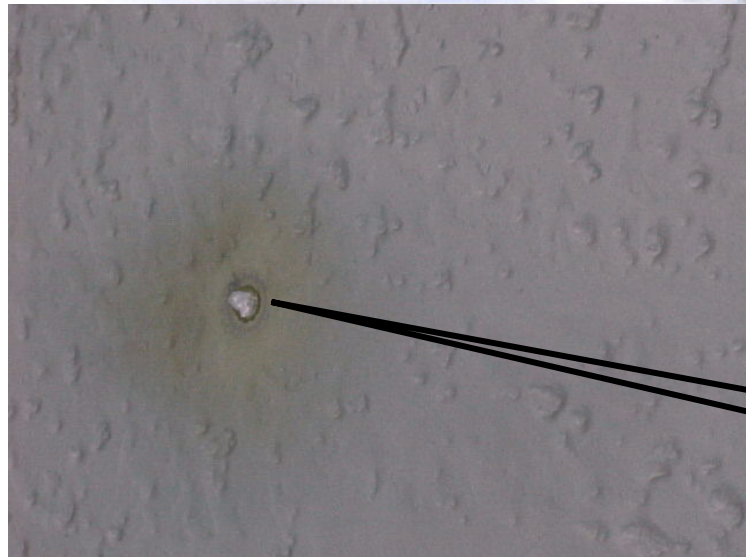
Melted Rivet

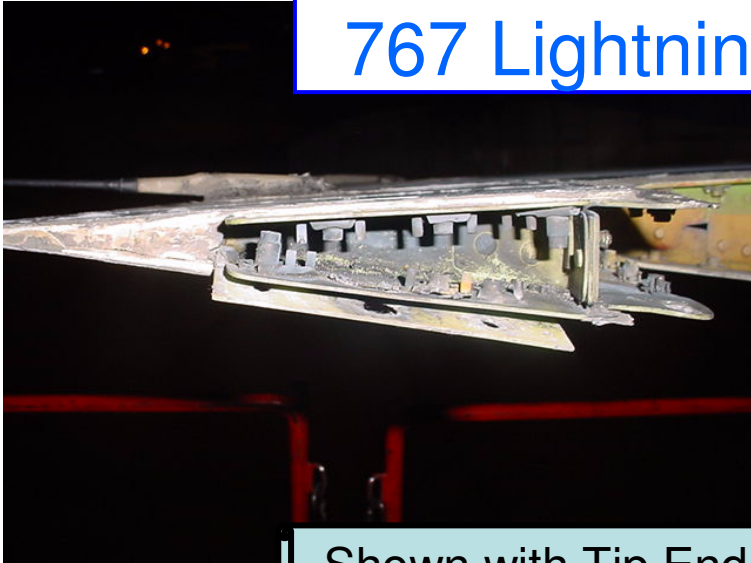
Shown with Tip End Panel removed.

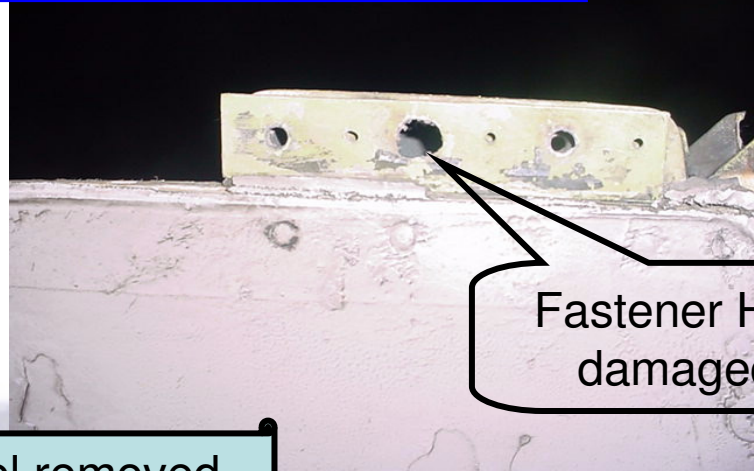
Fastener Hole damaged.

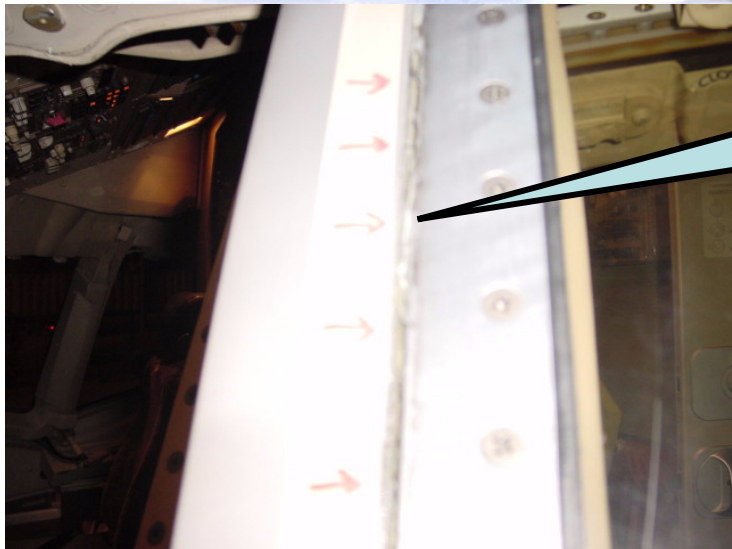
Window Sill melted.

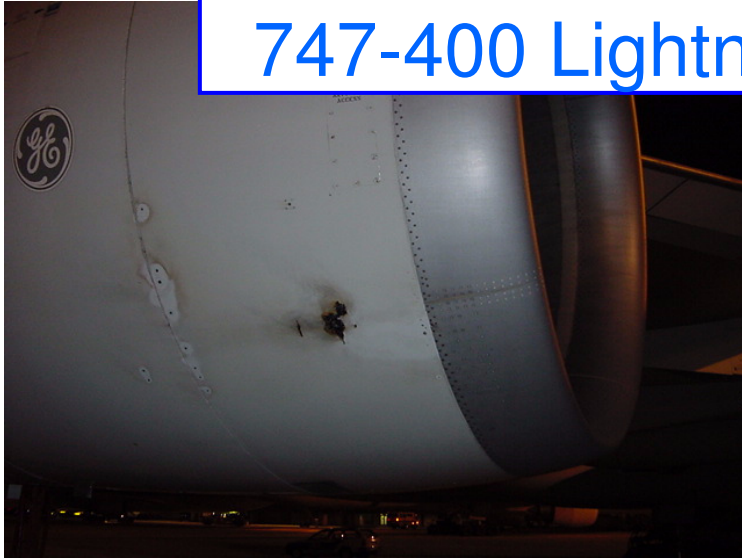
Rivets burned.

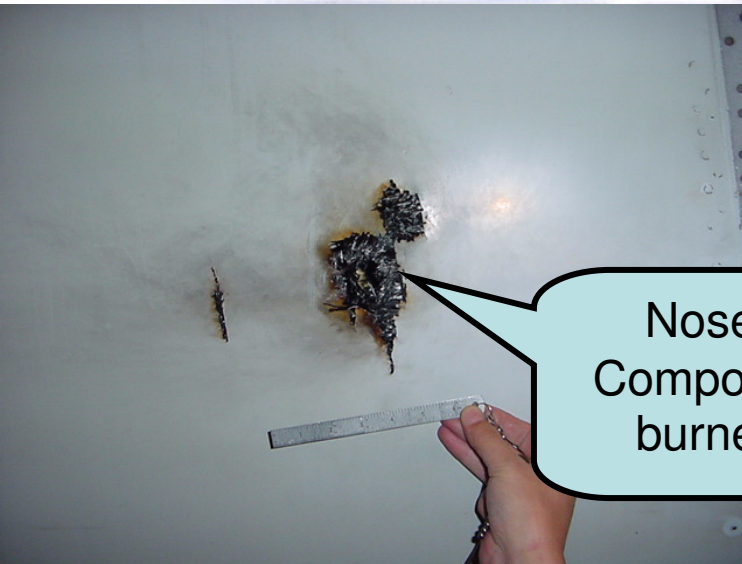
NO.4 ENG NOSE COWL SKIN

Nose Cowl Composite Skin burned. [|||||]

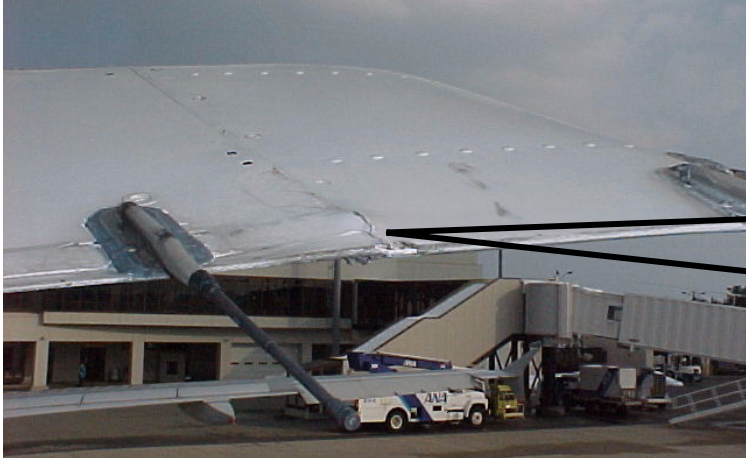
Elevator Tip
Composite Skin
Burned.

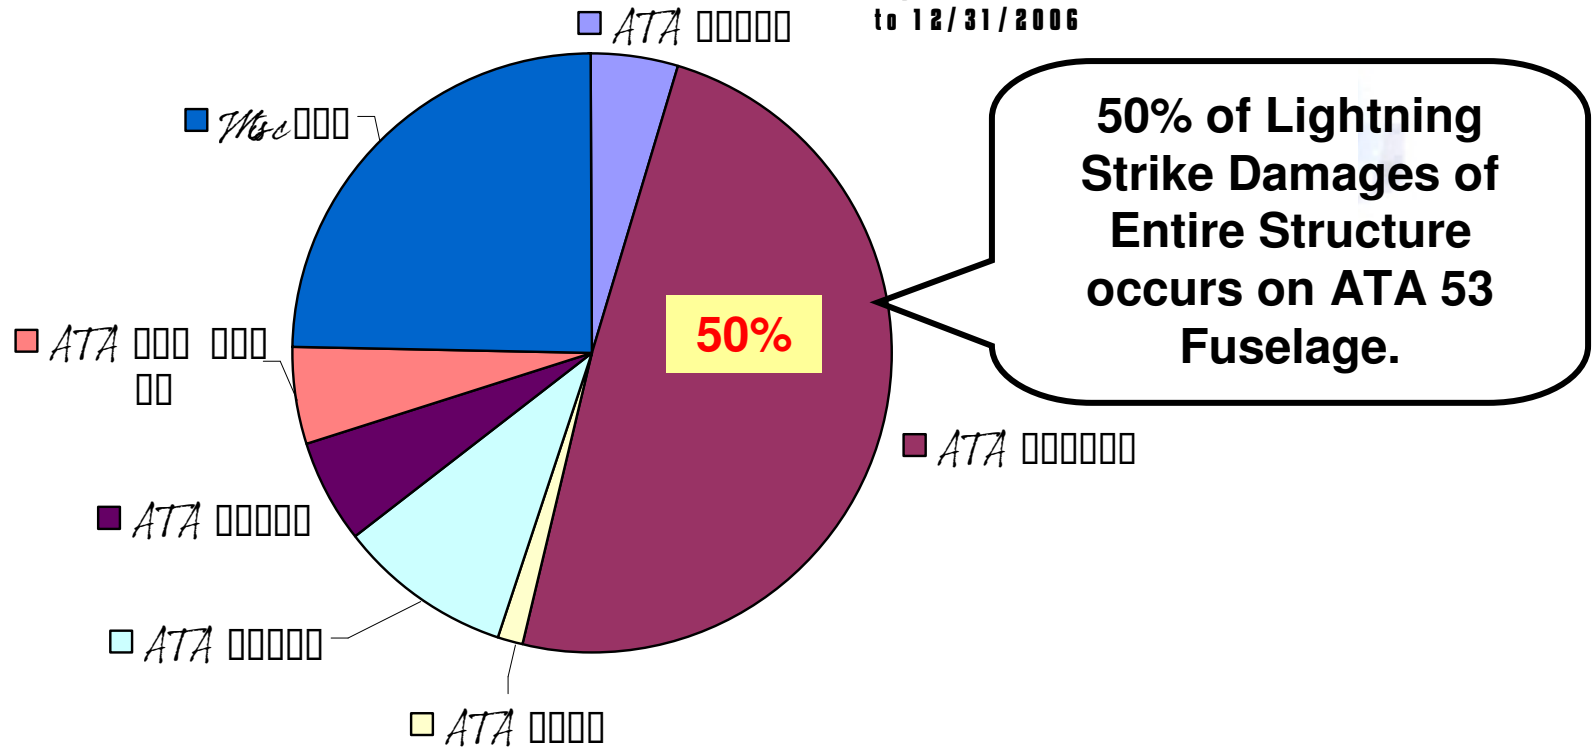
50% of Lightning Strike Damages of Entire Structure occurs on ATA 53 Fuselage.

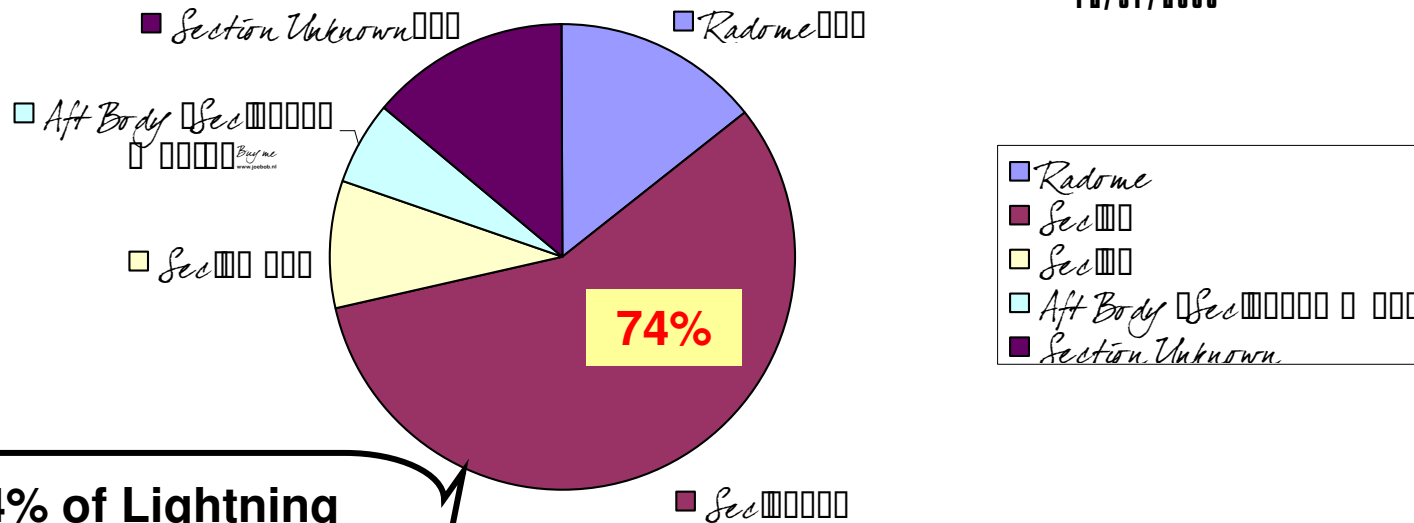
74% of Lightning Strike Damage of ATA 53 occurs on Sec. 41 including Radome.

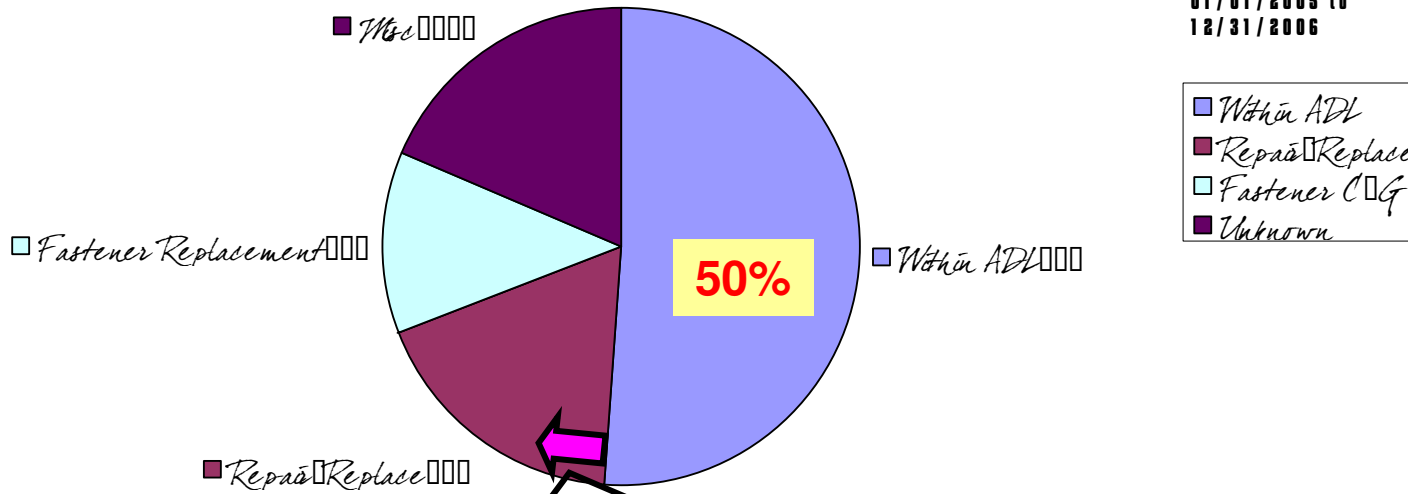
50% of Lightning Strike Damages of 53 is within Allowable Damage Limit.

Relaxation of ADL could reduce maintenance burden.

Our Proposal for Expansion of ADL of 41 Fuselage Skin.

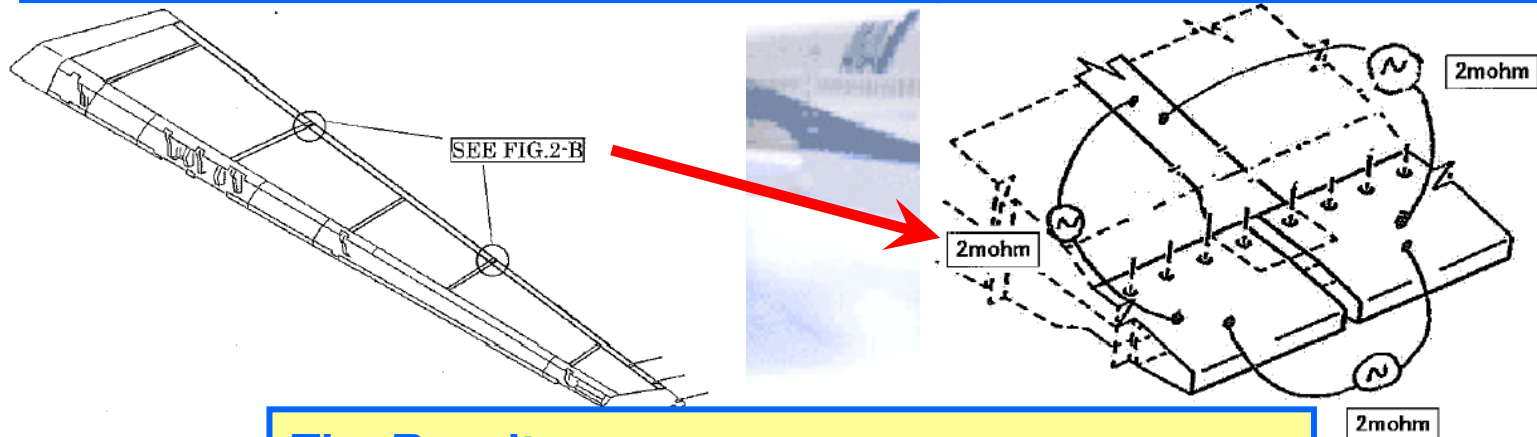
Before: 6 Repairs / 1 year

After: Just 1 Allowable damage / 1 year

- Resistance check & correction at the Elevator Trailing Edge Strap to relax maintenance burden.**

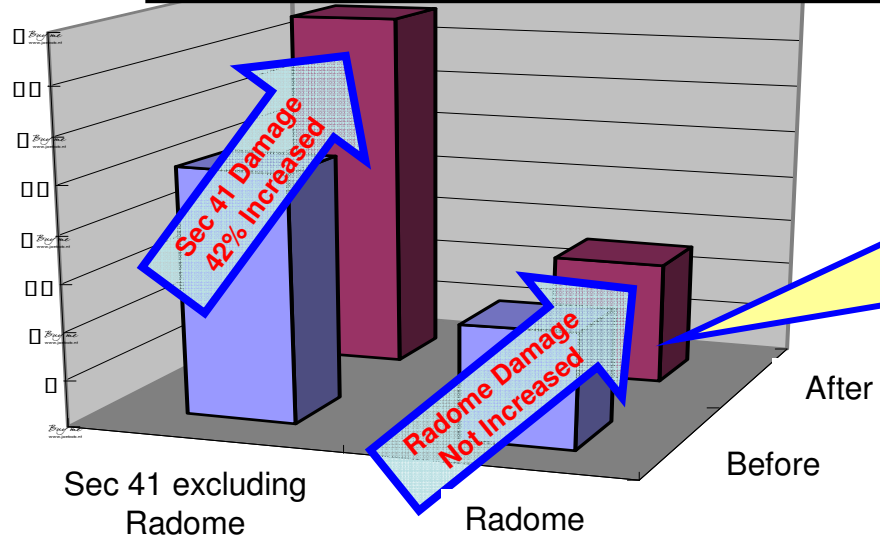
**Lightning Strike - Sec 41 / Radome
Before vs After the correction**

Increase of Radome Composite Repair could be restrained by conductivity correction.

The Result was:
Before: 0.2 Radome Repairs / airplane / year
After: 0.2 Radome Repairs / airplane / year
In Sec 41 Lightning Damage 42% Increased environment,
Radome damage increase was restrained.

- Resistance check and correction at the attaching points to relax maintenance burden due to Radome Repair.**
