WICHITA STATE
UNIVERSITY

NATIONAL INSTITUTE
FOR AVIATION RESEARCH

An experimental presentation on the effects of poor design or implementation of modifications involving composite materials

Presented at the FAA Workshop on Modifications and Alterations Affecting Composite Parts or Composite Structure
July 19-20, 2016 at the National Center for Aviation Training in Wichita, KS

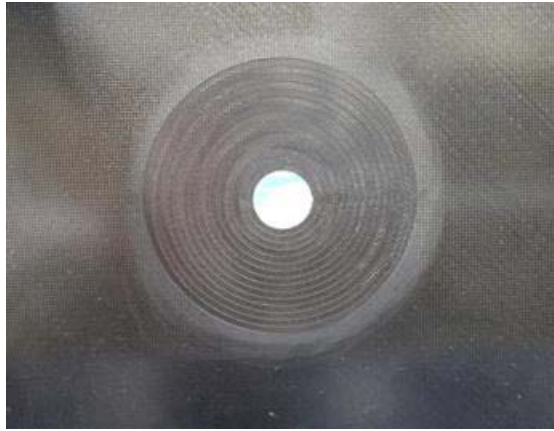
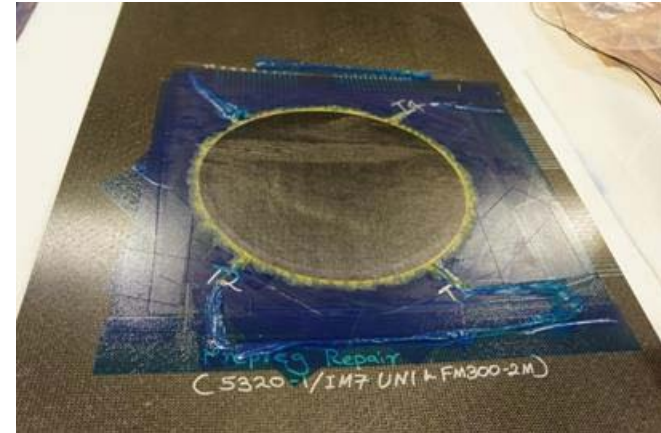
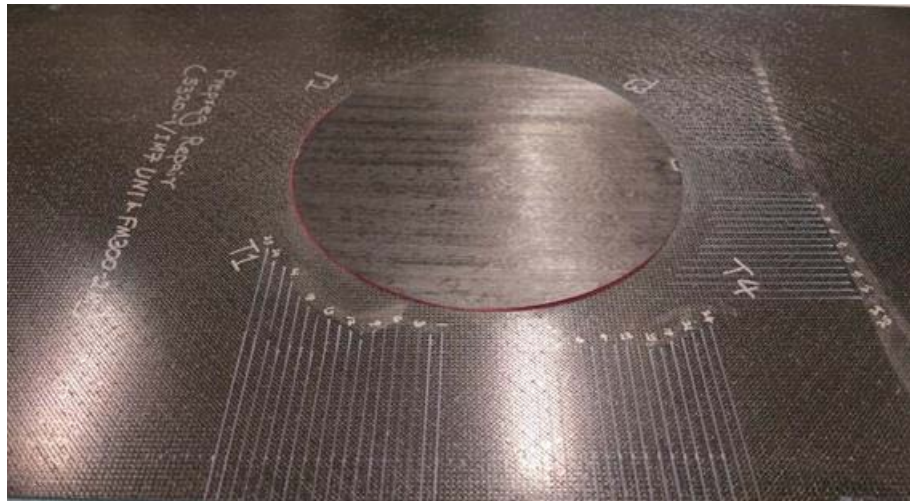
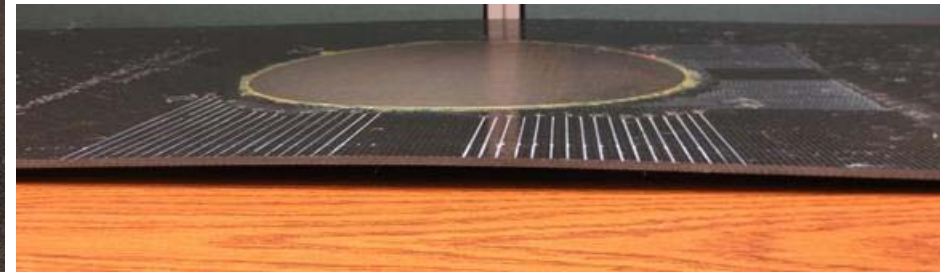
Prepreg Highly Stiff Repair Patch

Warped Repair Panel due to Stiffness/CTE Mismatch

Parent: Cytec T650/ 5320-1 PW, Quasi
Repair: Cytec IM7/5320-1 UNI, Highly Stiff

strain distribution showing stiffness mismatch
between parent and repair

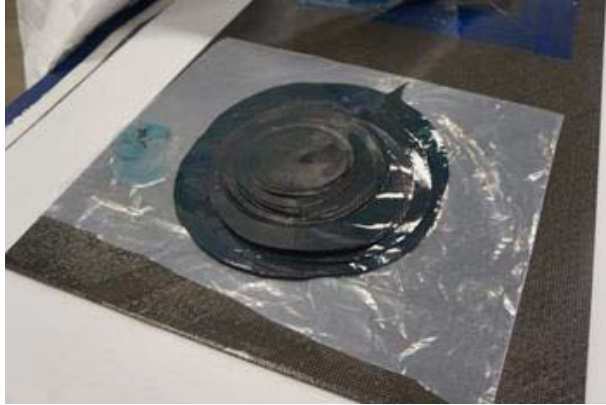
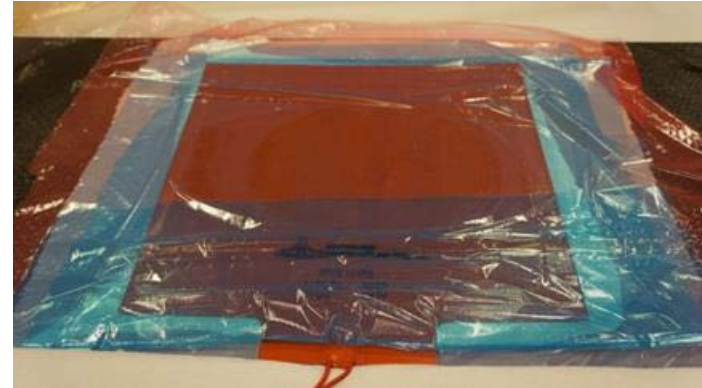
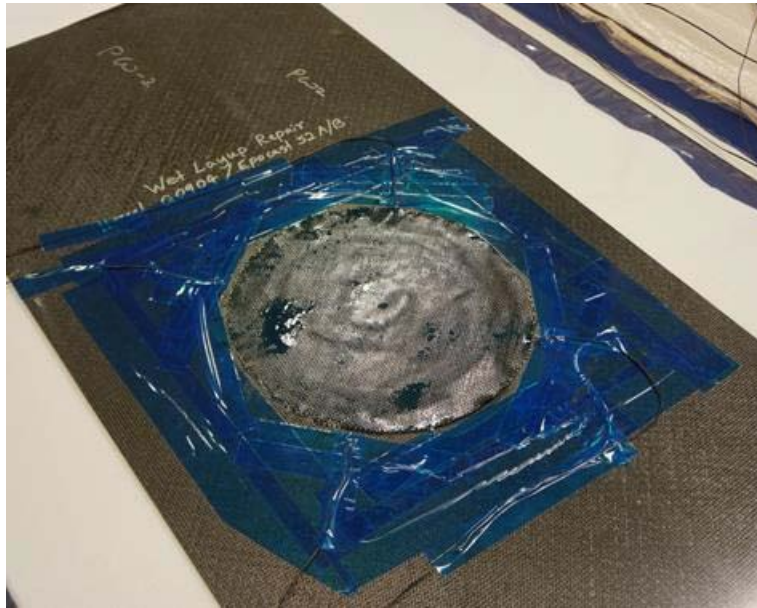
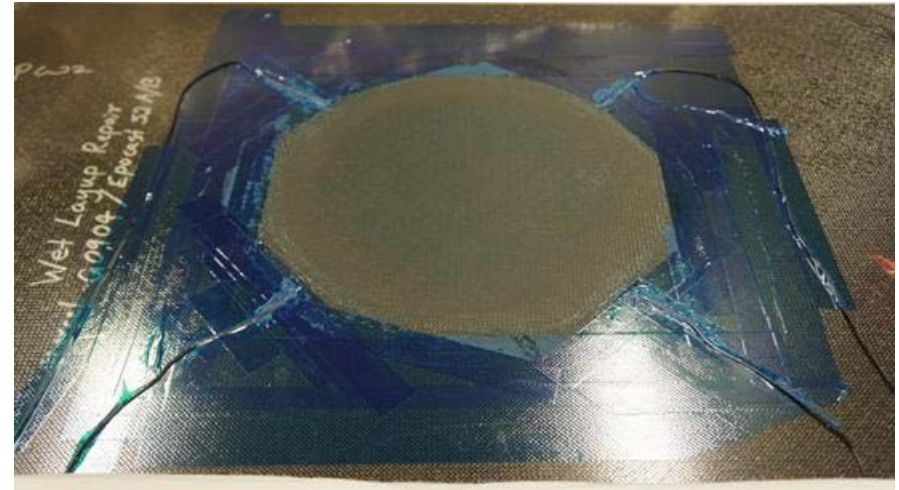
Wet Lay-Up Soft Patch

Parent: Cytec T650/ 5320-1 PW, Quasi
Repair: G904/ Epocast 52A/B wet lay-up, Soft Patch
Content created by Dr. Lamia Salah

strain distribution showing stiffness mismatch
between parent and repair

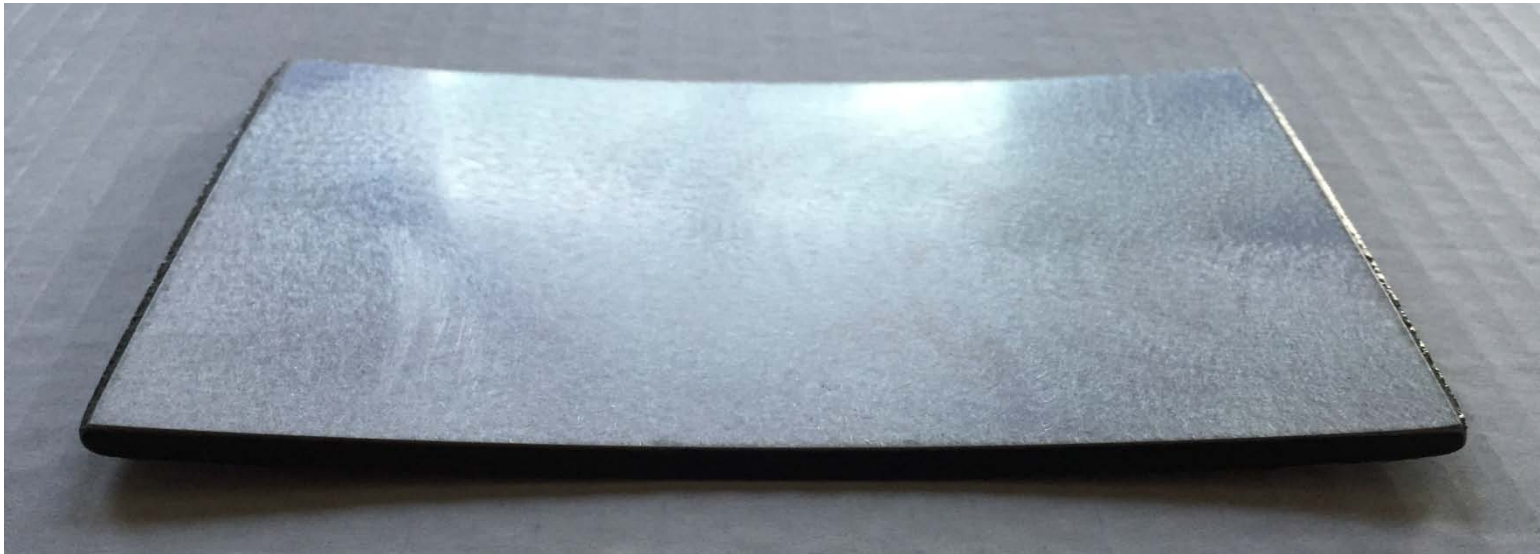
CTE Mismatch, Warped Panel

- A demonstration test panel: 7" by 4", 12 plies of carbon unidirectional tape cured onto a 0.064" thick aluminum
- Causes warpage and thermally induced stresses

- CTE mismatch can cause significant stresses and strains.
 - CTE of Al 2024 $\approx 12.7 \text{ me}/^\circ\text{F}$
 - CTE of composite $\approx 1.5 \text{ me}/^\circ\text{F}$
- CTE mismatch problem is more pronounced in large and/or thick structures that operate at wide temperature range and/or cured at high temperature

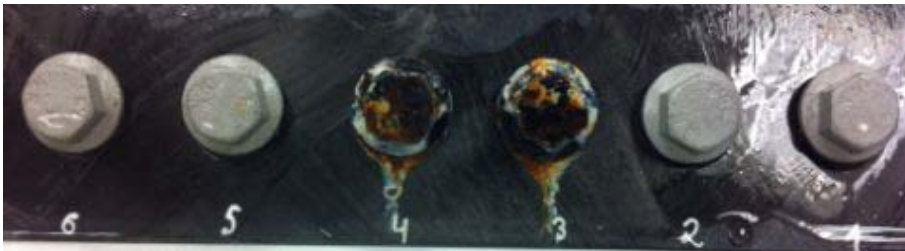
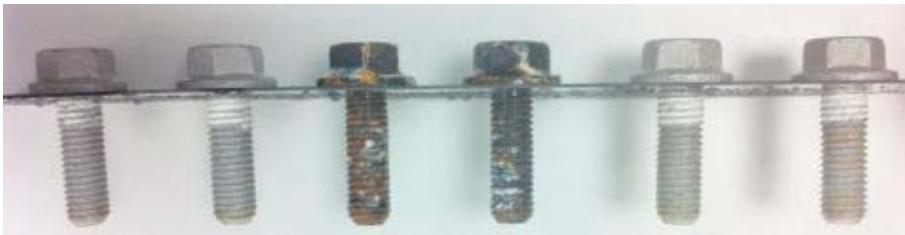
Pictures showing the effects of various coatings on galvanic corrosion of aluminum and steel bolts after more than 1,000 hours of salt spray testing.

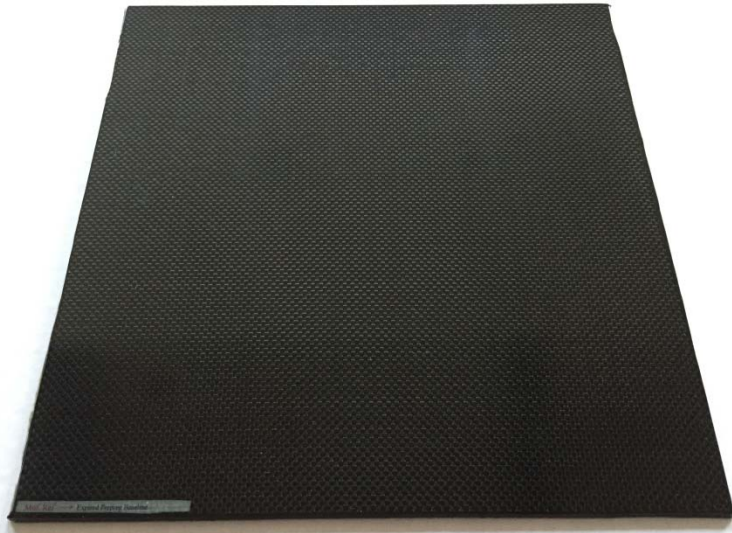
**Panel made from fresh prepreg
No void is visible on the
panel surface**

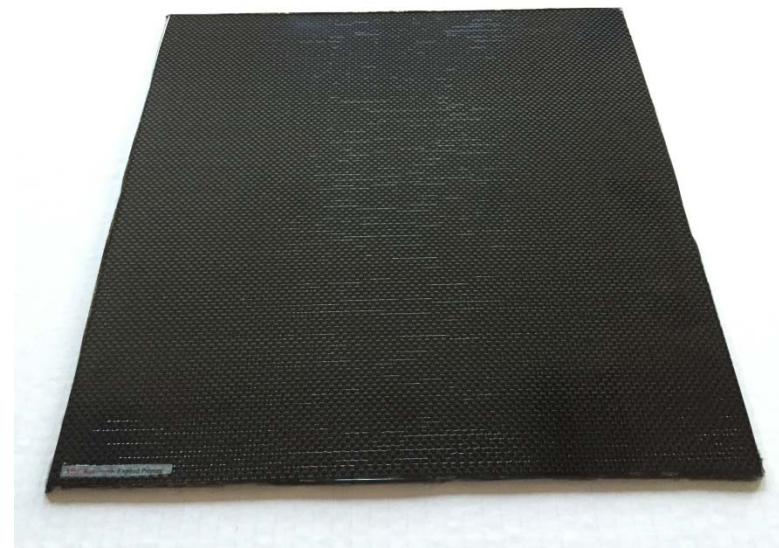
**Panel made from expired (6-year old) prepreg
High void content is visible on
the panel surface
(in addition, we had to use a very slow temp
ramp up rate to cause the high void content)**

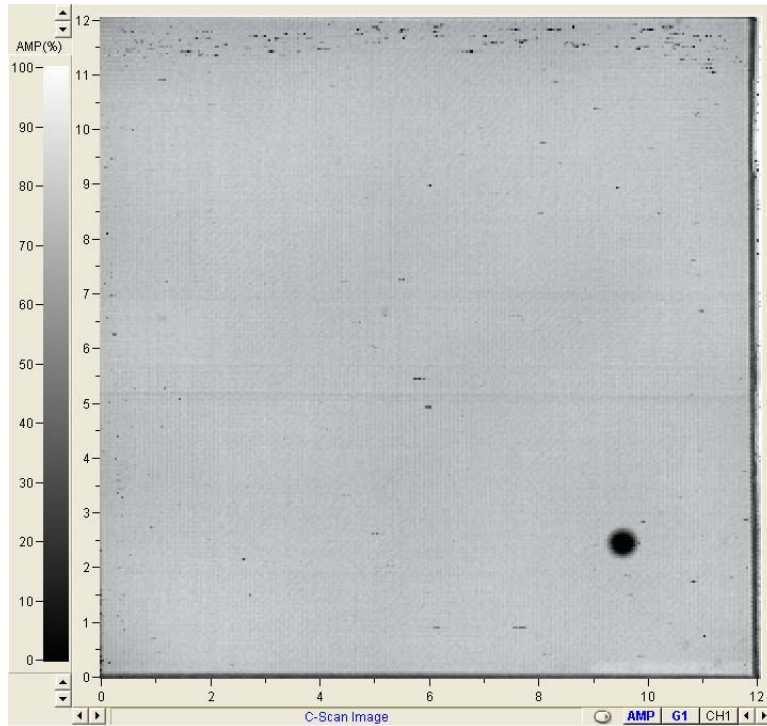
Fresh Prepreg Panel

Low void content = low attenuation

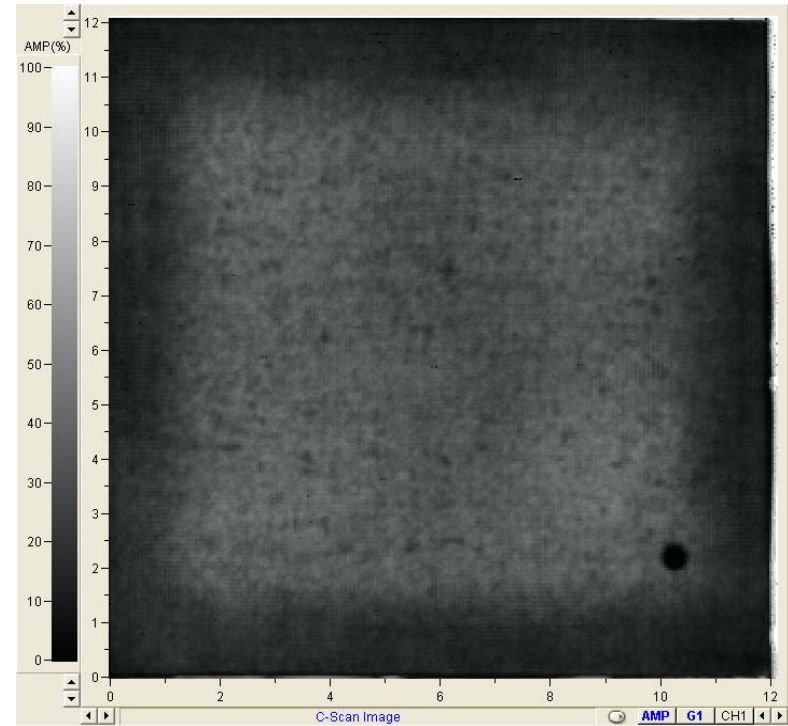
Expired Prepreg Panel

High void content = high attenuation

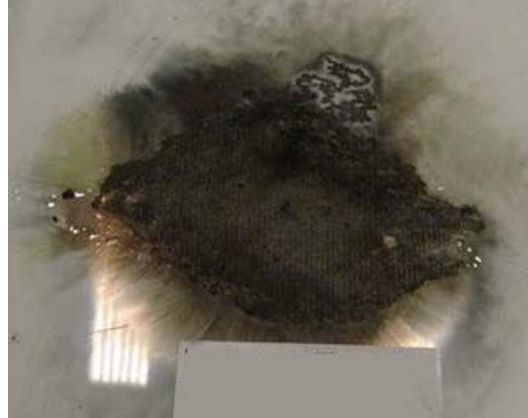
10 mils thick paint

Front side

No damage on back side

The two panels
are identical
The only difference
was the paint
thickness

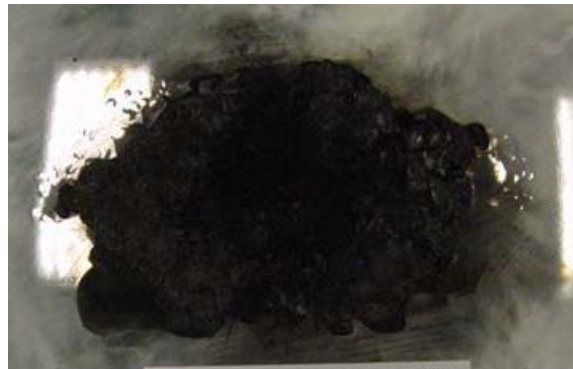
20 mils thick paint

Front side

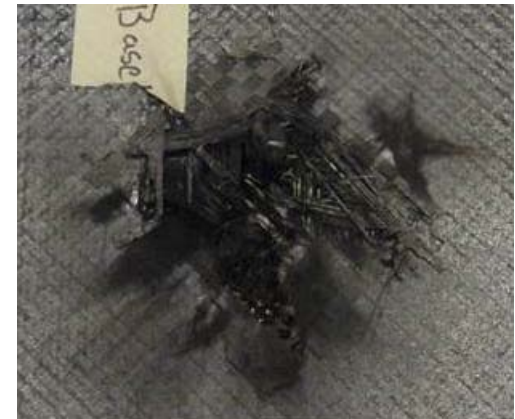
Back side punctured

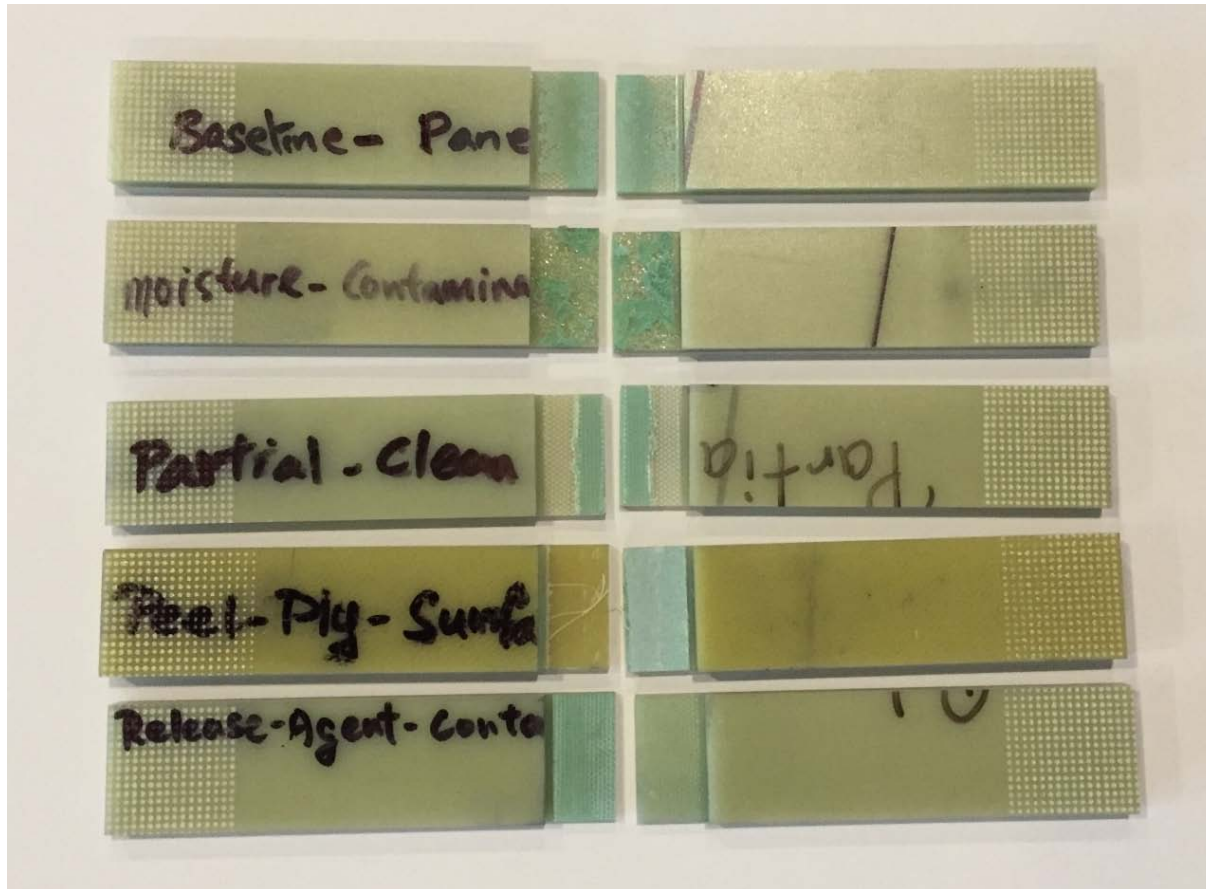
- Pictures showing failure modes

- All forms of contamination caused reduction in lap shear strength
- Surface moisture had the most severe degradation
 - This is not an unrealistic case since some companies are using water-based cleaners
 - Parts should be dried in the oven prior to bonding
