Lessons Learned from CACRC Depot Bonded Repair Round Robin Investigation

Dr. John Tomblin and Dr. Lamia Salah
NIAR/ WSU

September 15th, 2015

CACRC Depot Bonded Repair Investigation

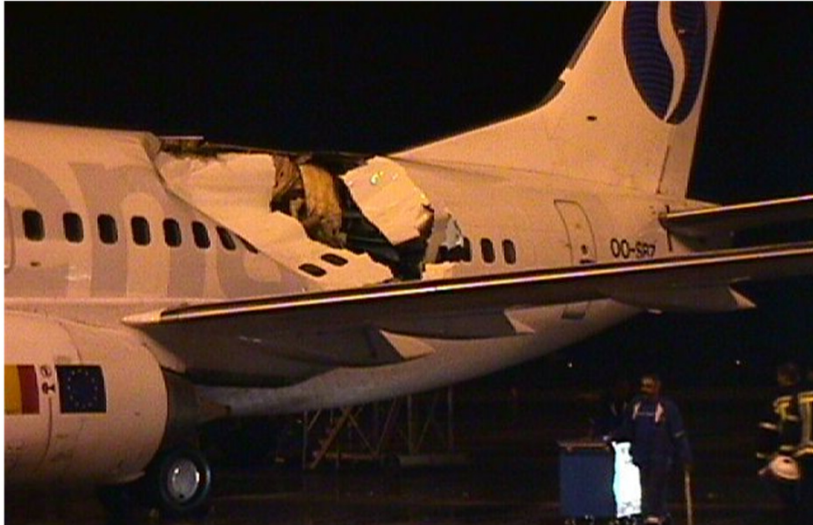
In-Service Damage, Courtesy Eric Chesmar, UAL [1]

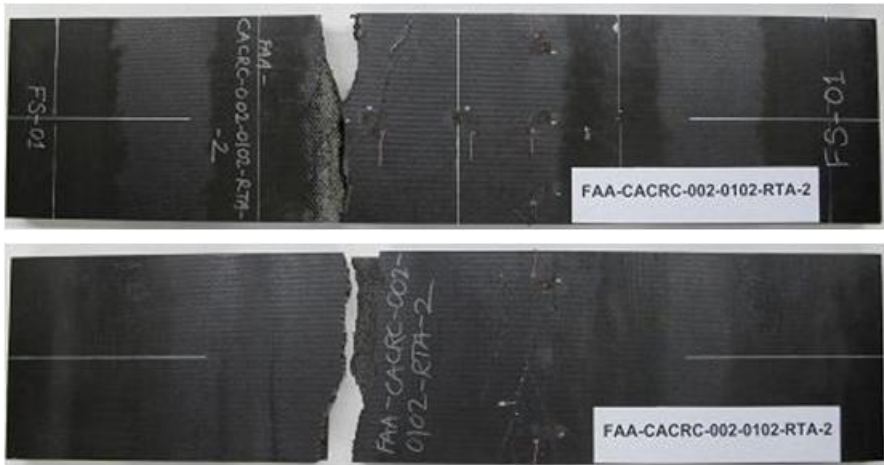
Typical Failure Modes – Undamaged beams

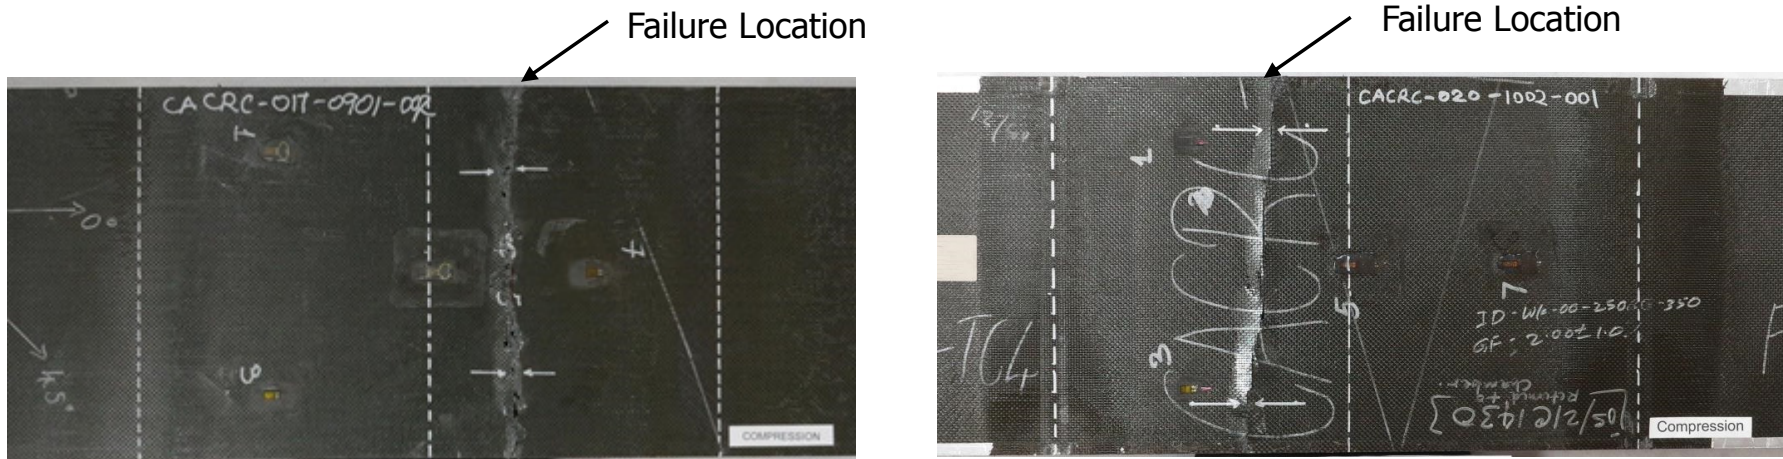
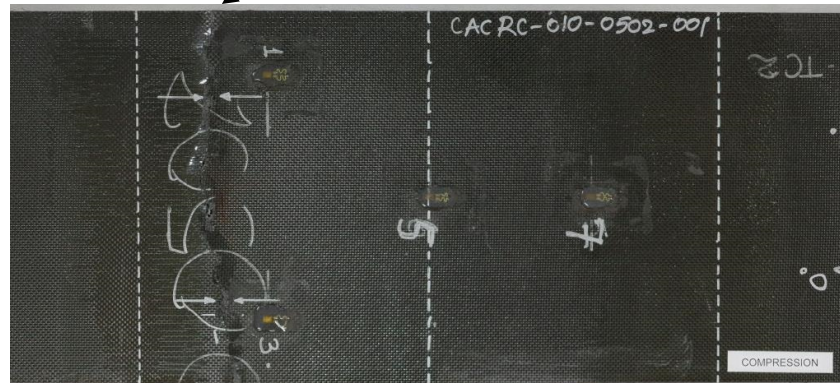
All baseline/ Undamaged Elements yielded facesheet compression failures in the gage section

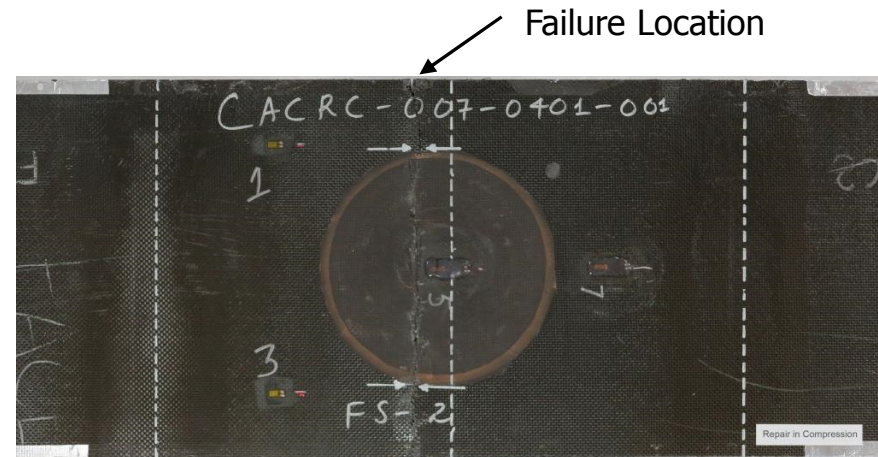
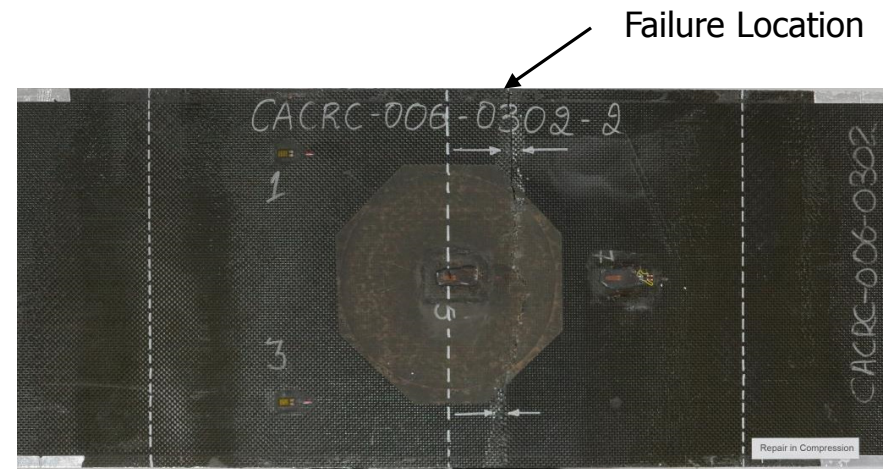
All elements repaired with CACRC prepreg yielded laminate compression failures in the gage section (48% failed outside the repair, 52% failed within the repair)

No adhesion failures, all facesheet failures

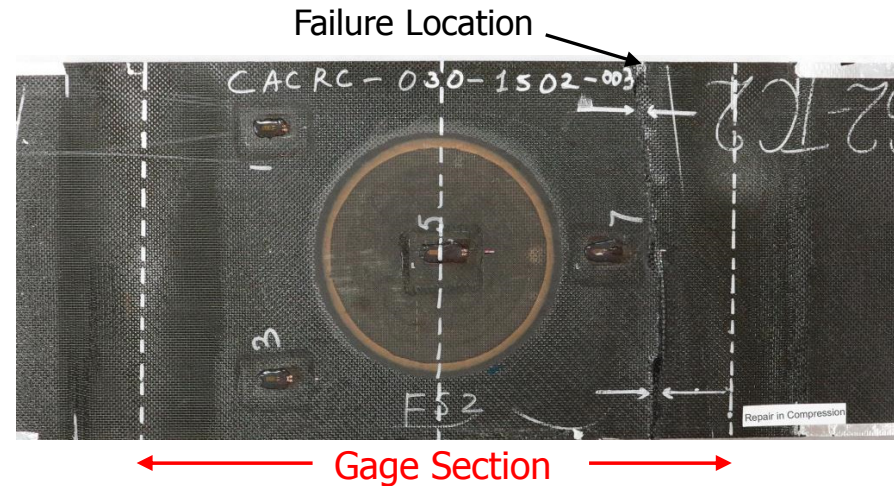
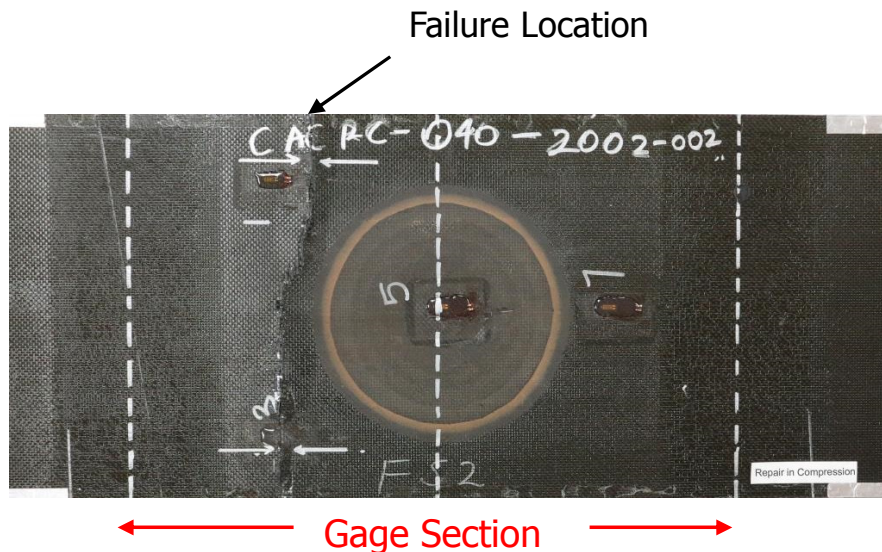
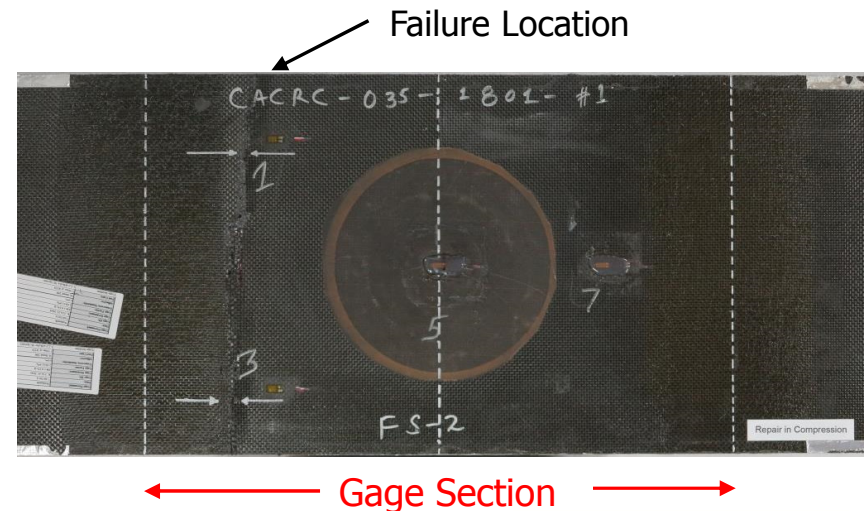
All elements repaired with CACRC prepreg yielded laminate compression failures in the gage section (48% failed outside the repair, 52% failed within the repair)

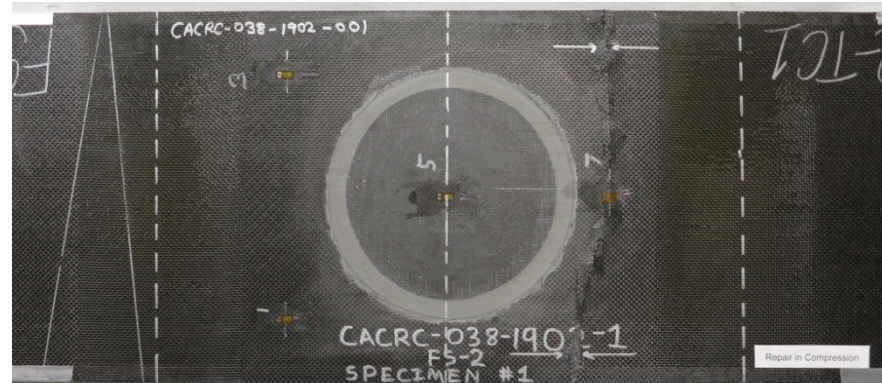
All elements repaired with OEM prepreg yielded laminate compression failures in the gage section outside the repair

Gage Section
0.5" scarf overlap repair

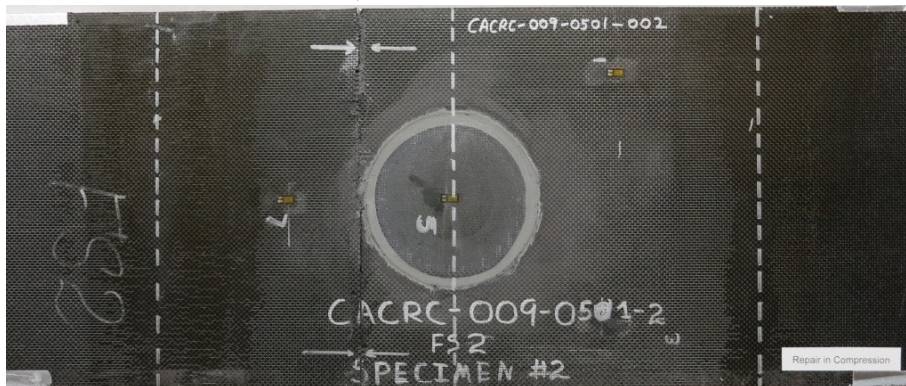
Gage Section
0.25" scarf overlap repair

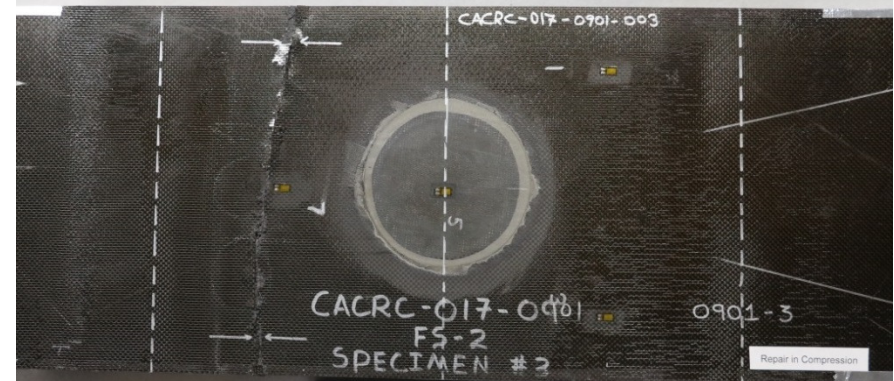
Gage Section
0.25" scarf overlap repair

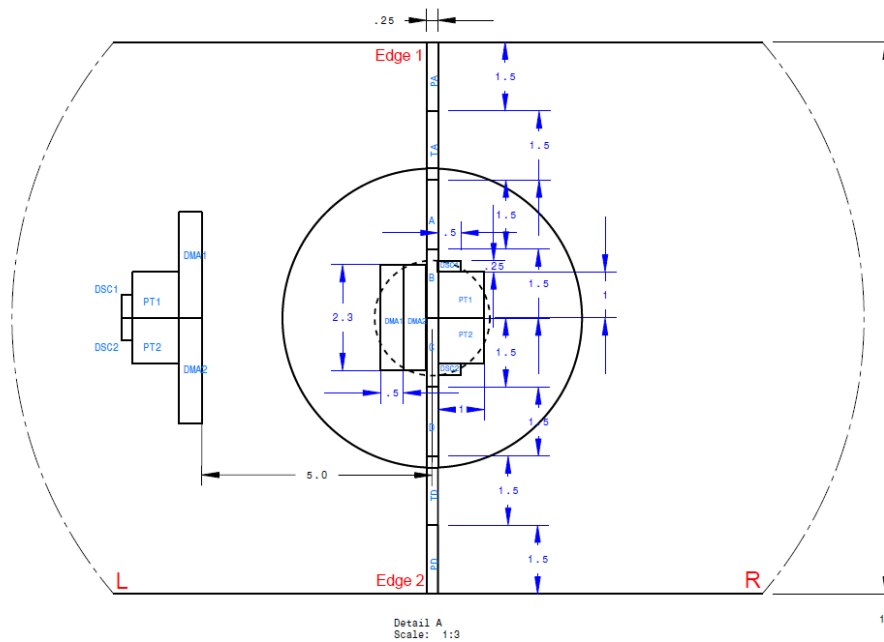
- Post-Test Analysis conducted on 18 elements repaired with M20
- Thermal Analysis
- Physical Tests
- Photomicrographs
- Optimal repairs
 - Porosity levels less than 3.8% (failure outside the repair)
- Low Performance repairs
 - High porosity (Up to 11%)
