Recent Incidents of HEWABI

Eric Chesmar
United Airlines

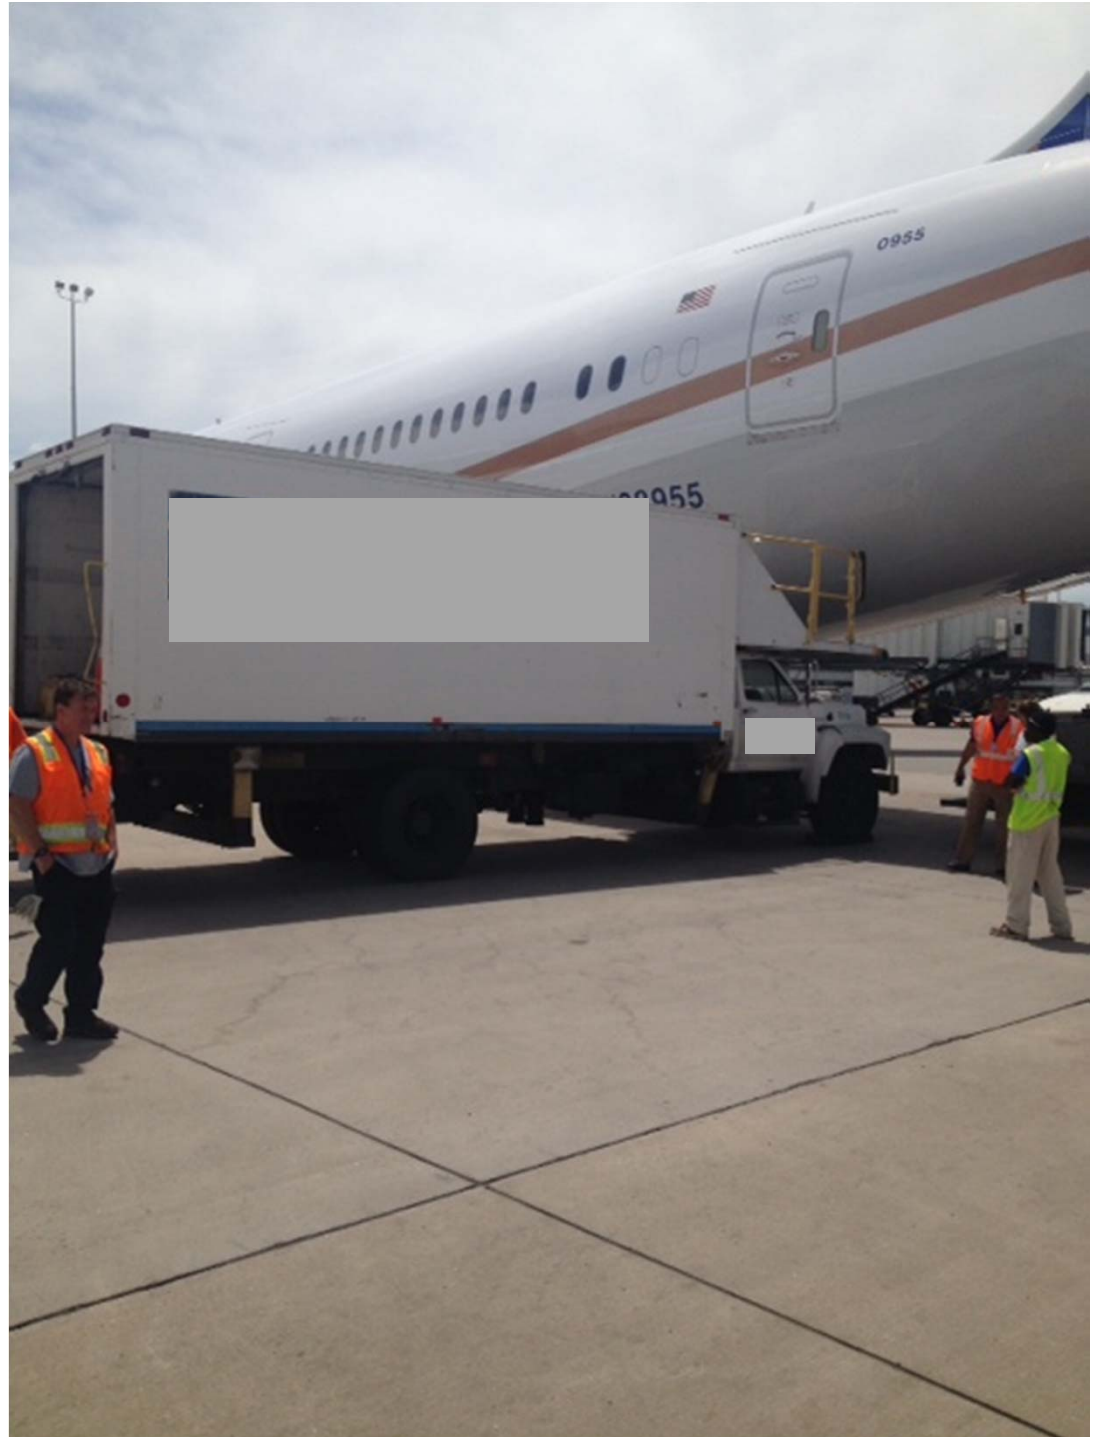
- June 16, 2015
- DIA
- Witnesses reported vehicle contact with 787

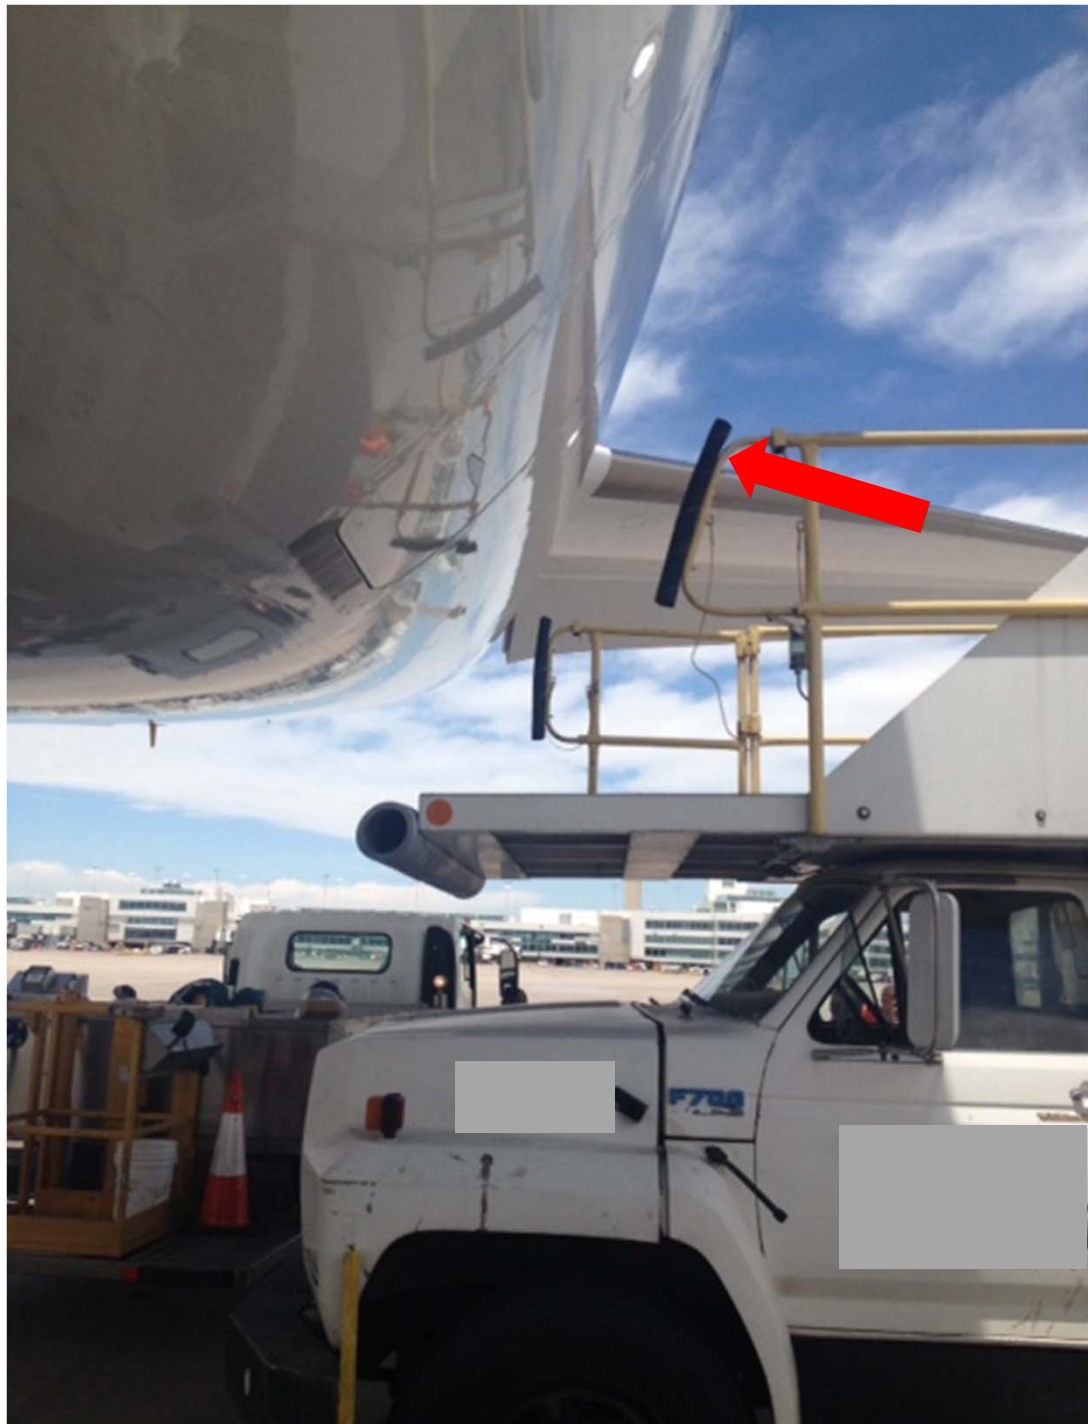
- View looking aft
- Contact made by rubber tube covering railing

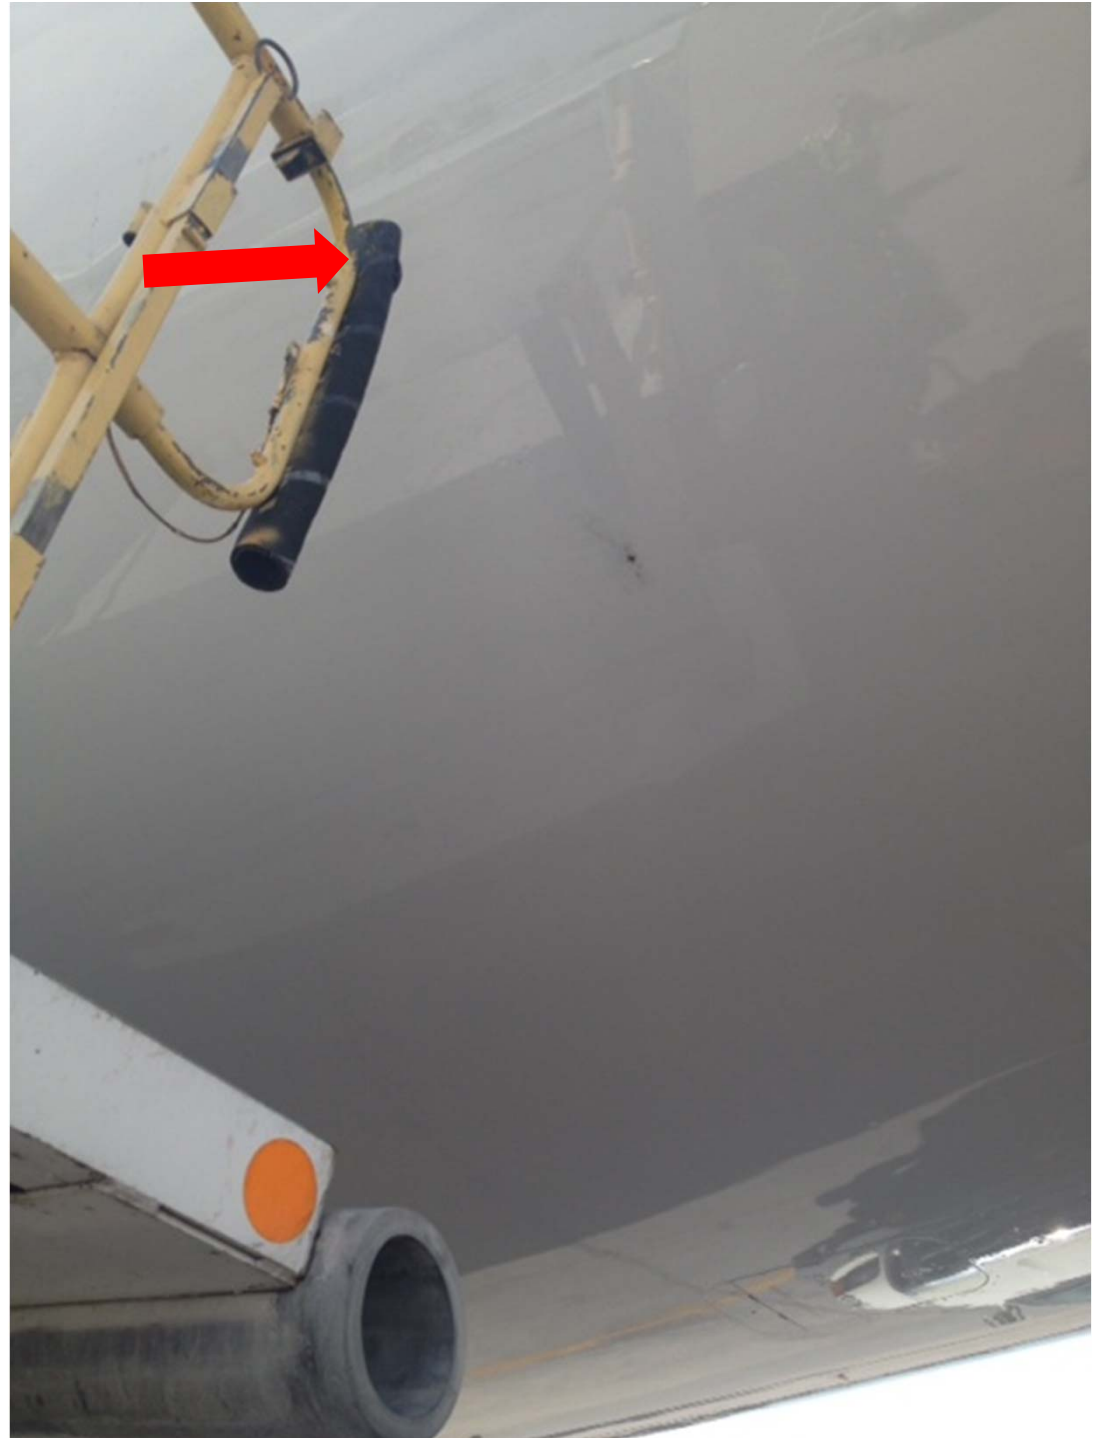
- View looking up
- Contact made by rubber tube covering railing at red arrow

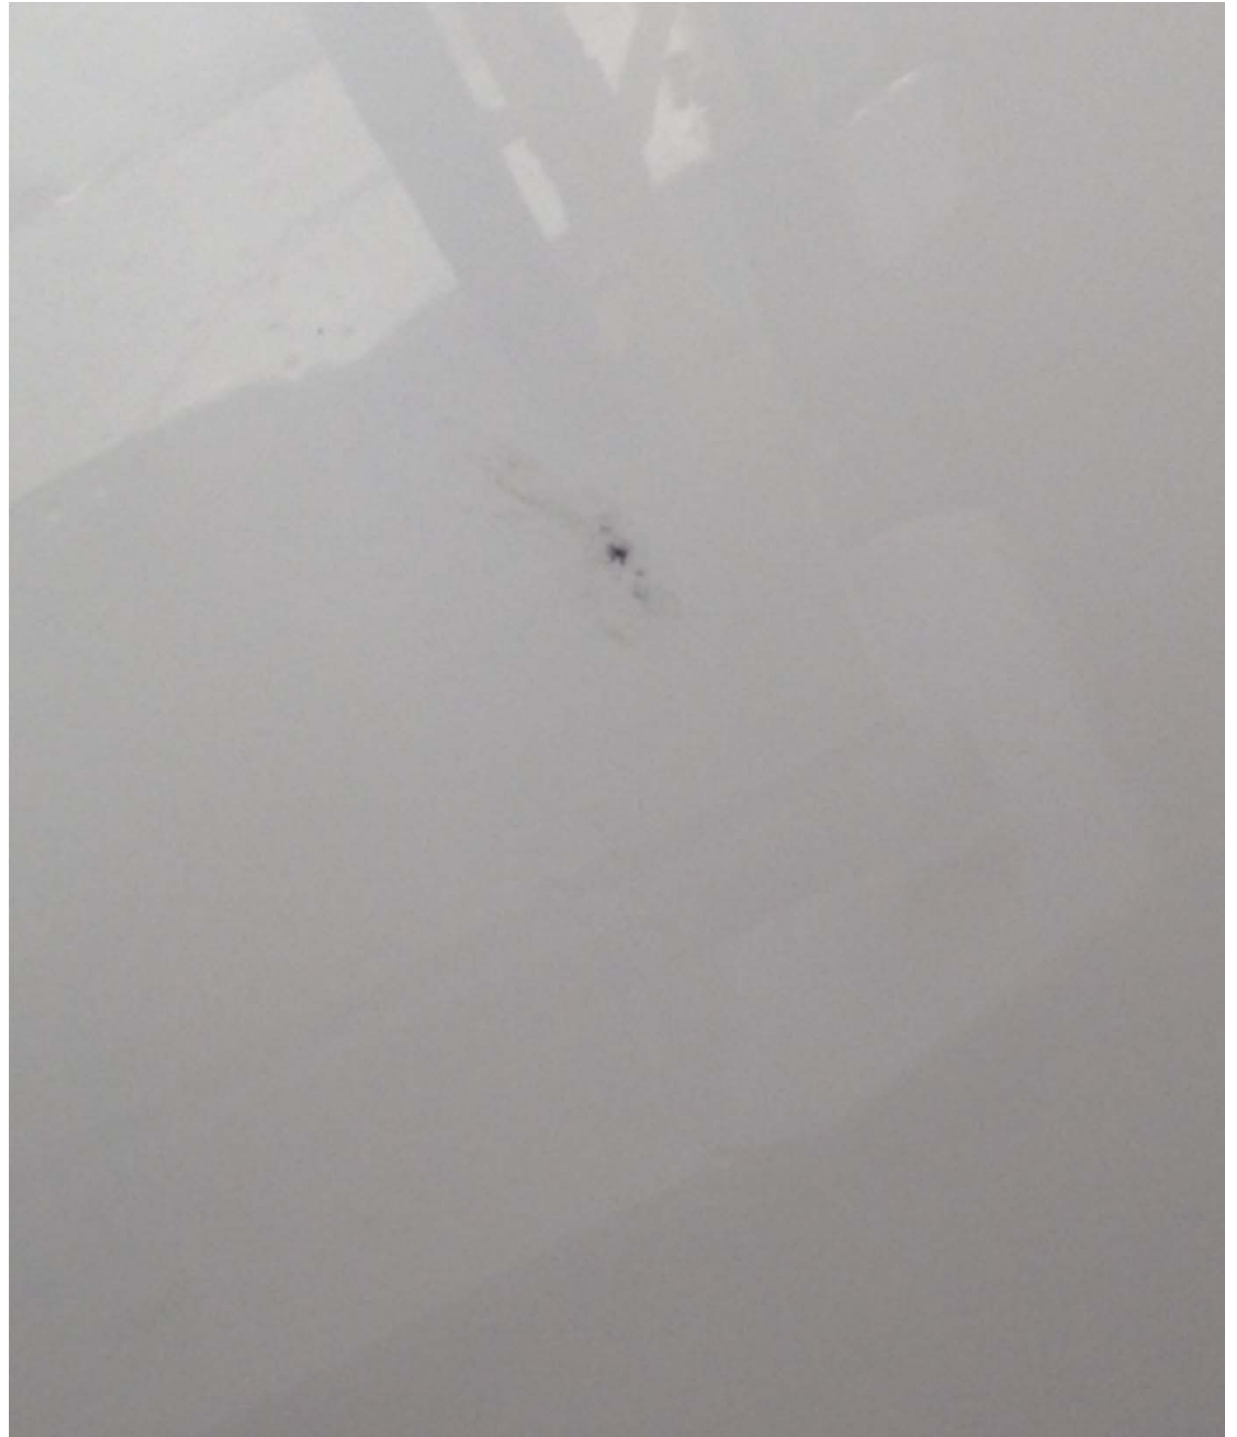
- View looking up
- Rubber scuff on surface
- Mechanic check per AMM chap 05 requirements
- Ramp Damage Checker shows acceptable

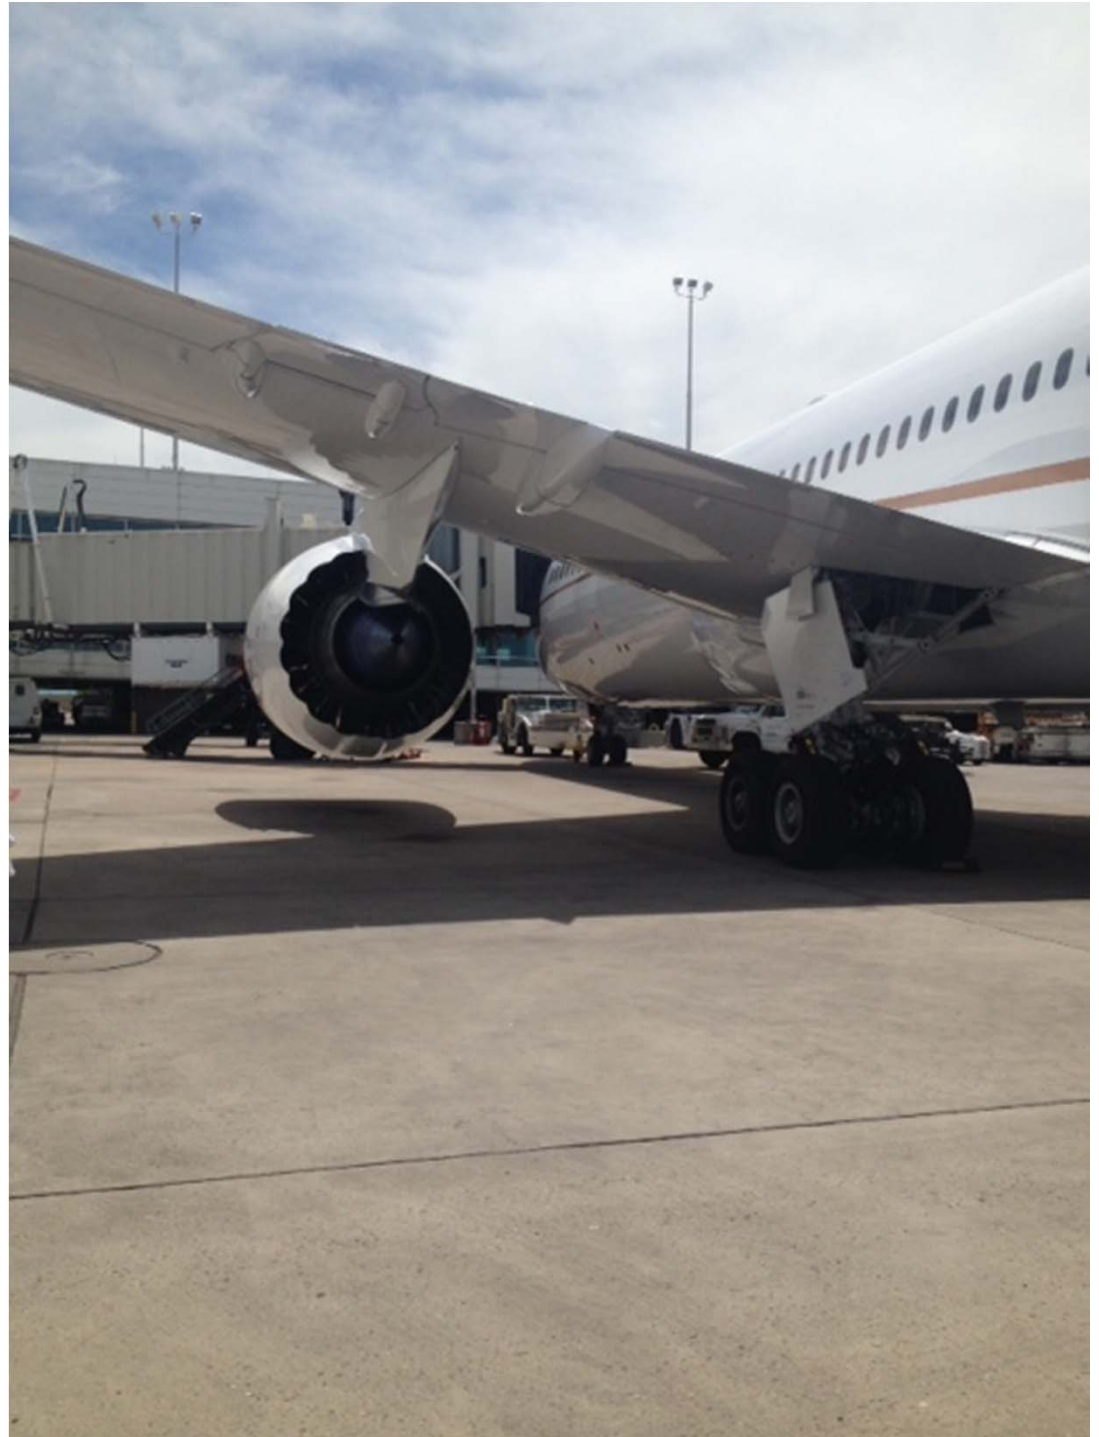
- During the same incident the aircraft was pushed hard enough that it pivoted around the landing gear and Door 1L contacted the jet way
- SRM Damage Assessment chapter requires NDT

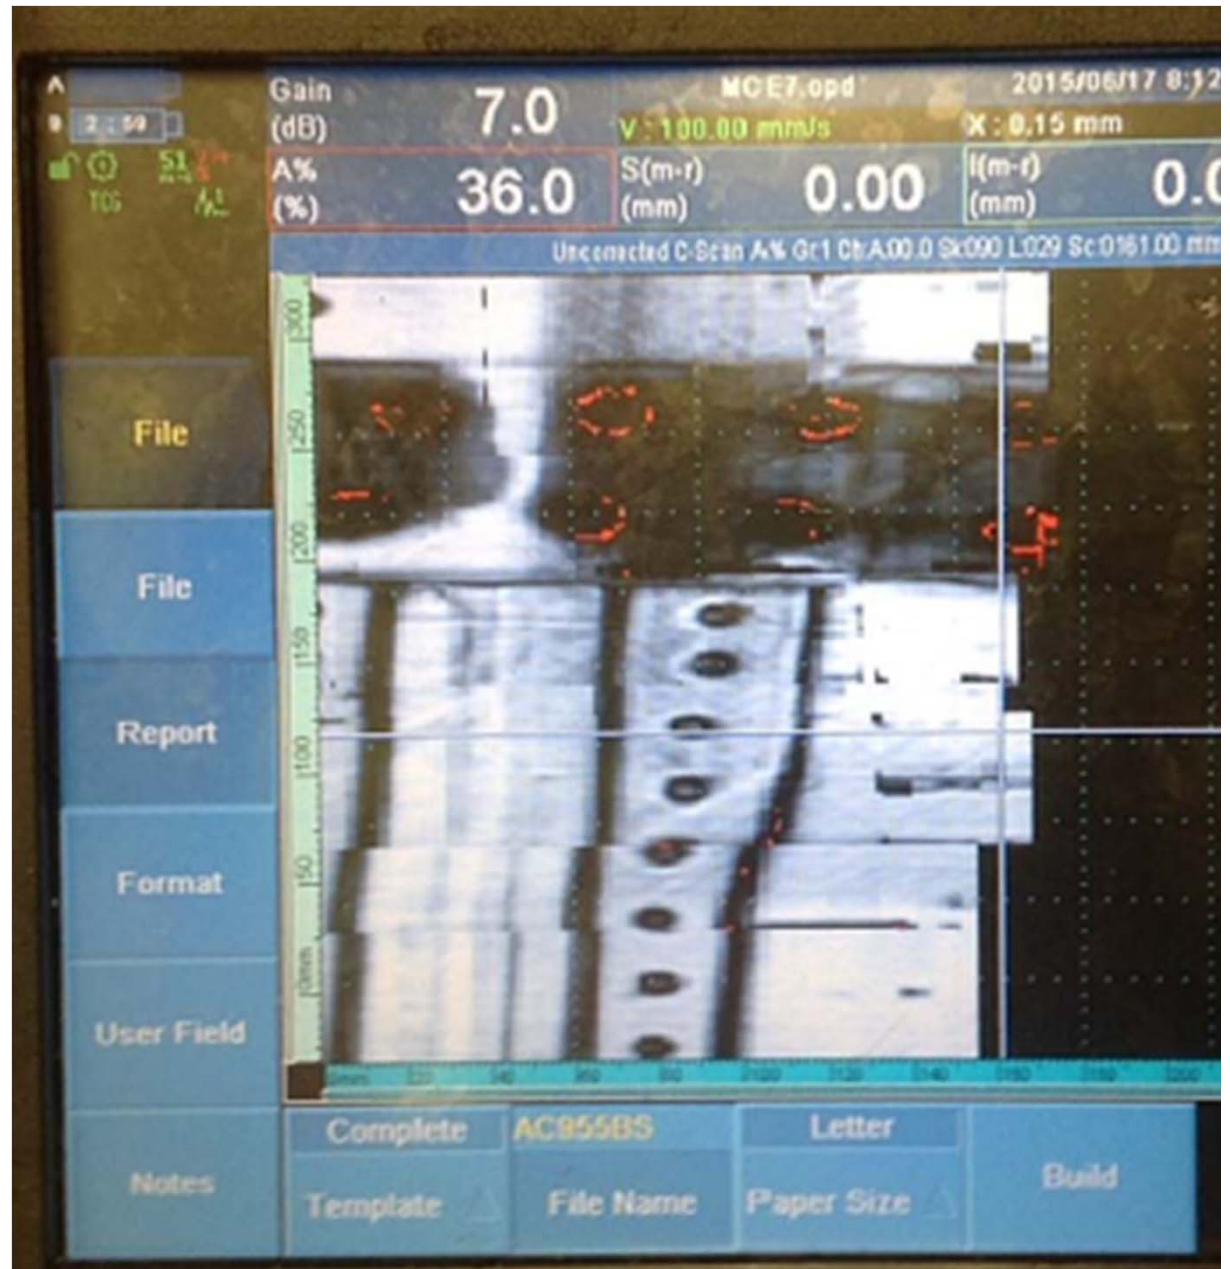
- C-scan NDI of Door found “anomalies” – the dark areas around fastener holes (red circles)
- SRM does not identify these
- Drawing not accessible by airline
- NDT manual unclear for pass/fail criteria
- Inspectors unable to find acceptable so the OEM was contacted to confirm signals are acceptable

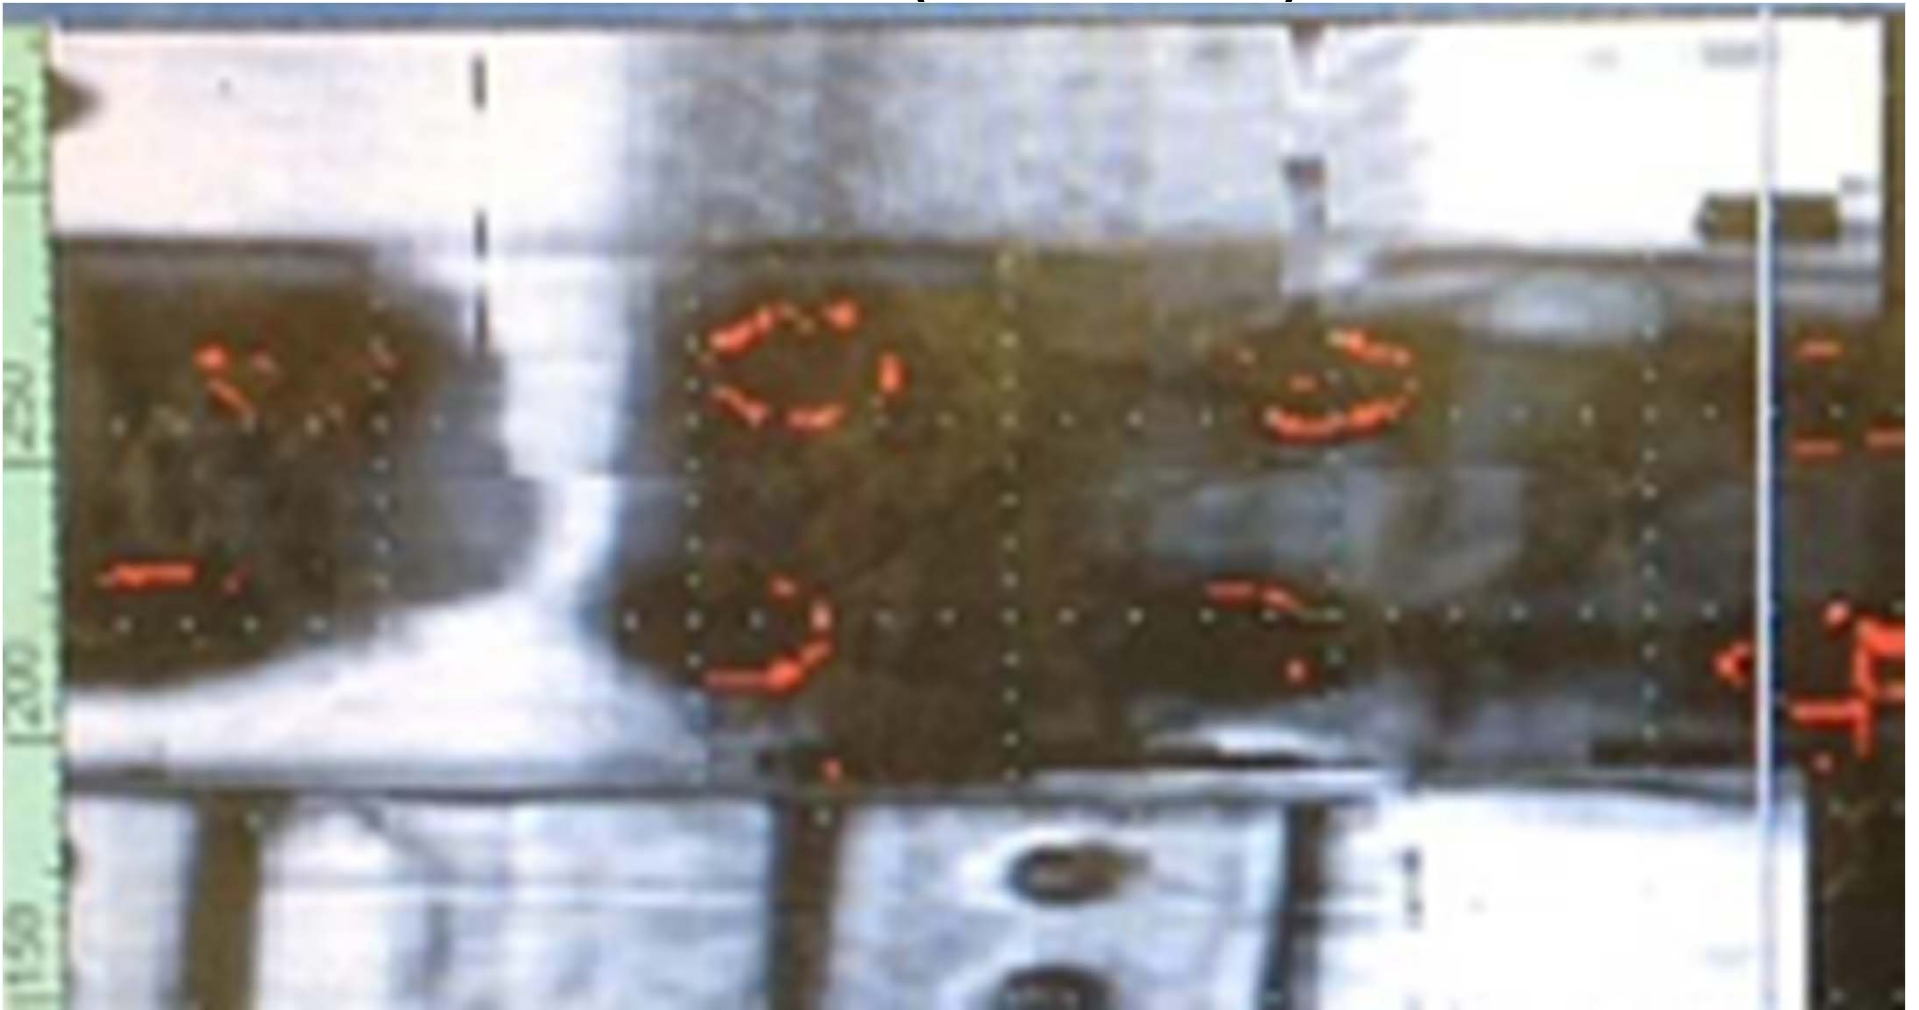
- Close up of Ultrasonic C-scan image: Dark areas around fastener holes (red circles)

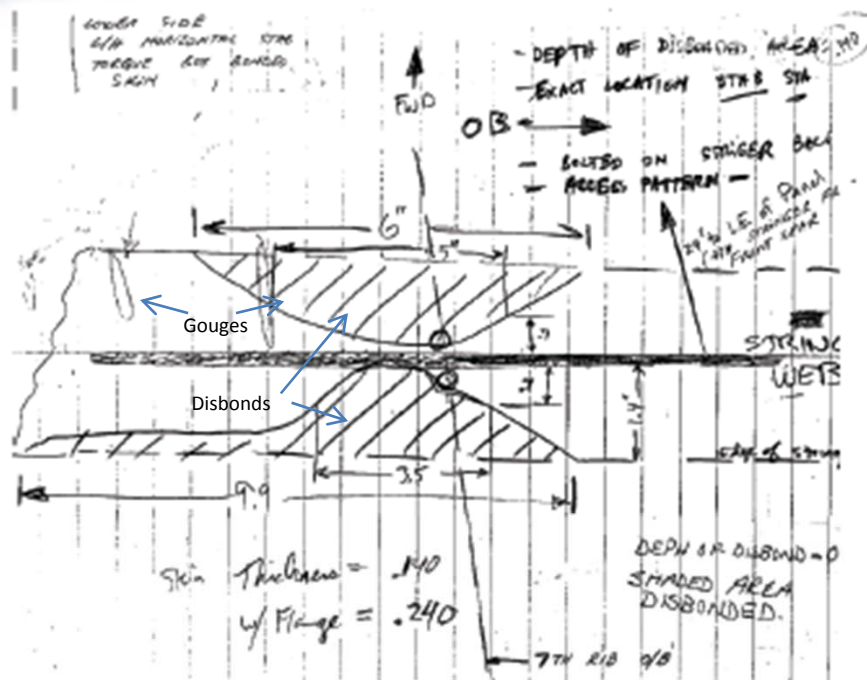
Empennage Stringer Disbond - Engine Thrown Debris

- **EXAMPLE #2: Runway Debris thrown by engine**
 - Engine test was performed over soft asphalt resulting in about 3 or 4 cubic feet of asphalt hitting the 777 Horizontal Stabilizer and Tailcone
 - Damage found to fiberglass panels, Tailcone, and Elevator.
 - Gouges found on Horizontal Stabilizer skin
 - Depth about .015 to .020” deep, including paint
 - SRM has limit for allowable gouge of “1 ply”
 - No instruction for mandatory NDT
 - Performed C-scan ultrasound inspection and found a disbond.
 - Contacted OEM for repair
 - Repair was to install fasteners

AOG Damage Description
