FAA Workshop for Composite Damage Tolerance & Maintenance in Tokyo 2009

Ralf Hilgers Composite Structure

Substantiation of Damage Growth within Sandwich Structures

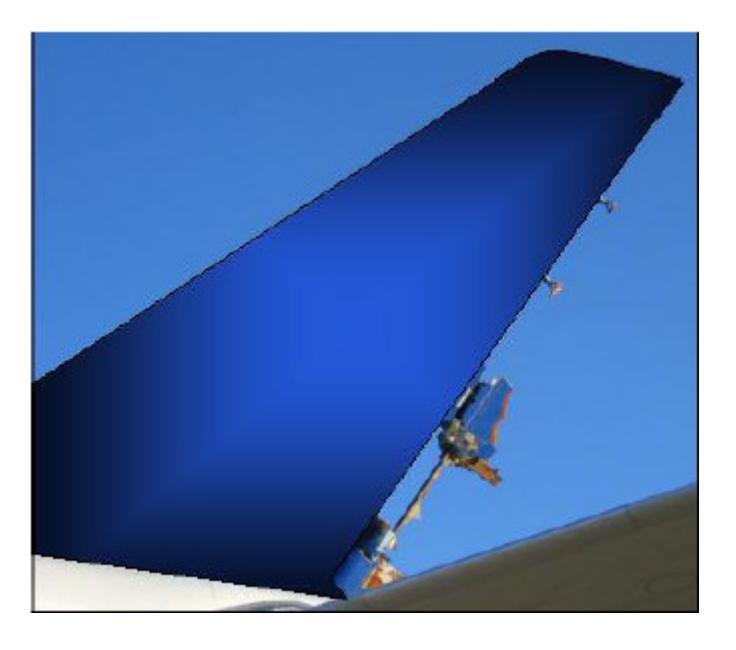
Rudder structural failure in flight March 2005

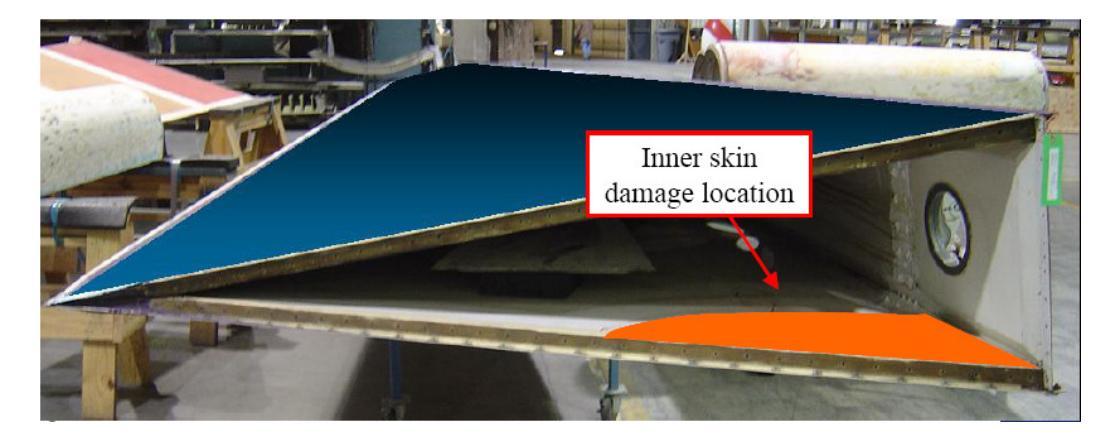
Rudder disbond detected during maintenance in November 2005

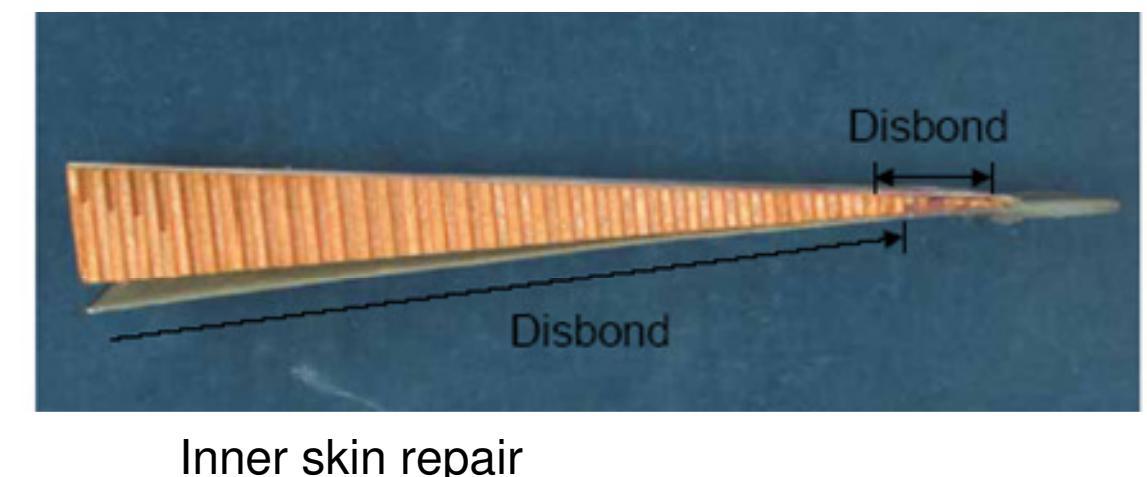
Source of damage \rightarrow Improperly performed repairs

- Airbus in-service experience showed few cases
- For one case the disbond was detected with an Elasticity Laminate Checker (ELCH) inspection performed on subject structure after the repair
- The knowledge on the consequences of an improperly performed sandwich repair is important
 - Deviation from the defined repair instruction, like overheating during curing
 - Deviation to the required environmental conditions (temperature, moisture, cleanness, ...)

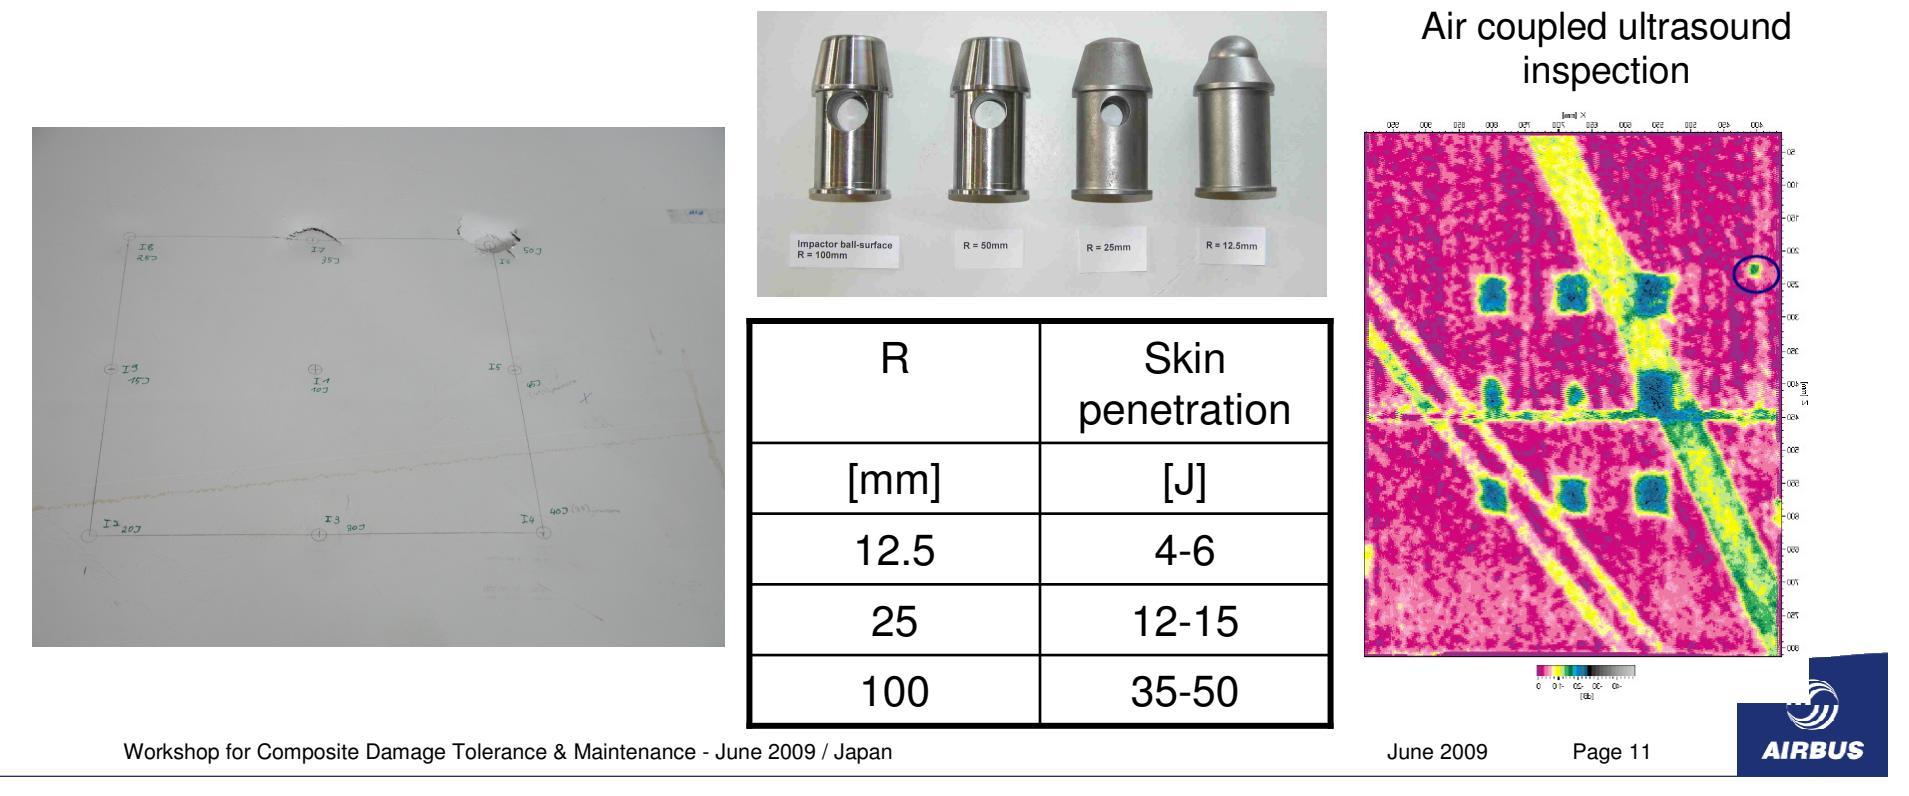
Source of damage \rightarrow Sharp impact damages

- Skin thickness (t=0.5mm)
- Skin penetration or local crushed core achieved as shown with standard impact
- No hidden damage like disbond or core fracture identified

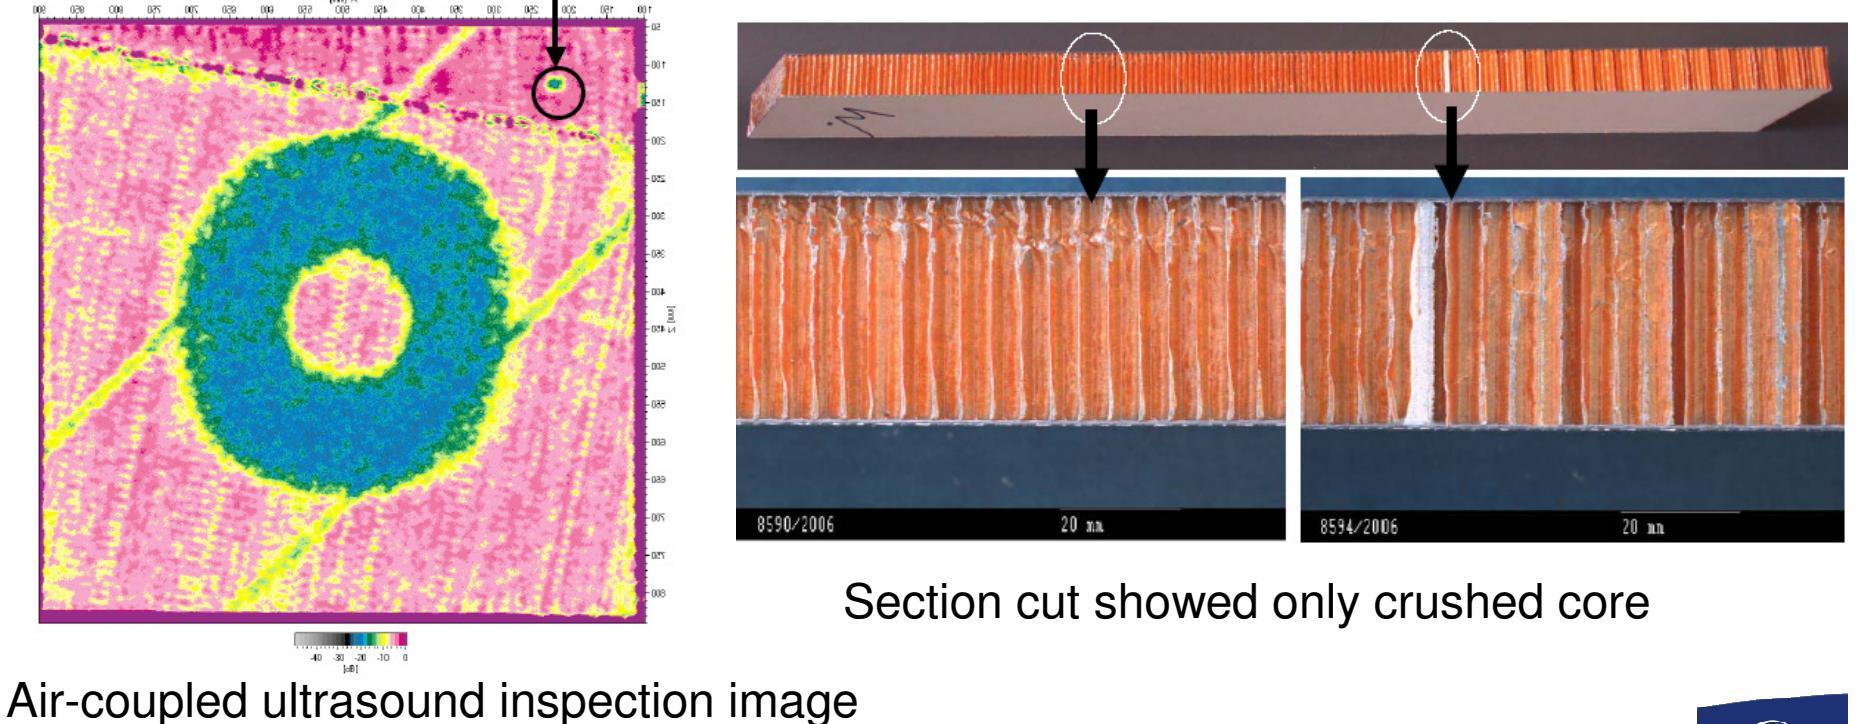
Source of damage → Large blunt impact damages

The blunt impact test on both panel configurations revealed that hidden disbond or core fracture does not occur.

Subsequent ground-air ground cycling showed no disbond initiation

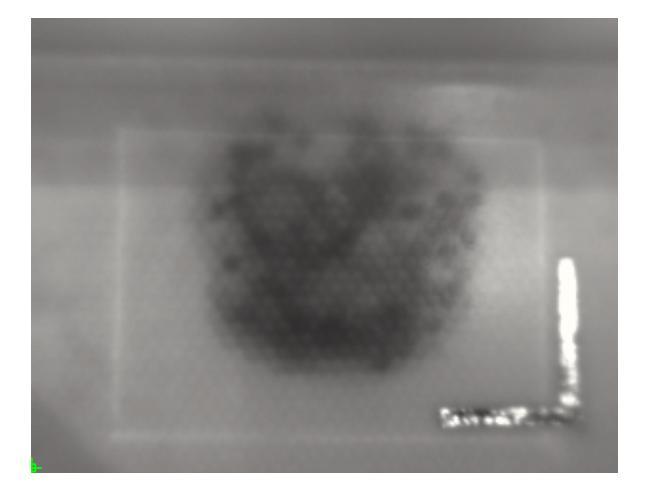
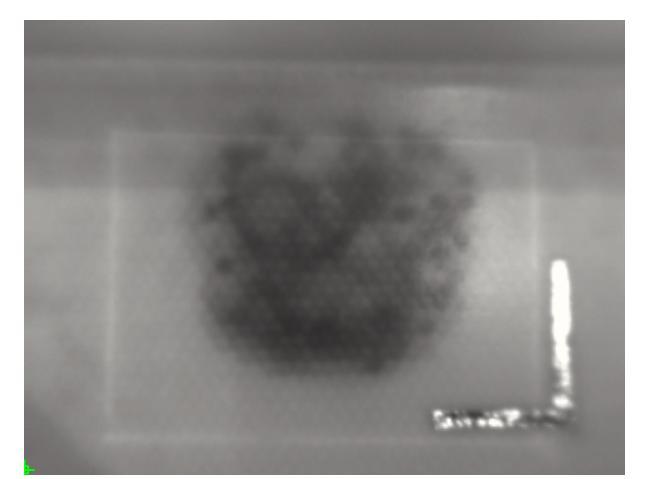
Source of damage → Fluid ingress – thaw & freeze cycle

- Concern: Can fluid ingress create a damage due to thermal expansion
- Test program: 10.000 thaw & freeze cycle with different location of fluid
- Intermediate Results: After 6000 cycles no disbond or core damage initiated

After 6000 cycle

Thermography image of the affected area

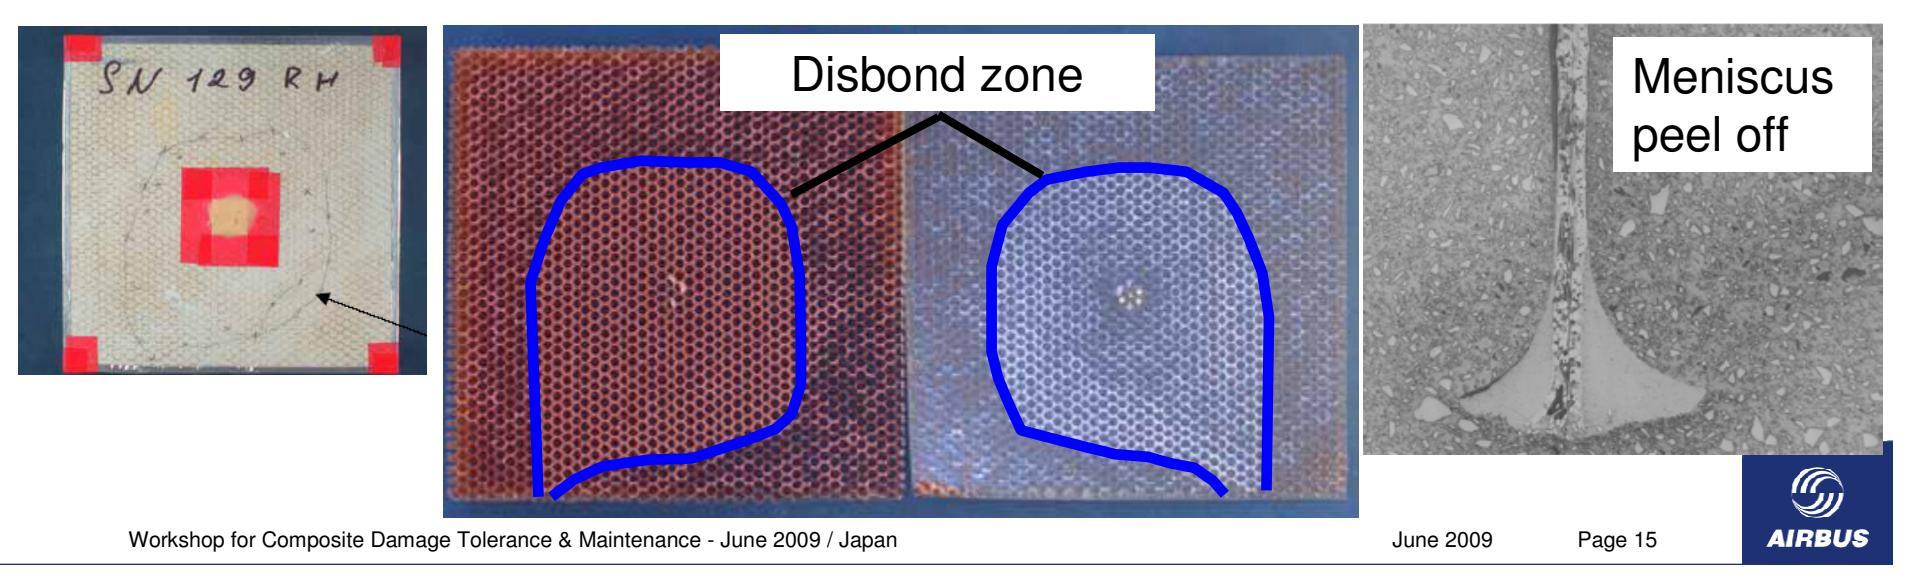
Source of damage \rightarrow Fluid ingress – Physical test of structure temperature exceeding 100 °C

- **Concern**: Effect of fluid ingress and structure temperature above 100 °C
- **Phenomenon**: Well known effect that water vaporized above T=100 $^{\circ}$ C \rightarrow producing high pressure
- Test specimen: 5 cells with 5mm water at 110 °C/1h
- Result: Disbond detected by tap test
- Performing repairs in areas not checked concering fluid ingress in the surrounding

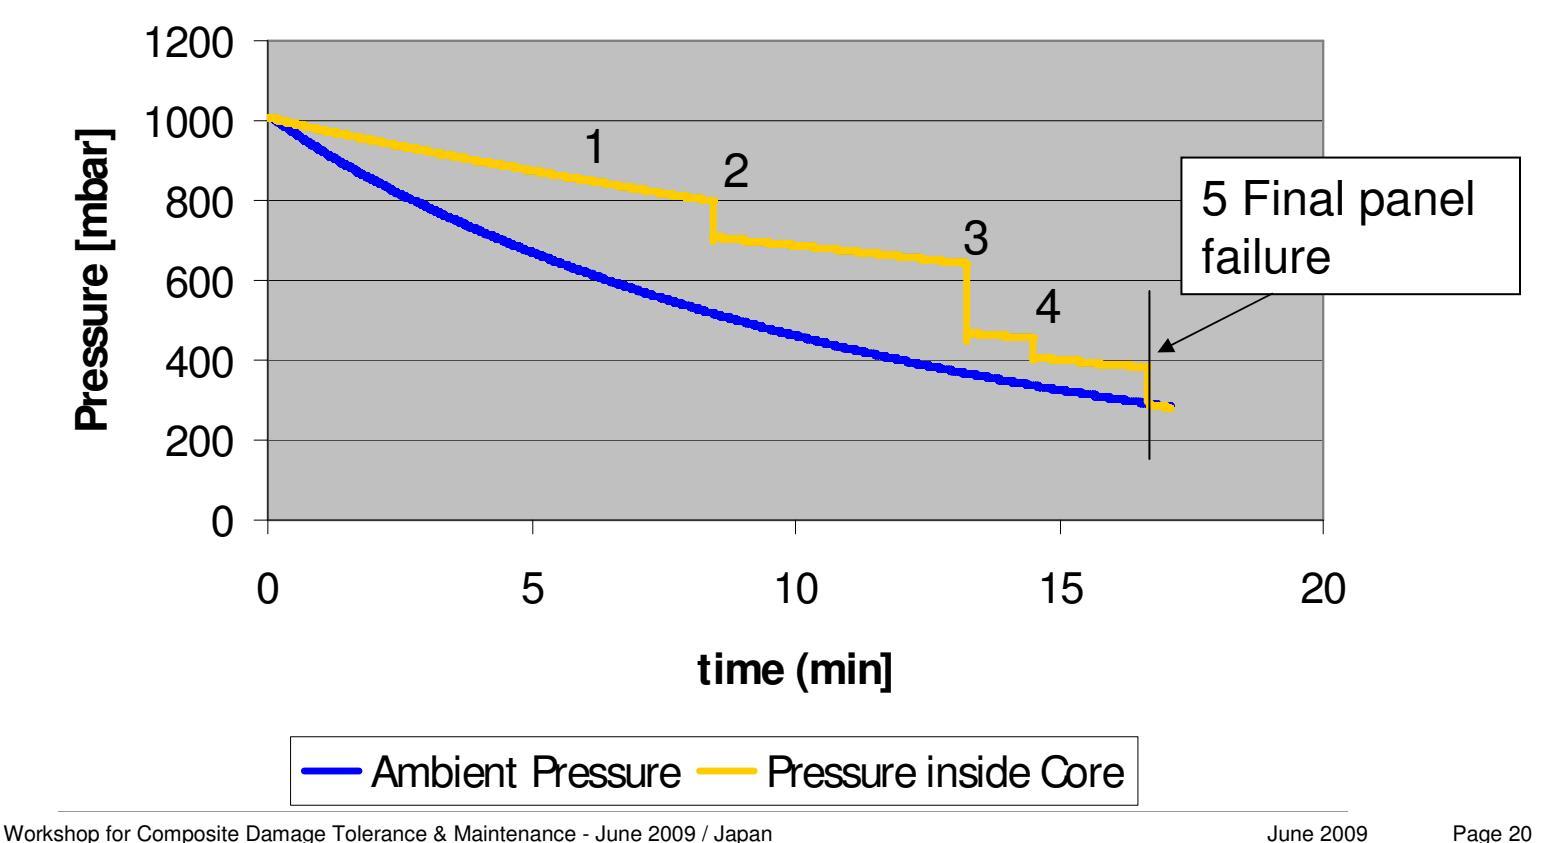
The chamber pressure and pressure inside the core vs. time indicates several disbond propagation steps, before the complete panel fails at $p_{ambient}=240$ mbar.

Pressure inside core \rightarrow stepwise decrease \rightarrow damage propagation [2 – 5]

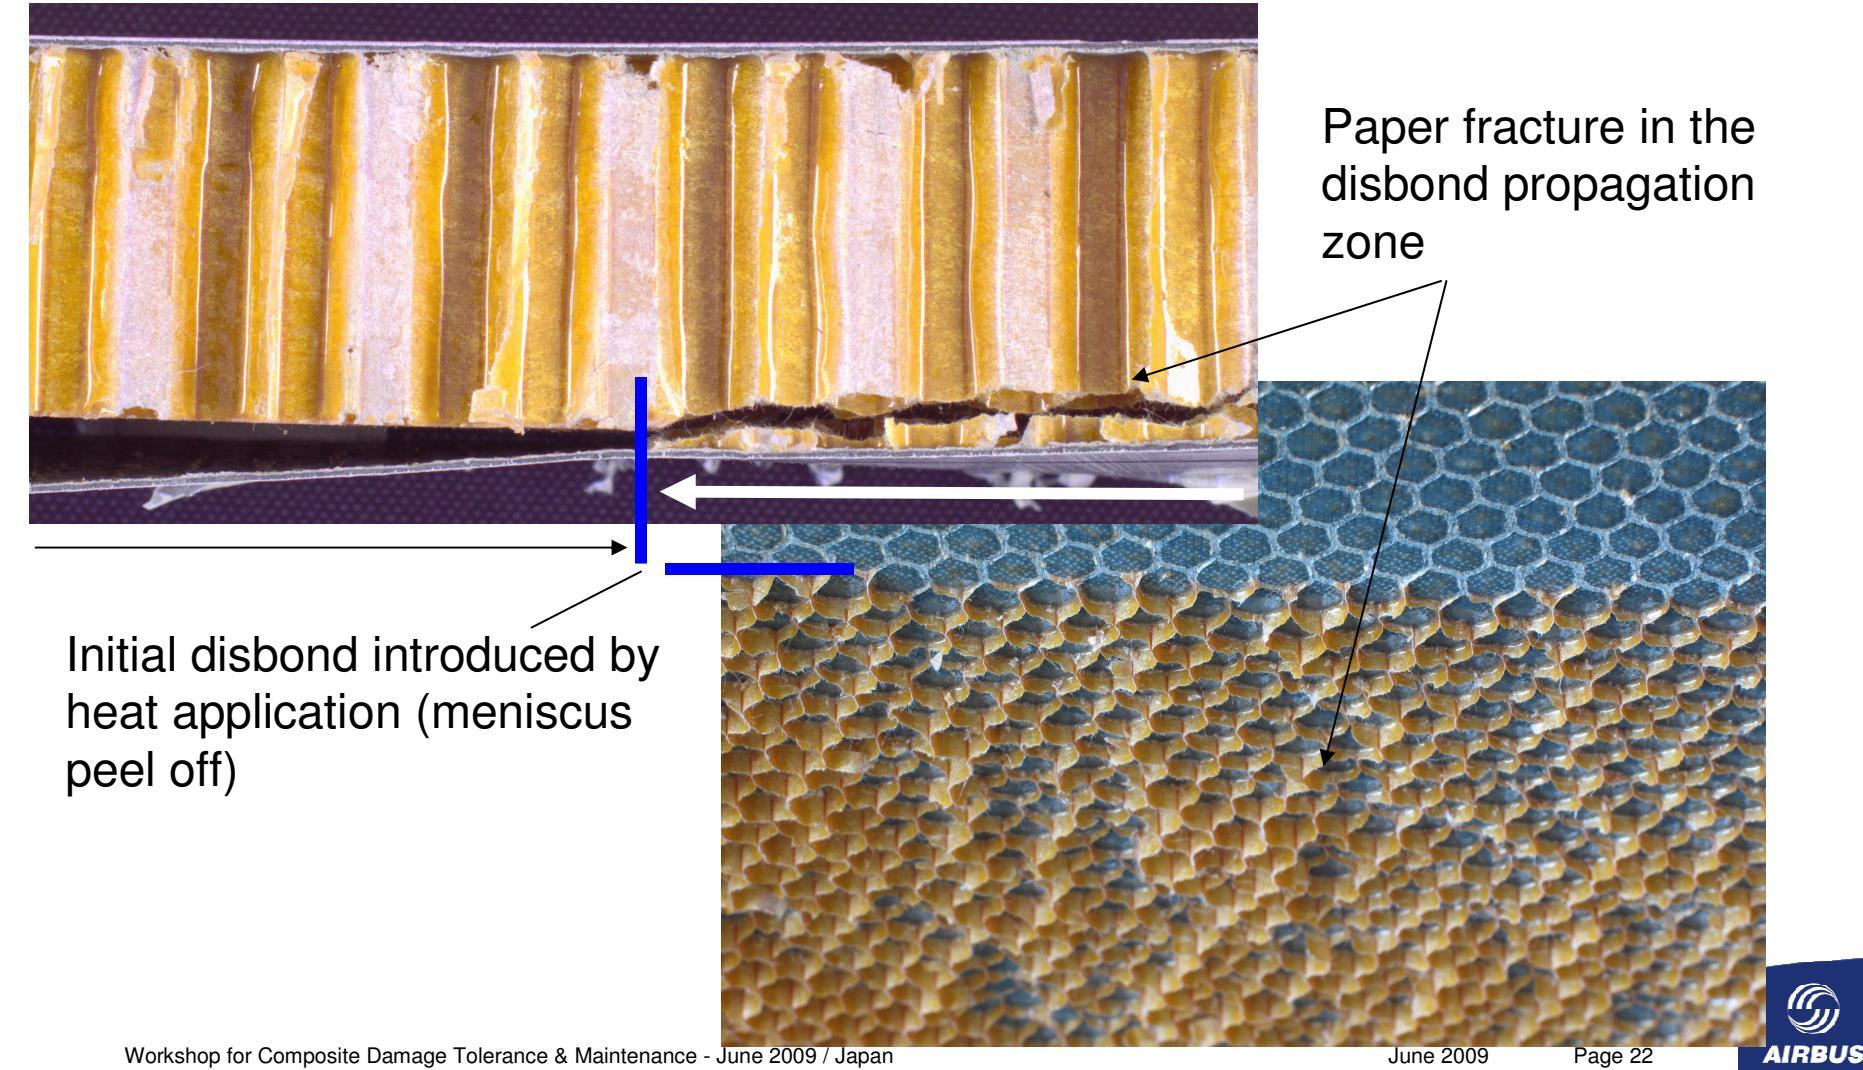
Disbond propagation occurred within the paper

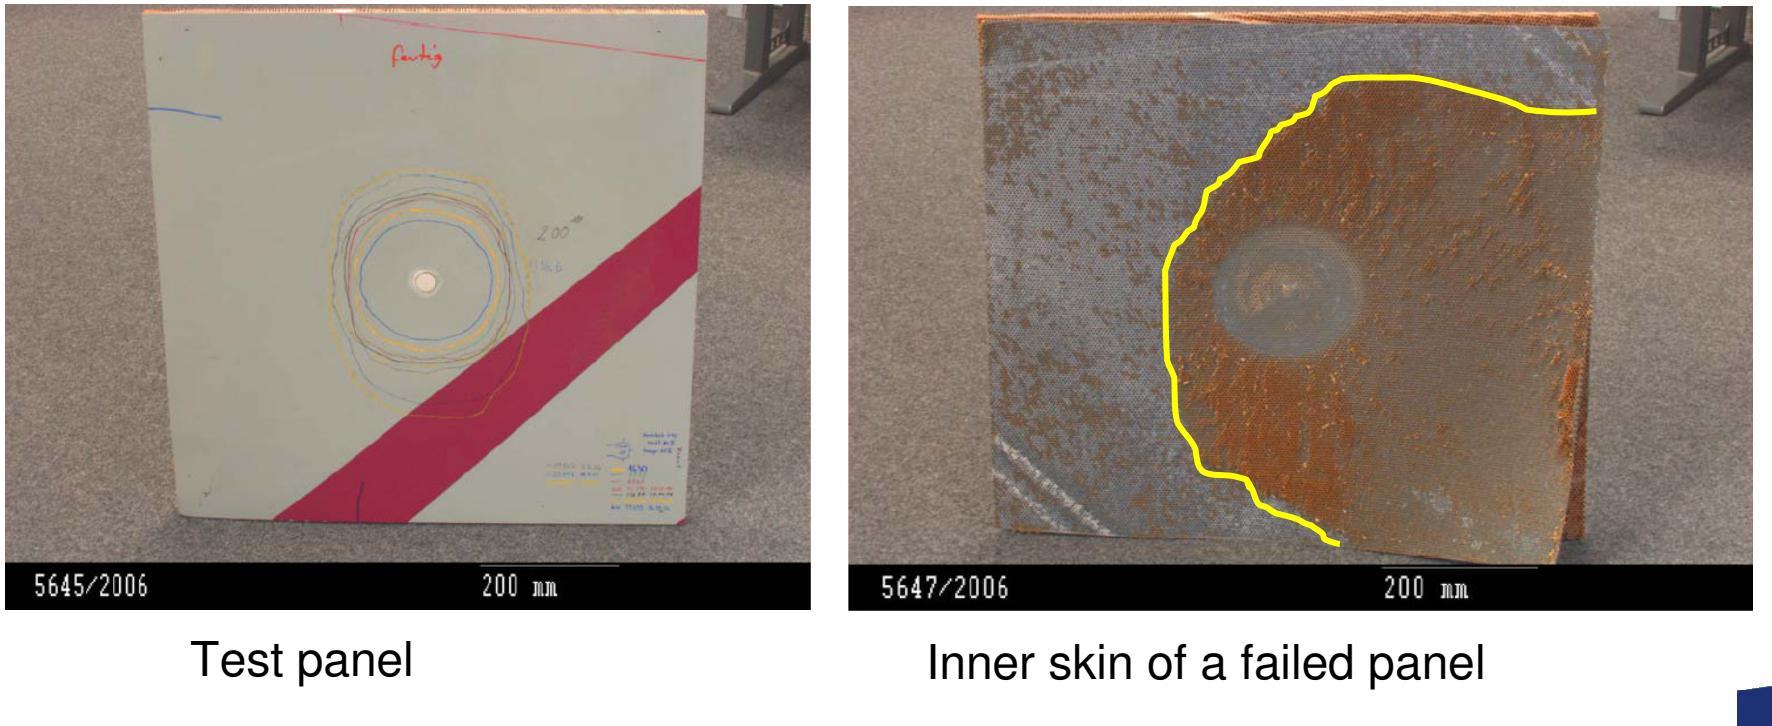
- Ground-air-ground cycle tests performed for disbond propagation demonstration
- Different disbond sizes tested
- All tests showed paper fracture within the disbond propagation zone

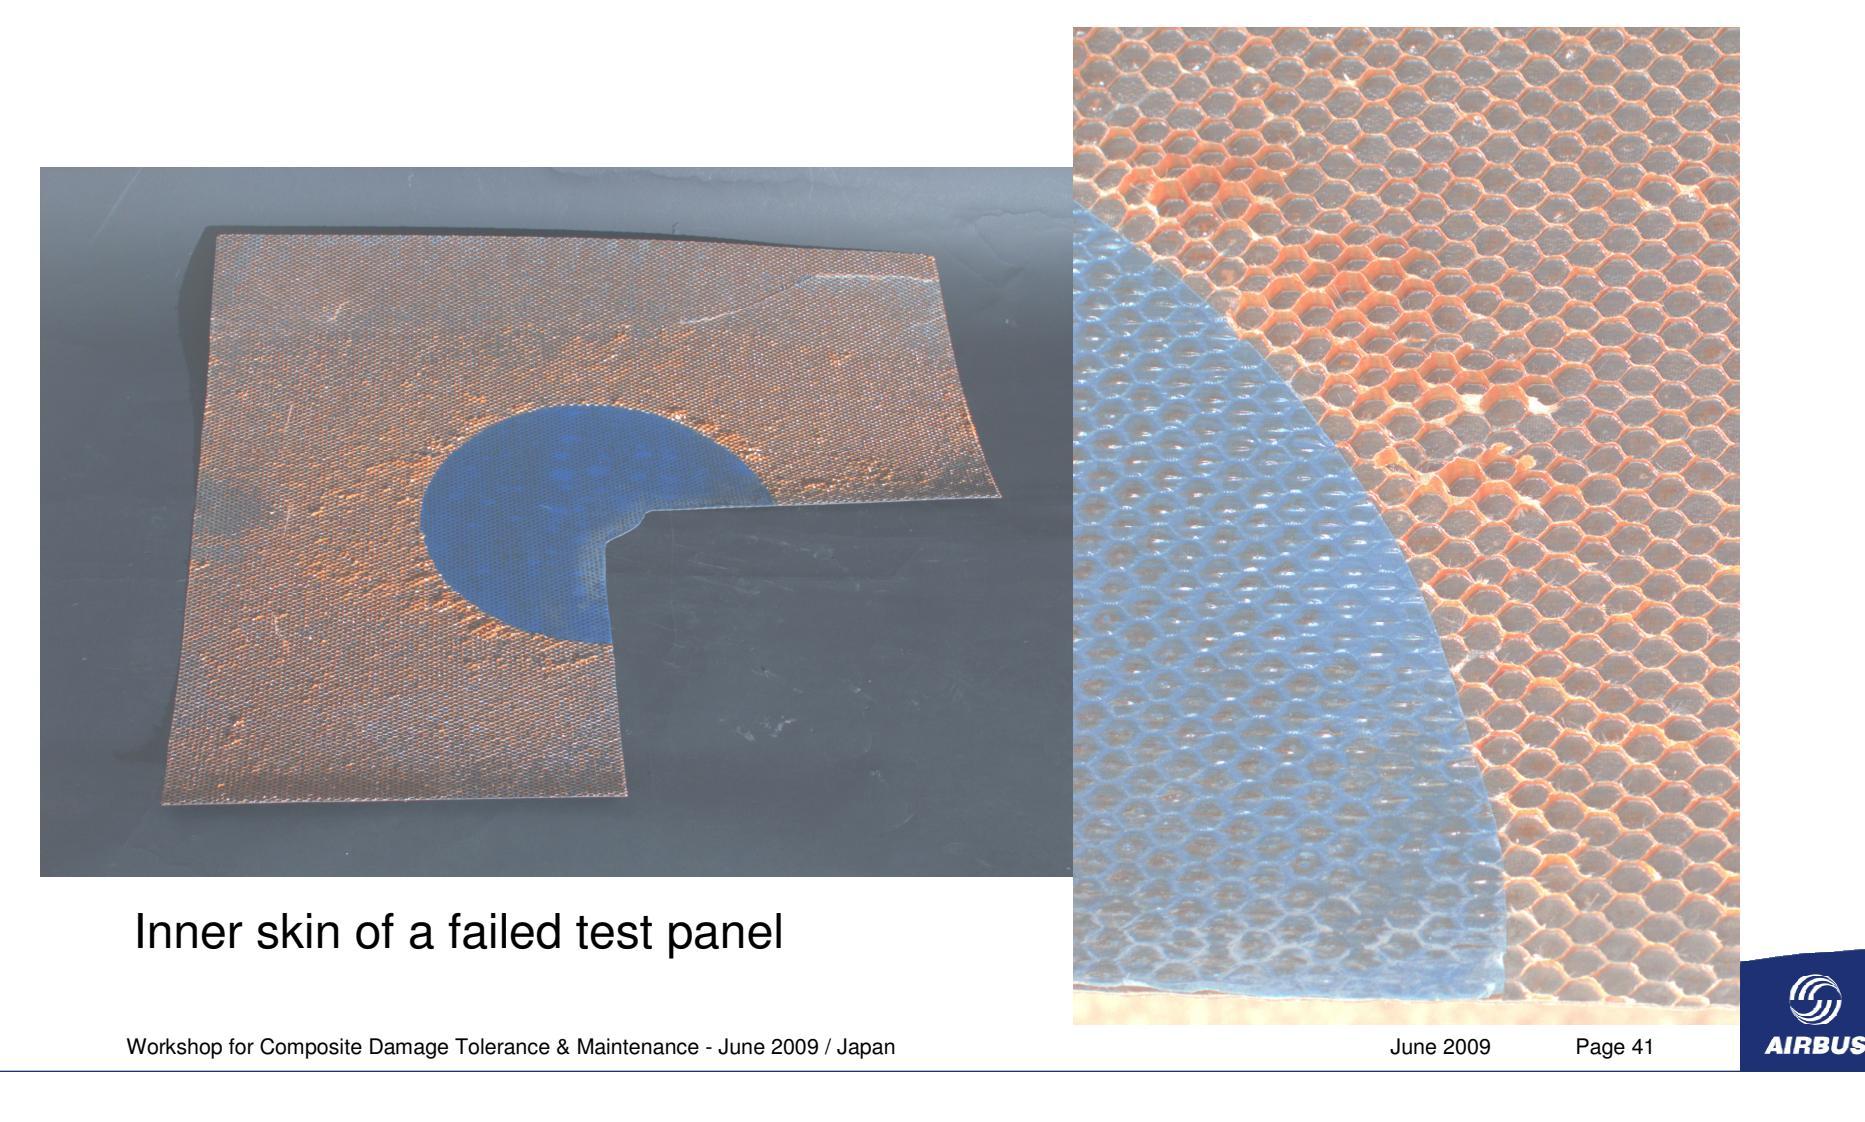
Face sheet of the disbond panel showed paper fracture
