CACRC AE-27 Guidebook: Design of Durable Aircraft Composites: Problems with Sandwich Structure

Eric Chesmar, United Airlines

17 May 2011

# AE-27: Design of Durable, Repairable and Maintainable Aircraft Composites

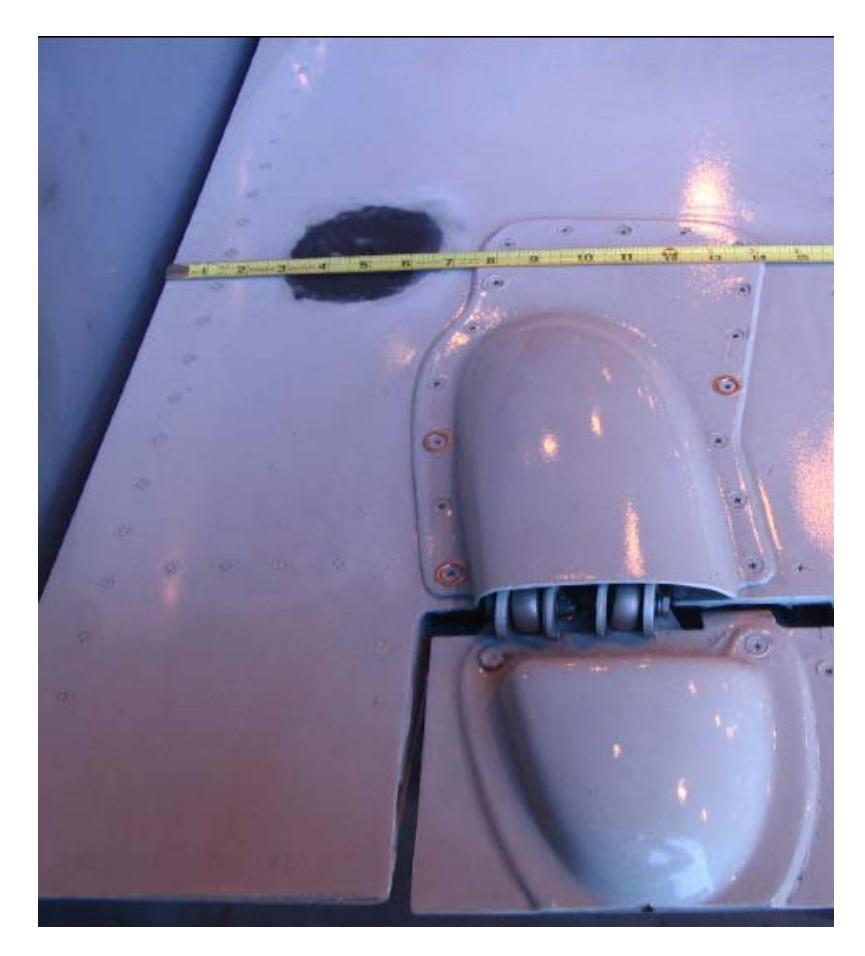
Elevator skin puncture in critical area

- Minimum skin gauge
- Minimum honeycomb density
- Skins less than minimum should not be in critical areas, and should have large allowable limits.
  - Repair must be considered during design
- Avoid thin skins in zones that are critical, or have no allowable damage, or not deferrable.

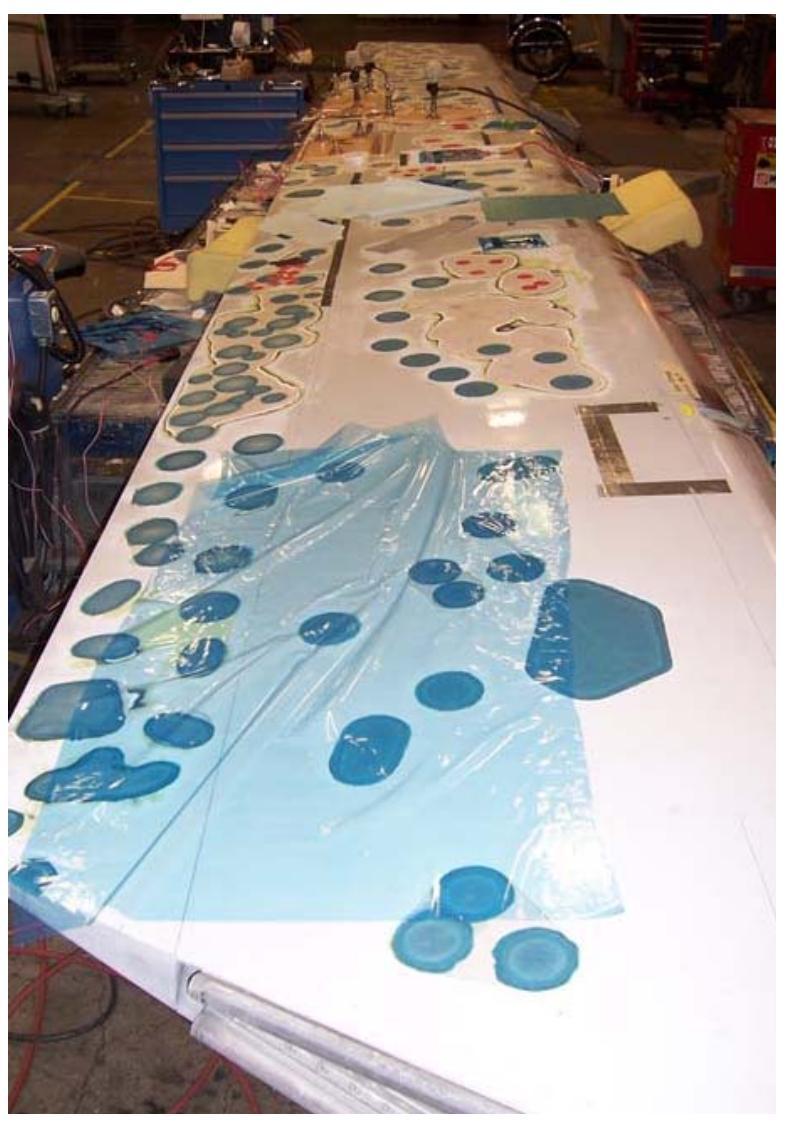
#### Outboard Elevator after hail

- Requires significant time just to evaluate. Consider there may only be cracked or delaminated paint.
- If beyond or not covered SRM, to get approval from OEM, the evaluations must be transferred to maps. Time increases ten-fold.

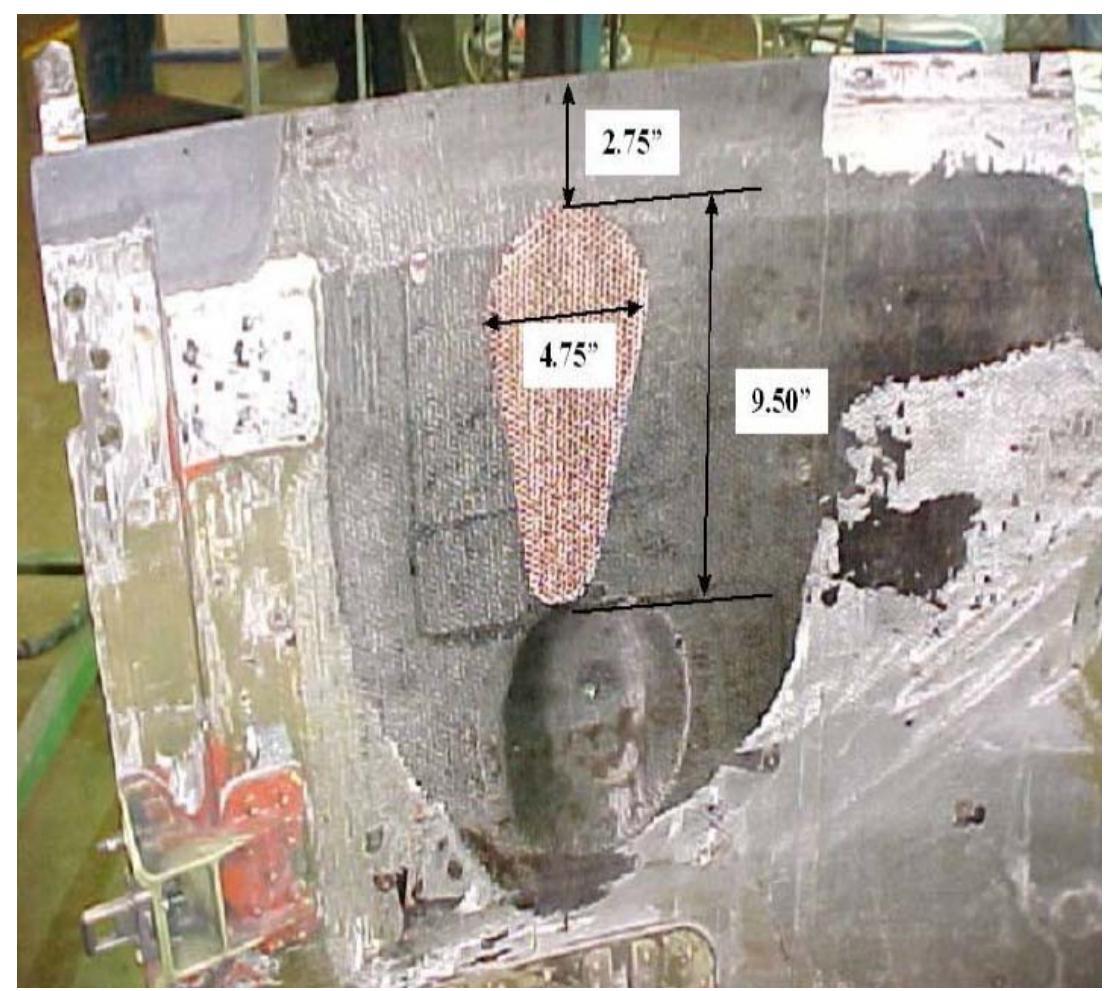
Fan Cowl

- Hydraulic fluid
  - Fluid leaks are not unusual from many hydraulic system components
  - Difficult if not impossible to remove from damaged parts
  - Protect panels that are below hydraulic components that will leak, such as Belly Fairings and Fan Cowls.

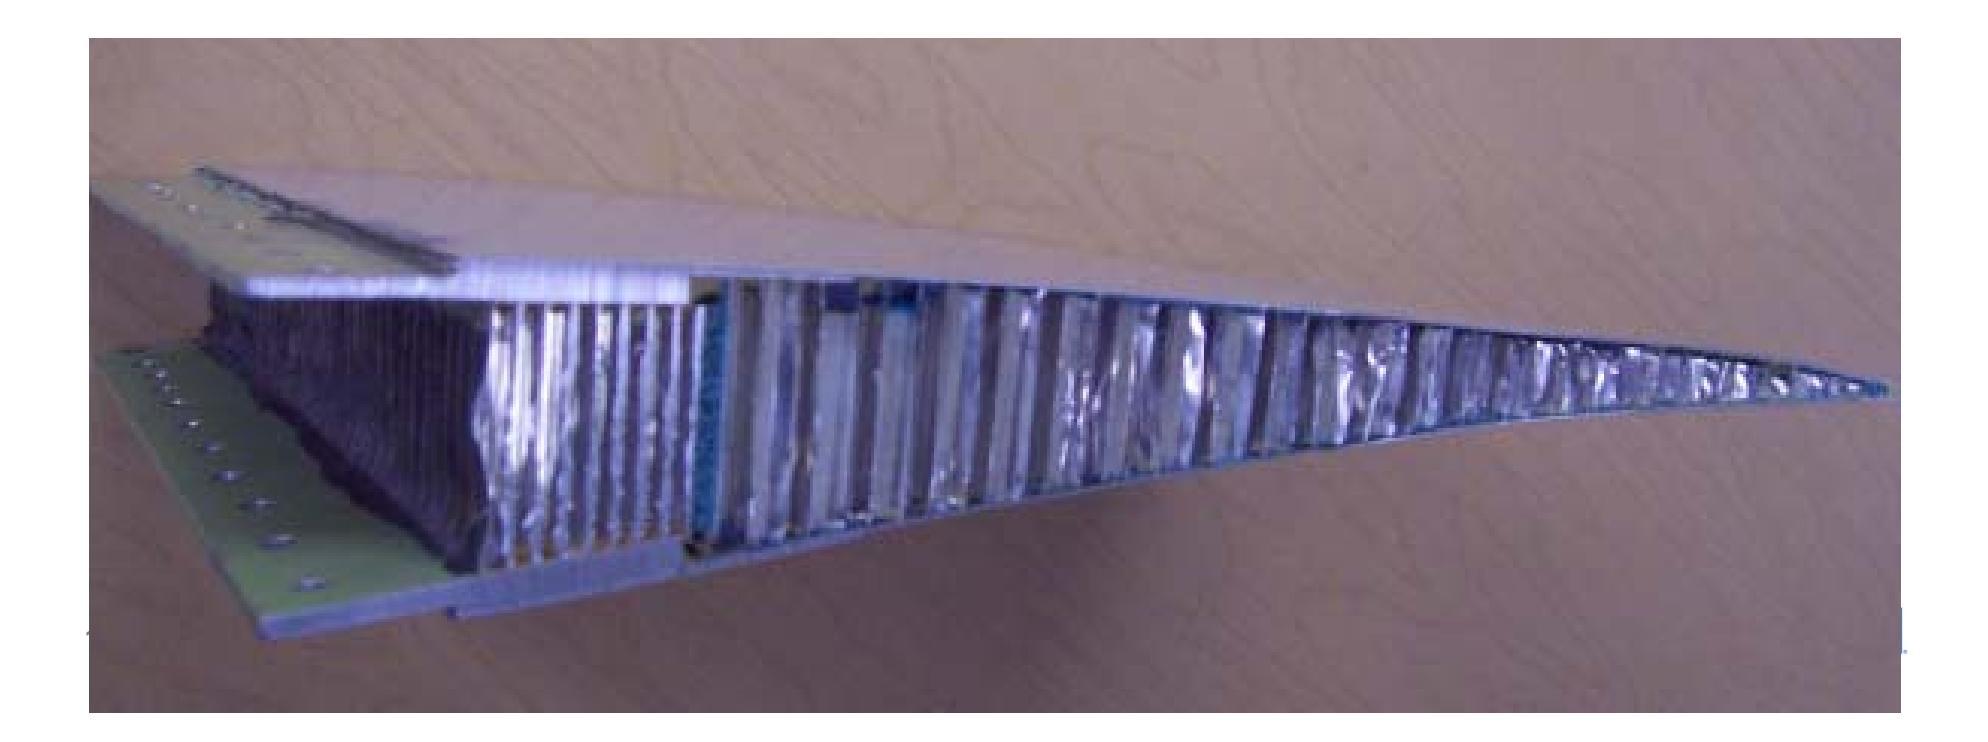
Close-out of trailing edge wedges – aluminum metalbond

- Ingress through square edge close out and bondline
- Propagation via foaming adhesive
- Failure mode is corrosion of aluminum honeycomb

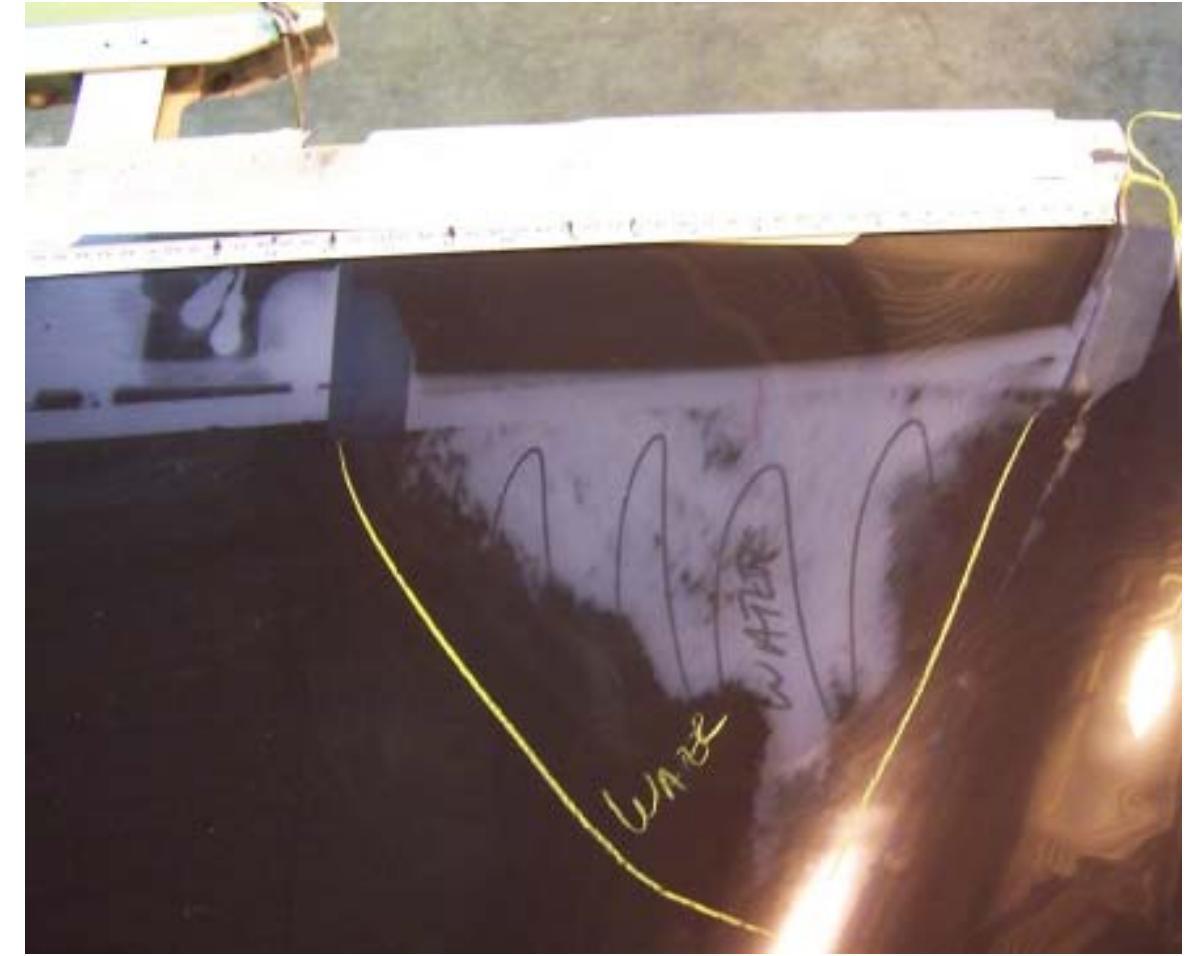
- Square-edged panel close-out without skin covering.
- Phenolic sheet bonded to honeycomb.
- Sealant breaks down over time or sheet is deformed.
- Foaming adhesive allows propagation

X-ray of outboard end of Aileron showing extent of water ingression into honeycomb

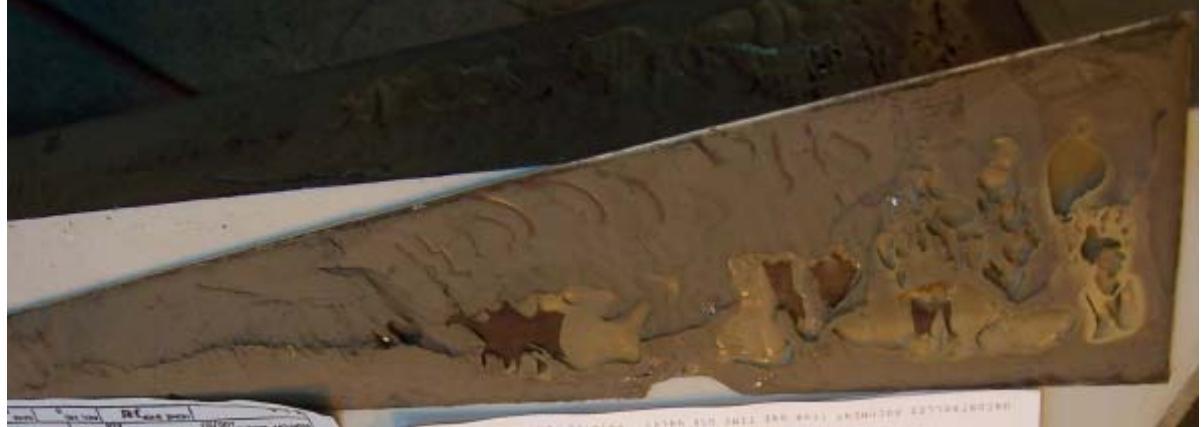
Original design is a thin sheet bonded with sealant to honeycomb.

Potting alone on end will crack with age and flexing.

Removed sheet that was covering outboard end.

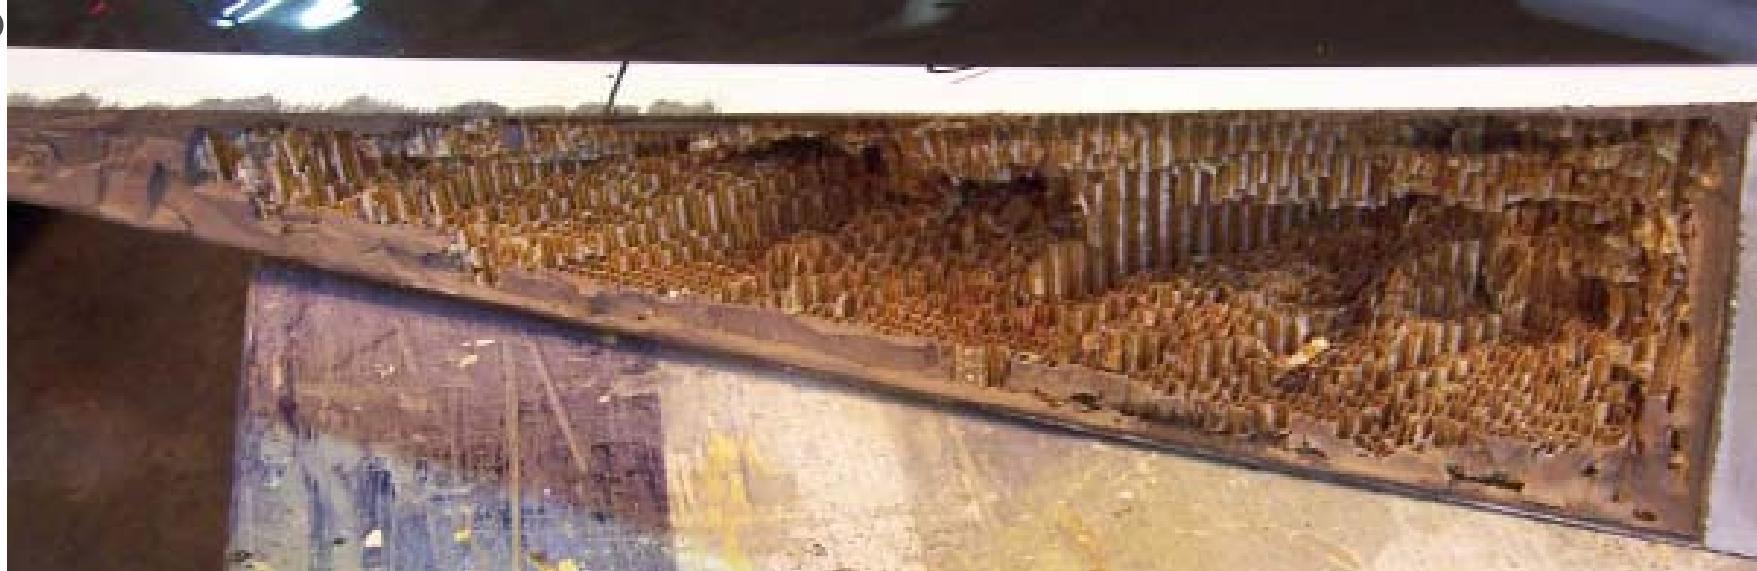
Alternative – Pot honeycomb Outboard end showing crushed honeycomb.

and wrap skins.

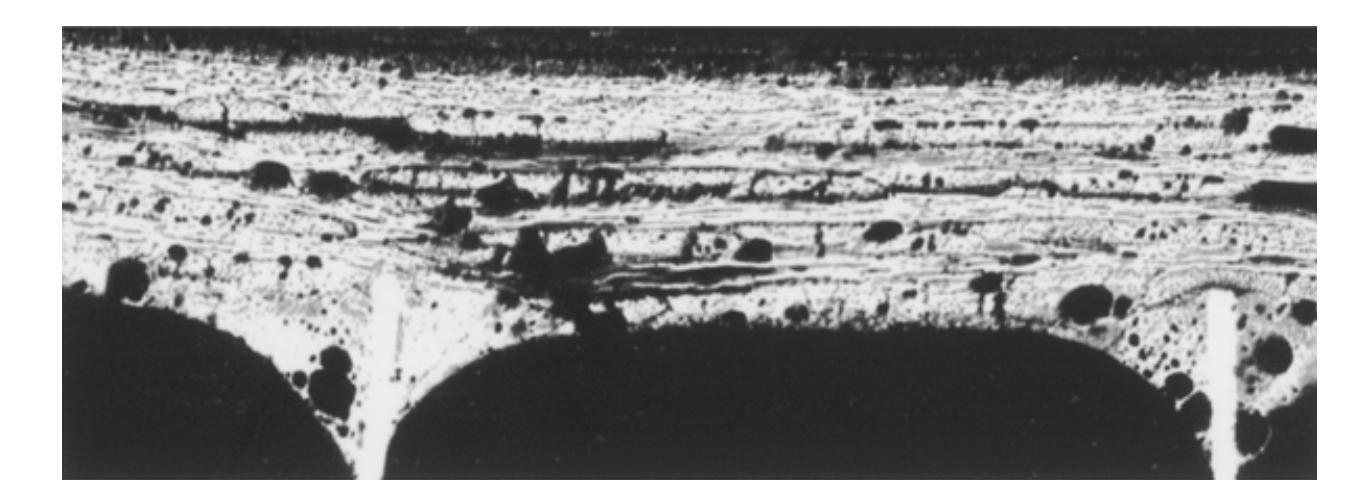
- Through skins
  - Porosity from cure
  - Fracturing of skins and delamination after impact
  - Micro-cracking of matrix

Photomicrograph of impacted skin 3 plies 7781/epoxy prepreg, co-cured in autoclave to honeycomb

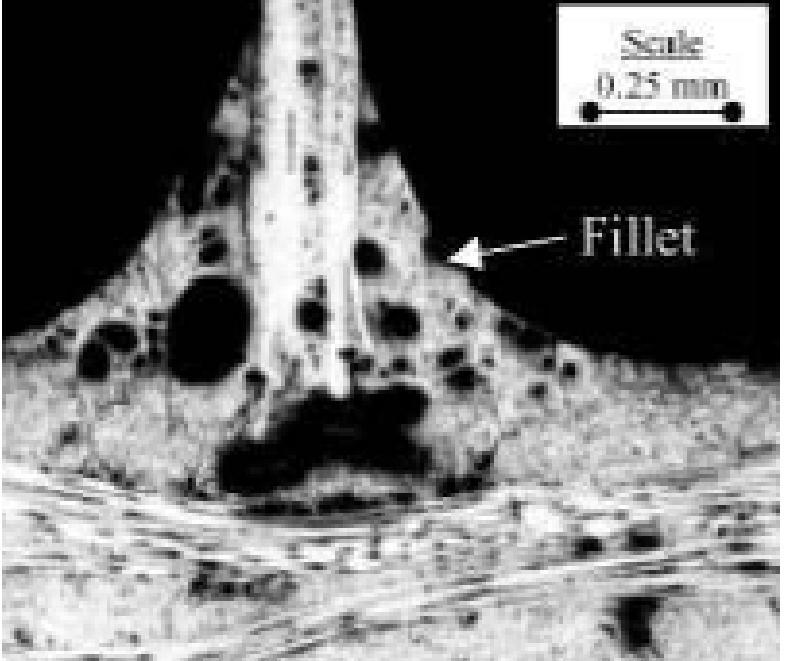
- Over cell walls
- Porosity
- Through cell walls
  - Porous to water vapor

Photomicrograph of film adhesive fillet after autoclave cure

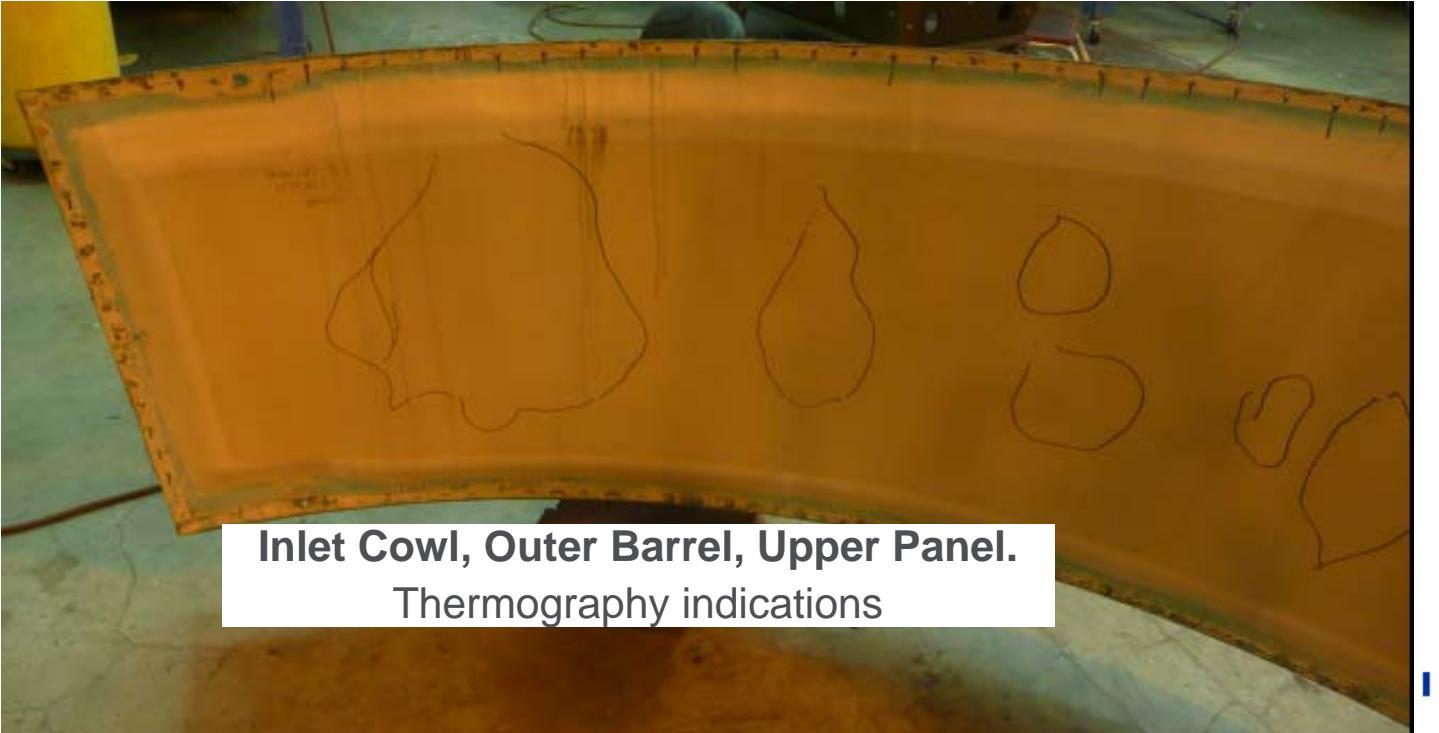
Water found visually at overnight check. No delamination, no scratches. Tap test fine, but thermography performed showed water scattered across about 30% of surface, but no single area more than 2" on cells with water touching.

- Checked with OEM for other operator experience.
- Refinished paint
- At engineering direction, deferred repair until next C-check with re-check at A-check.
- Before next check, we bought spare panels with 120 day lead time, built an autoclave tool, and performed 350F prepreg autoclave repair

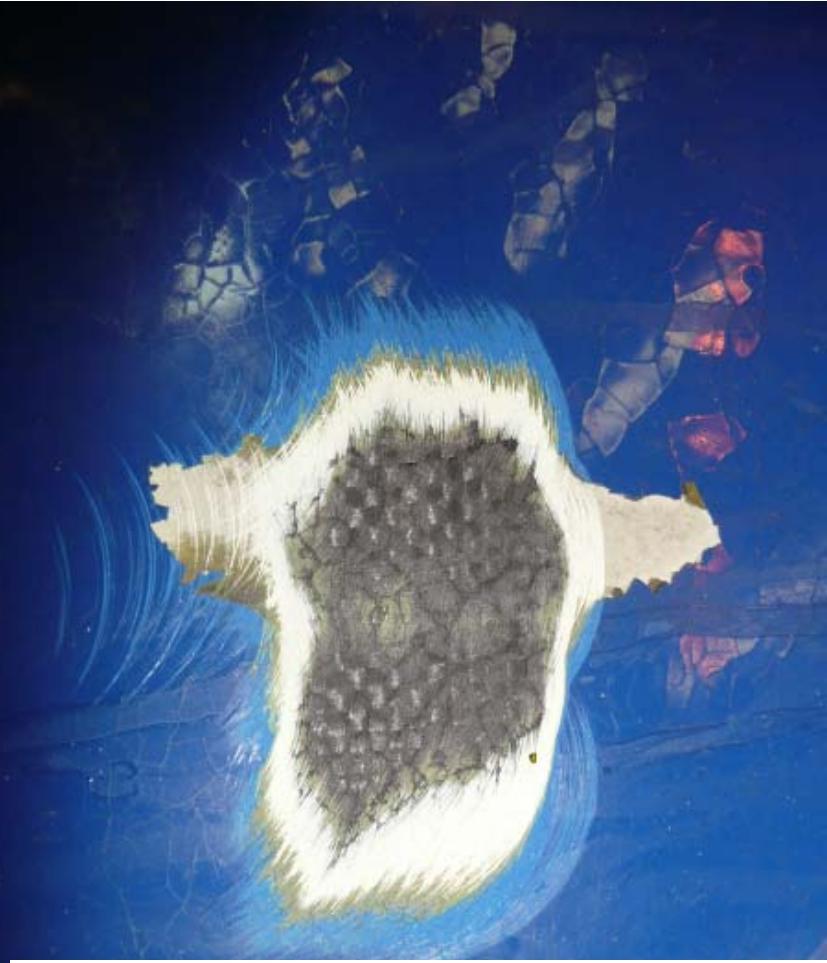
Inlet Cowl, Outer Barrel, Upper Panel. Close-up of paint

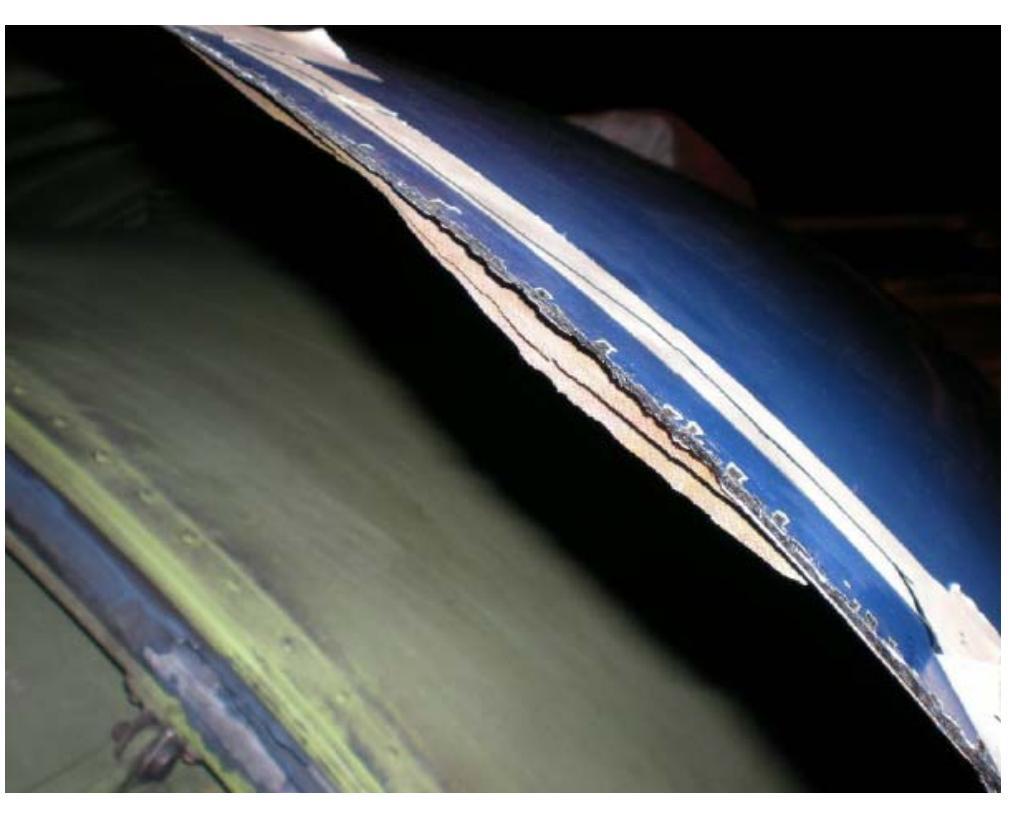
Thrust Reverser Sleeve

- Surface mismatch or positive step or facing into wind
- Primarily fairings, leading edge panels, radome
- Can lead to delamination and moisture ingression

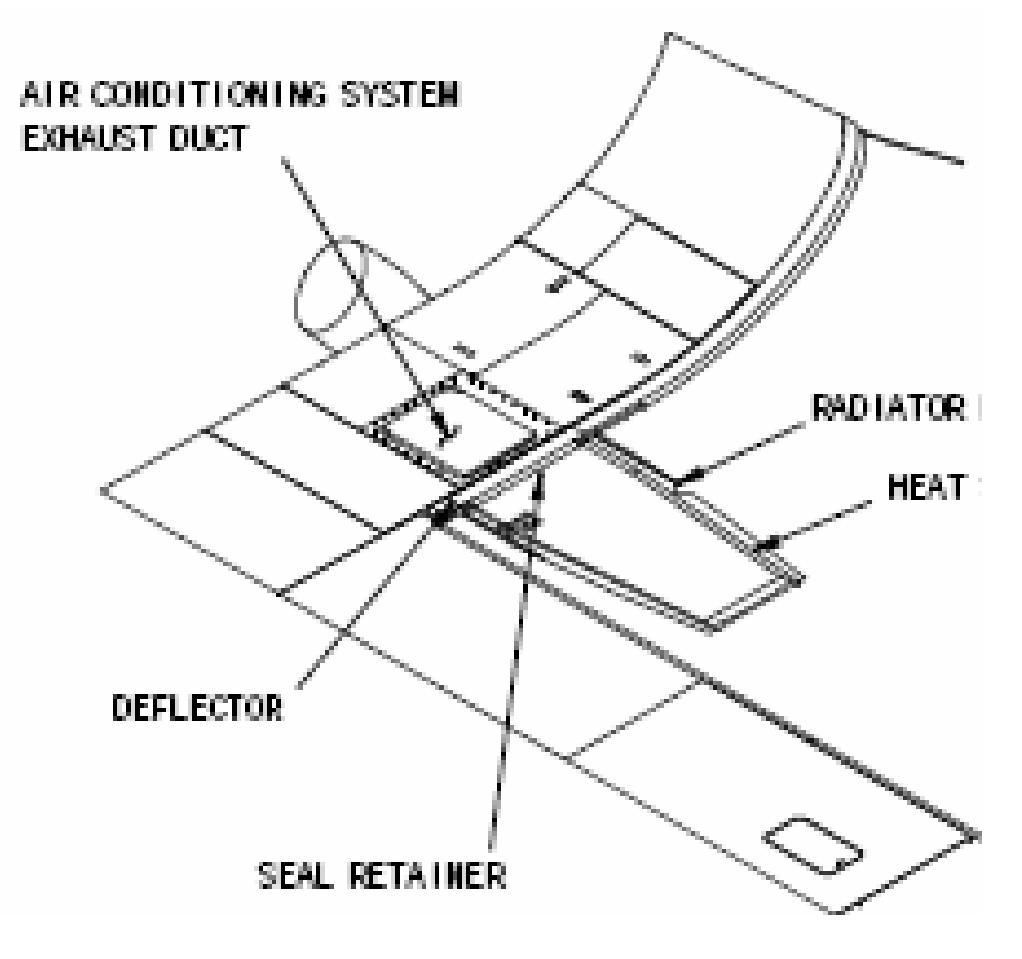
#### Heat shield aft of AC exhaust

- Heat from bleed air exhaust after heat exchanger
- Heat from due to failed valves in open position
- Heat shields used which aren't big enough
- Heat shield materials not
