# FAA R&D in Composite Sandwich Structures

Presented to: Damage Tolerance & Maintenance  
Workshop

By: Peter Shyprykevich

Date: 20 July 2006

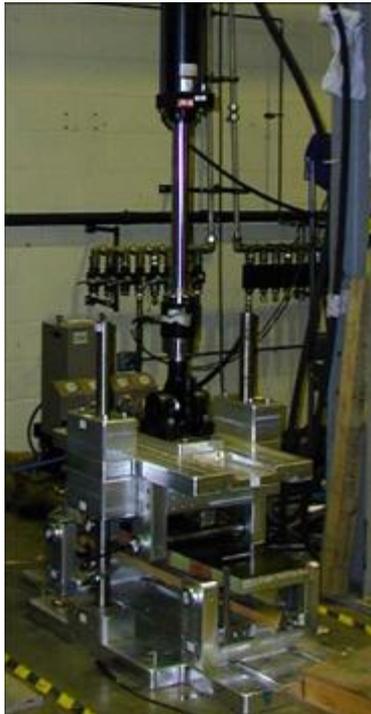
**Large (11.5"X46") and small (14"X3")  
Four-Point Bending Beams**
