# Bonded Repair of Composite Airframe Laminate and Sandwich Structures

Presented at the CACRC Meeting, November 16<sup>th</sup>, 2007

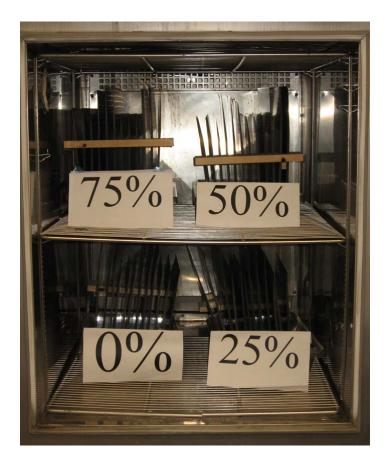
#### Exposure to Water and Skydrol

After saturation, coupons have been dried to achieve saturation levels of 0%,25%, 50%, 75% and 100%

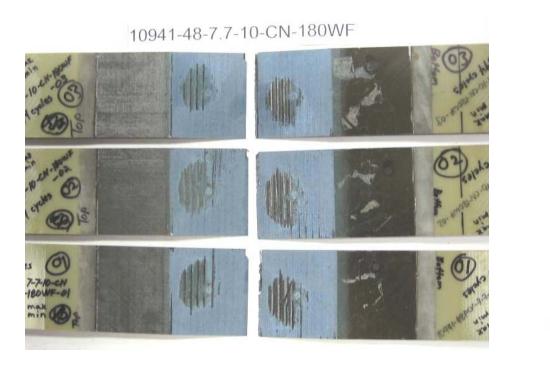
18-9.1-10-CN-RTA-01 ARAMIS strain Map

Failure Modes (Mainly cohesive)

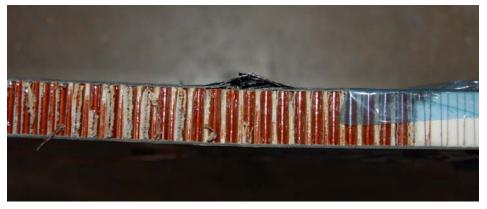
Screening Panels yielded acceptable Failures (9000-10000 microstrain at failure) Panel Manufacturing and scarfing complete Repair in progress (OEM)
