Fluid Ingression Into Composite Sandwich Structure: History And Future Research

Commercial Aircraft Composite Repair Committee (CACRC)

Composite Damage Tolerance & Maintenance

May 9-11, 2007

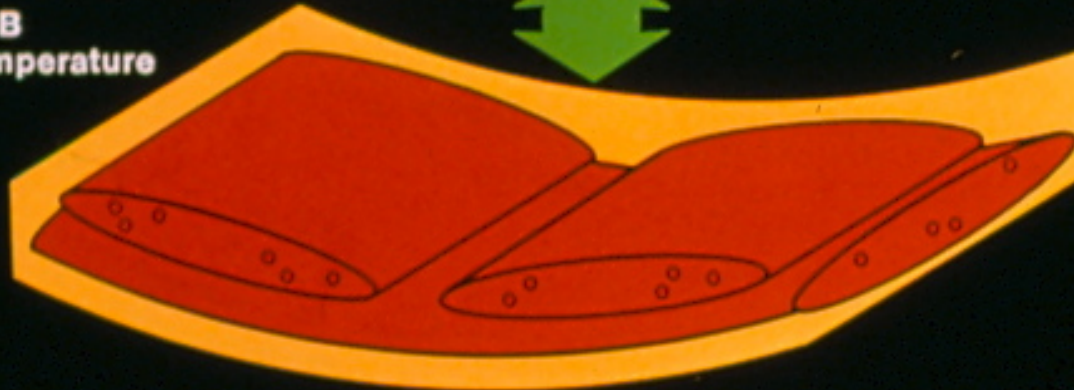
B
Low Temperature

Strained
Condition

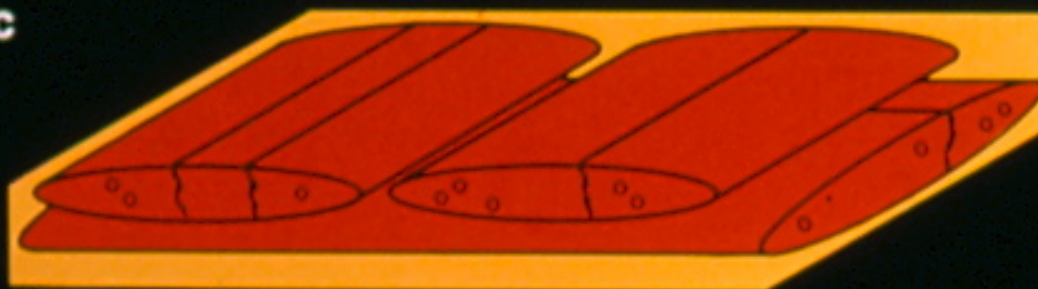
C

Cracked
Condition

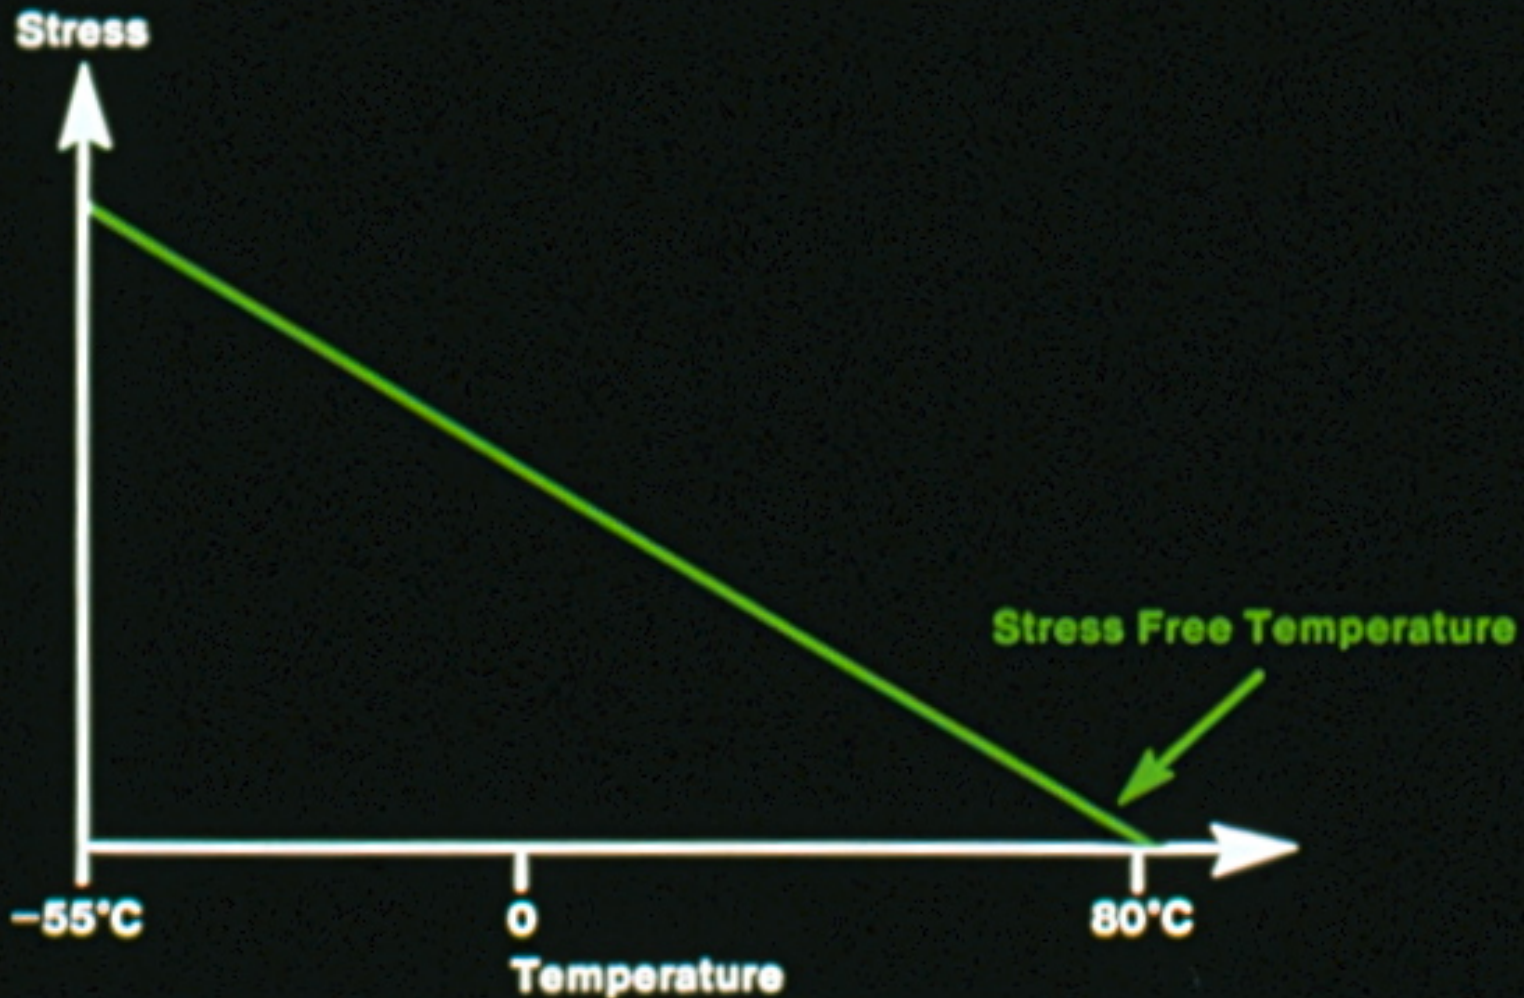
Transverse Residual Stress

- Moisture has similar effect on transverse stress, with increasing moisture reducing the stress
