Materials and processes

Fluid ingress in rudder sandwich structure

Effect of aggressive fluids on durability

A300-600/A310 and A330/A340 Pre-MOD 8827 / 40904

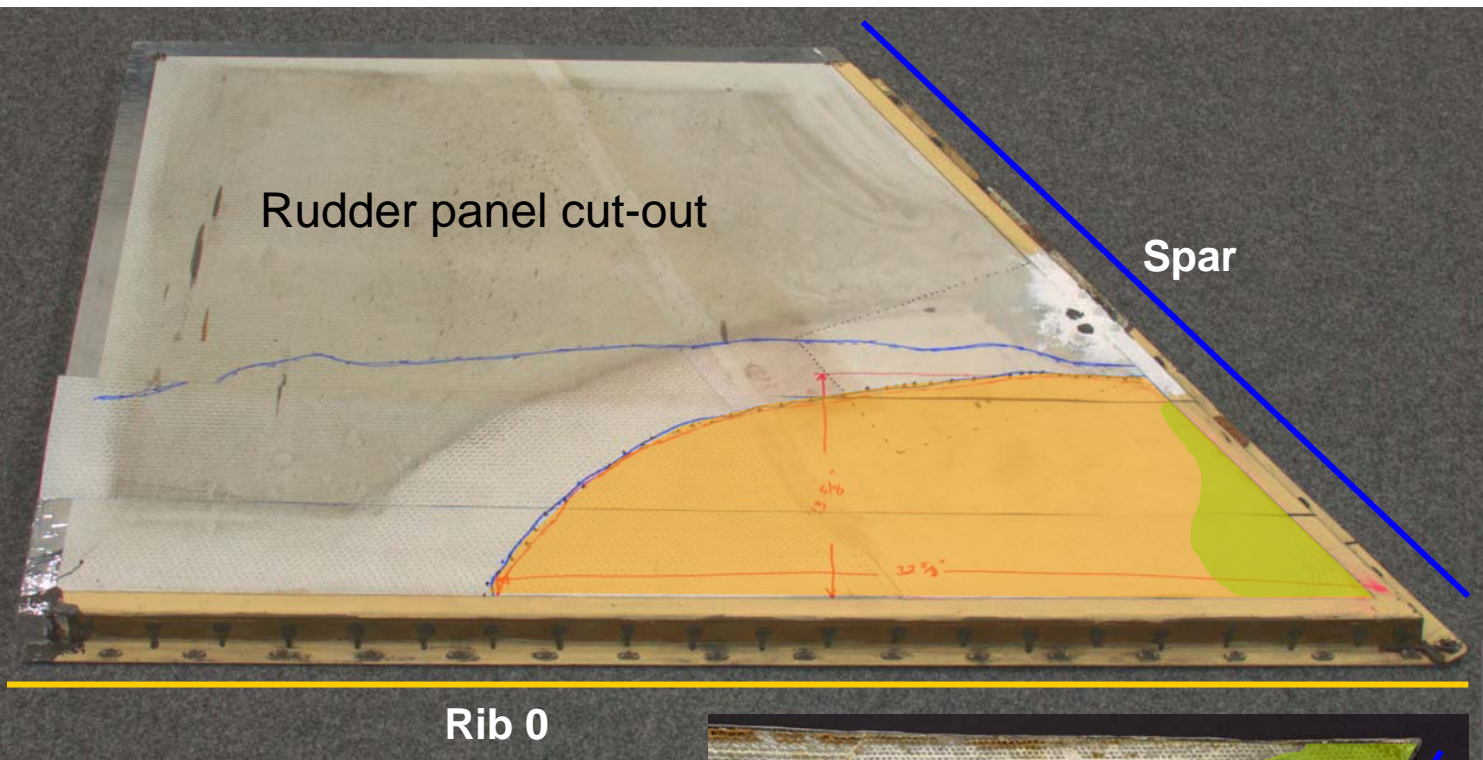
Hydraulic fluid contamination at inner face

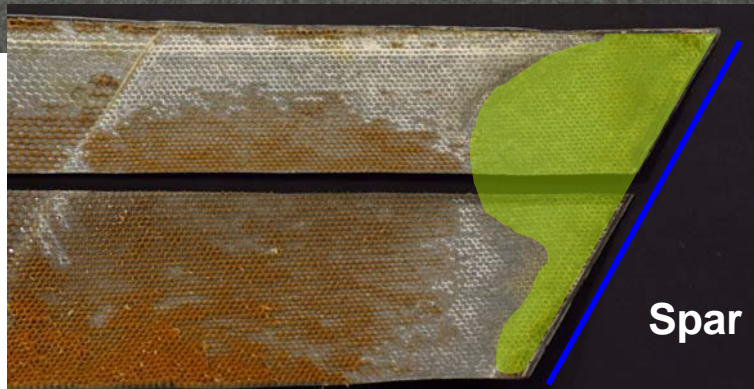
Inner skin flipped after removal

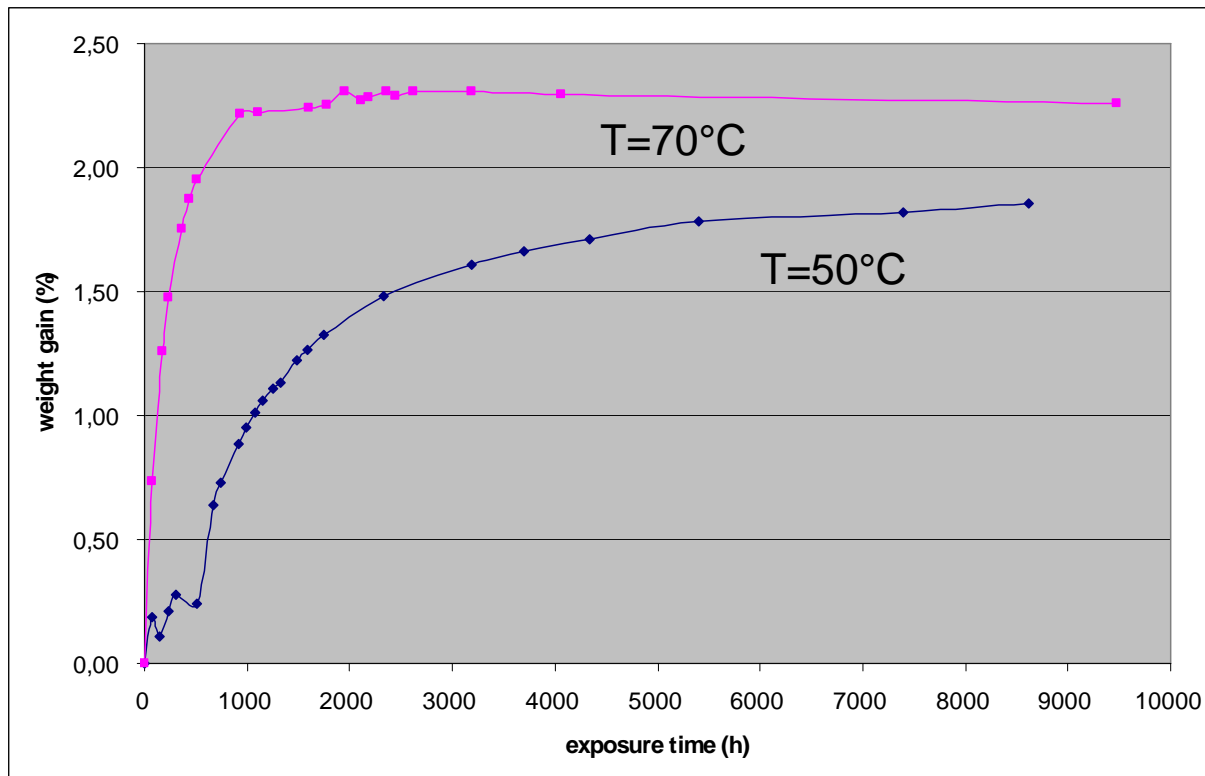
Self Adhesive prepreg A: moisture absorption

Exposed at
85% rel.H.

- as expected: diffusion rate increases with T
- untypical: different level of moisture gain

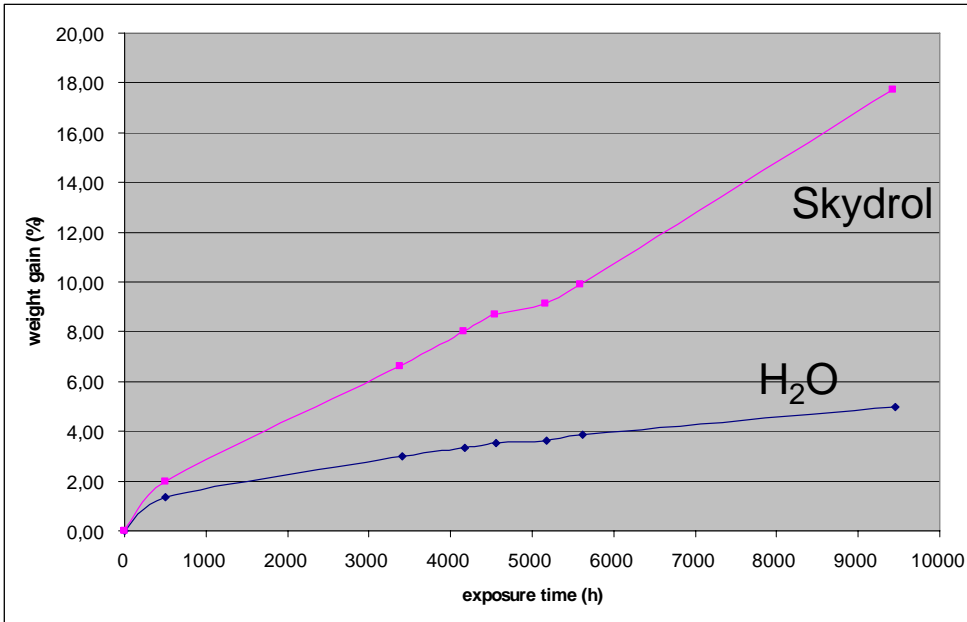
Absorption behaviour Self Adhesive prepreg A

Exposure at T = 50°C

- untypical: no saturation in water
- untypical: resin picks-up Skydrol

- Self Adhesive Prepreg A exhibits “untypical” behaviour
 - ▶ Skydrol gain
 - ▶ No saturation at water exposure
- Use of Self Adhesive Prepreg A was never intended for such an extreme environment
- But: Very limited “self propagation” of disbond even at extreme conditions and long time exposure

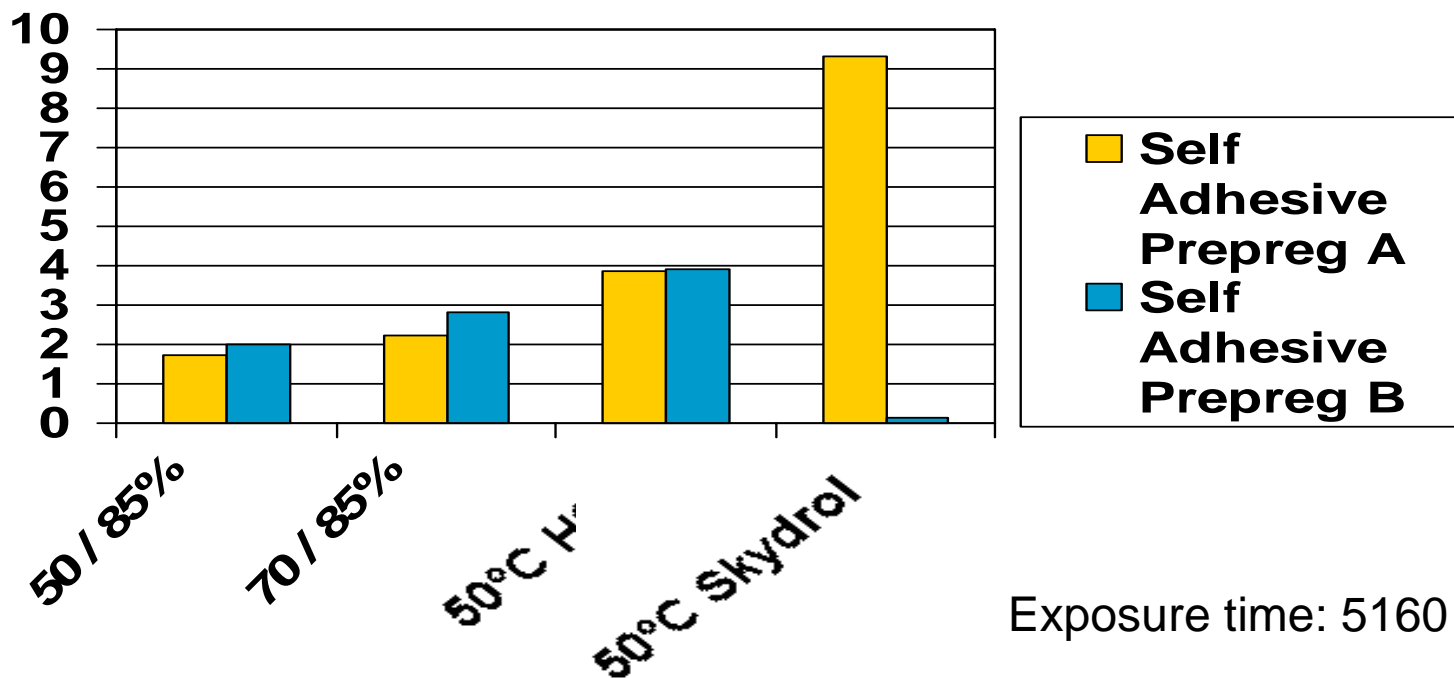
Humidity / fluid absorption of self adhesive prepregs

- as expected: both pick-up moisture and water
- untypical: Skydrol pick-up for bonding prepreg A

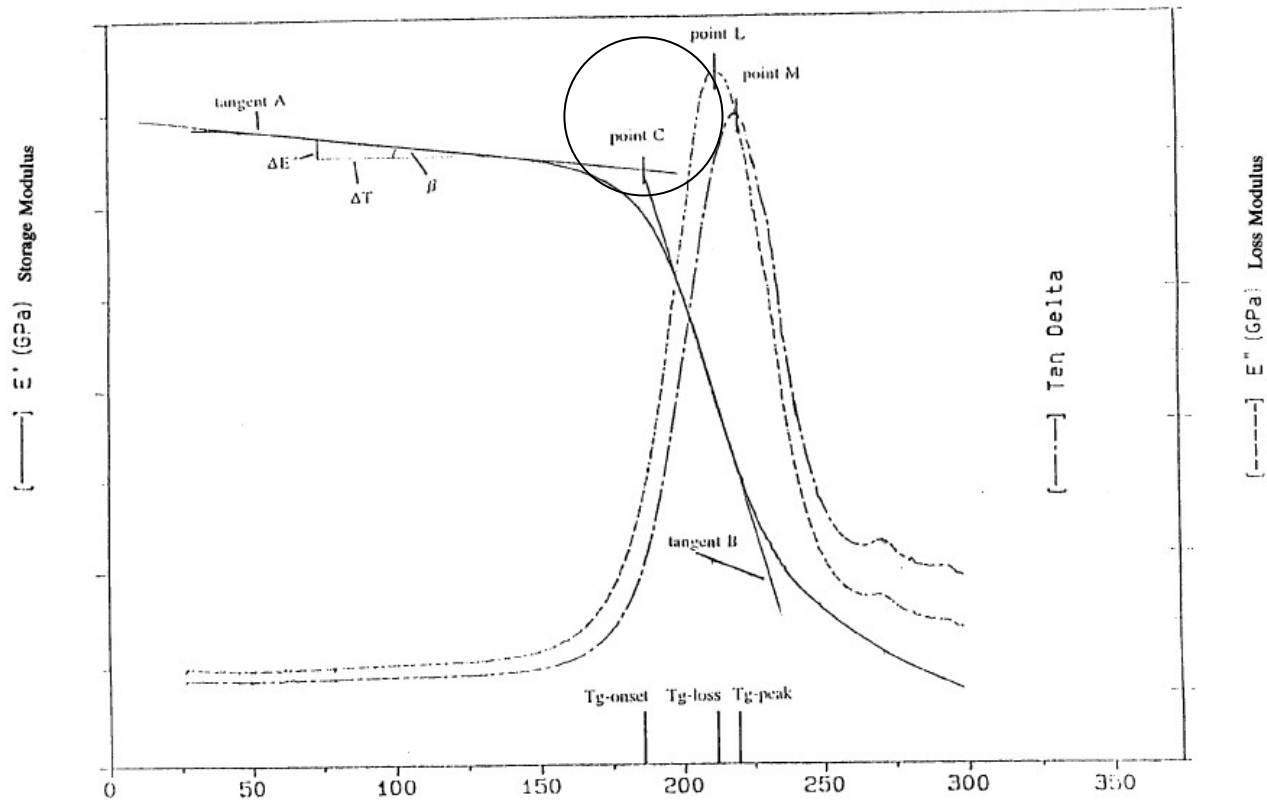
Figure 1

Tg onset explained

A conservative assessment of temperature capability

Typical diagram storage modulus, tan delta and loss modulus versus temperature determination of tg-onset, tg-peak, tg-loss and β

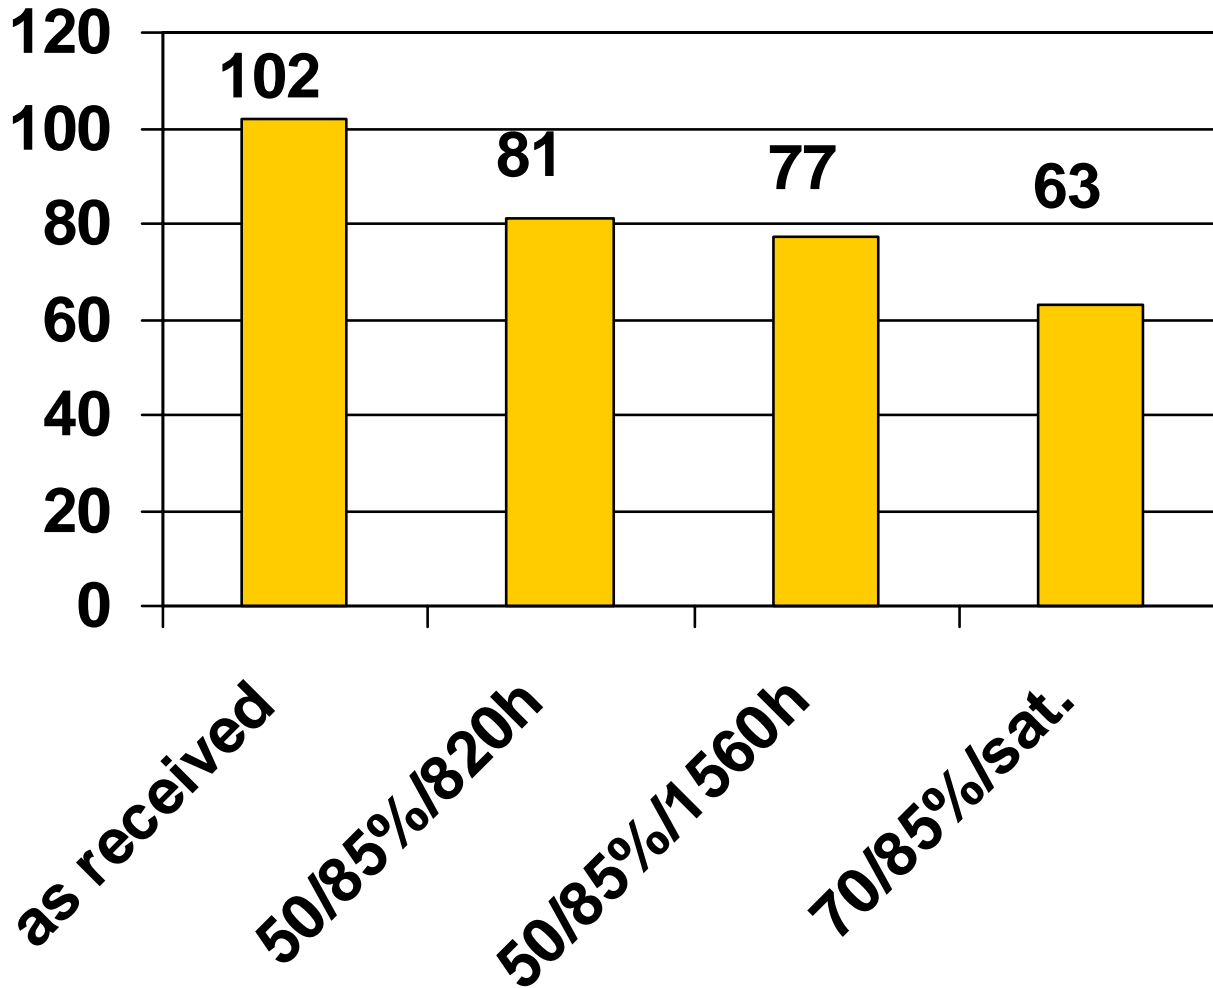
Tg onset

■ Self Adhesive Prepreg A

- Typical behaviour of self-adhesive resins

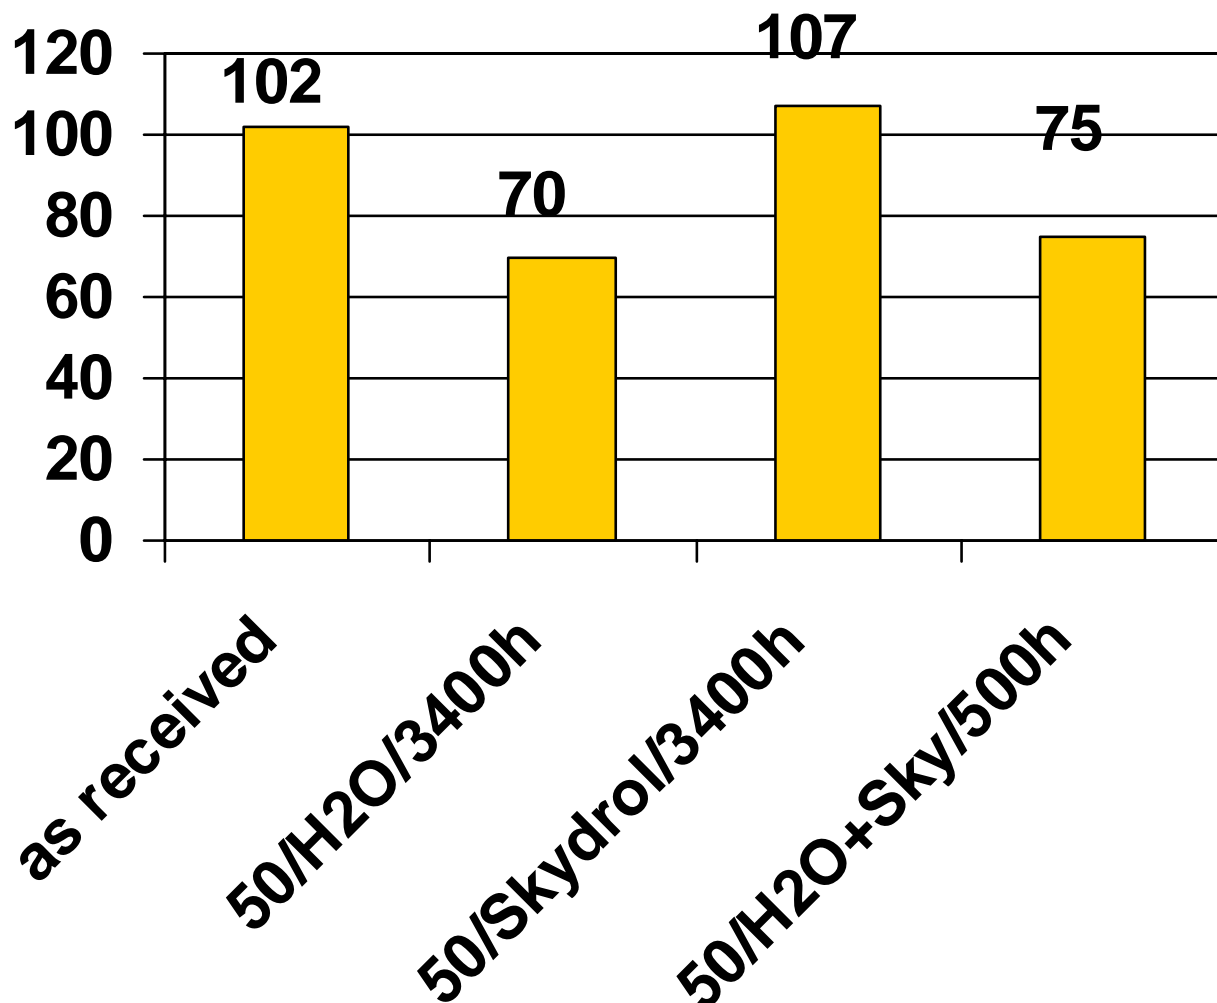
Tg onset

■ Self Adhesive Prepreg A

- Humidity effects
- no effect due to Skydrol (3400 h)
- Skydrol/water affects resin, after 500 disintegration of specimen

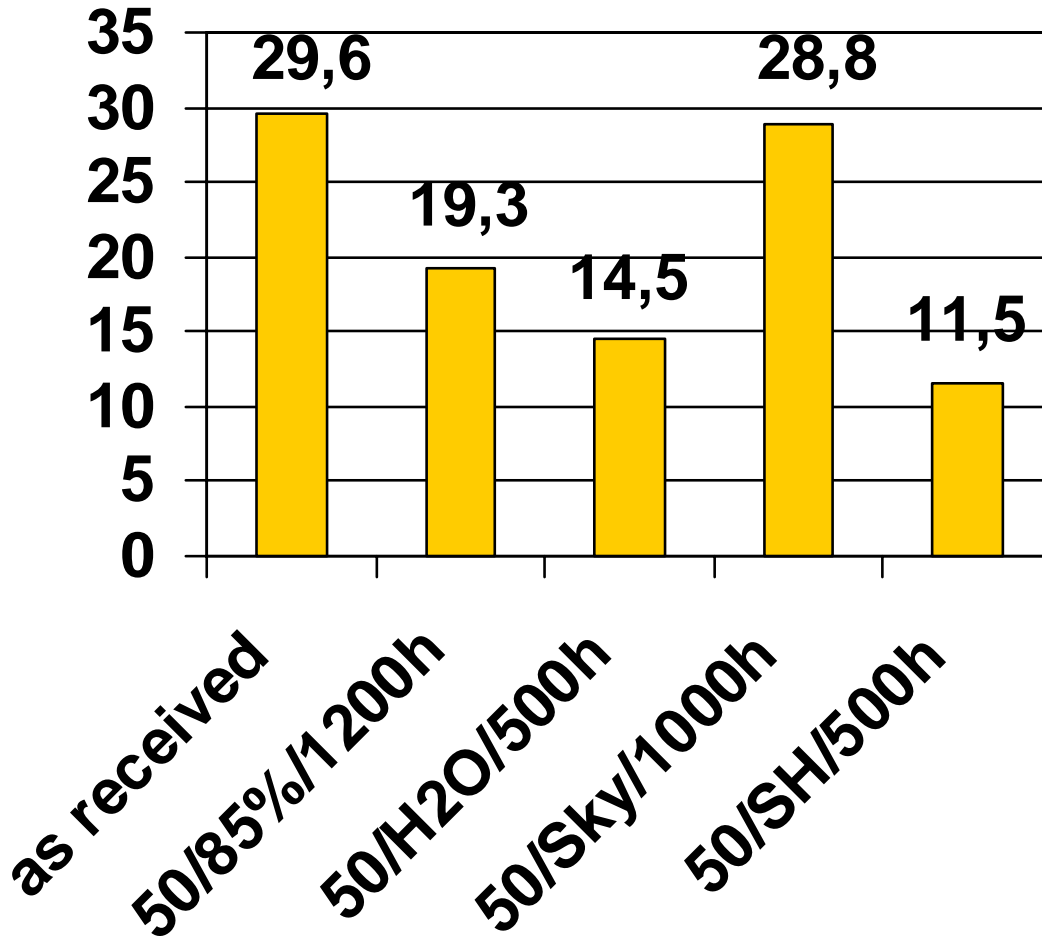
Interlaminar shear strength ILSS at 70°C

■ Self Adhesive Prepreg A

- Humidity effects
- no effect due to Skydrol (1000 h)
- Skydrol/water affects resin, after 500 disintegration of specimen

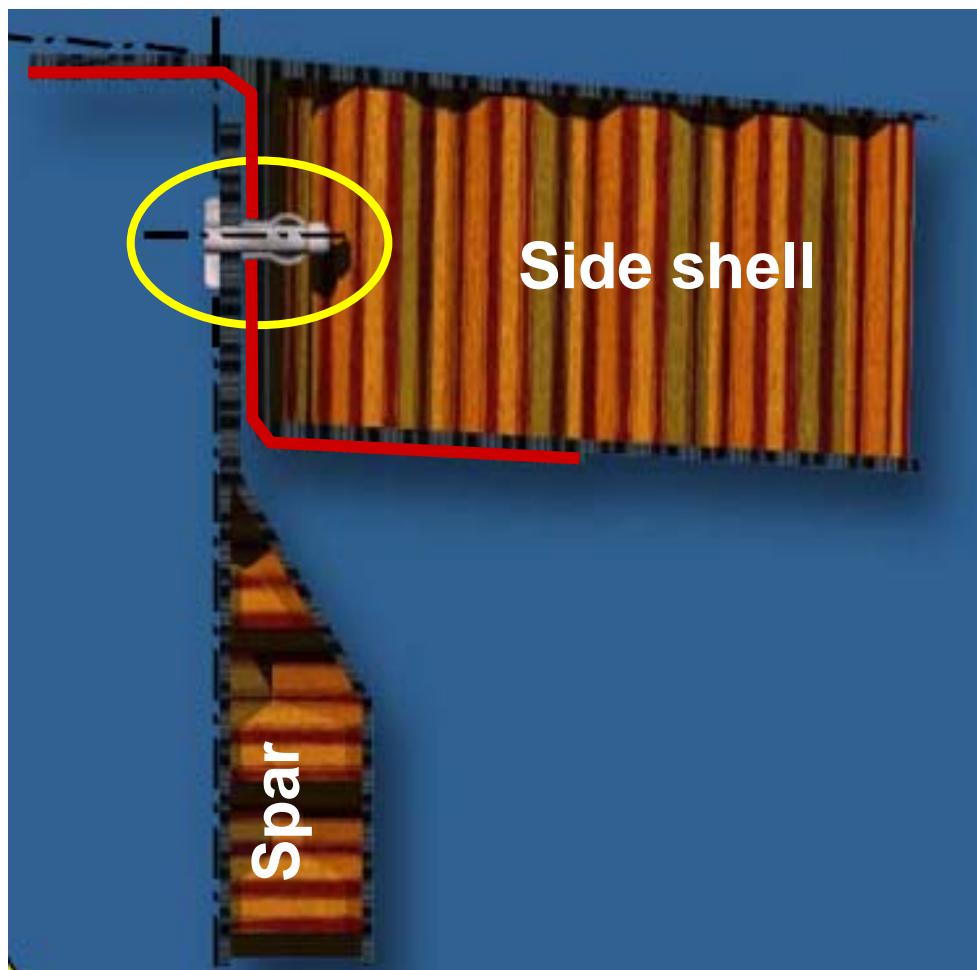
Fluid path specific to Z-profile design rudder series

- Blind rivets used for spar to shell connection
- Hydraulic fluid had penetrated past some rivets

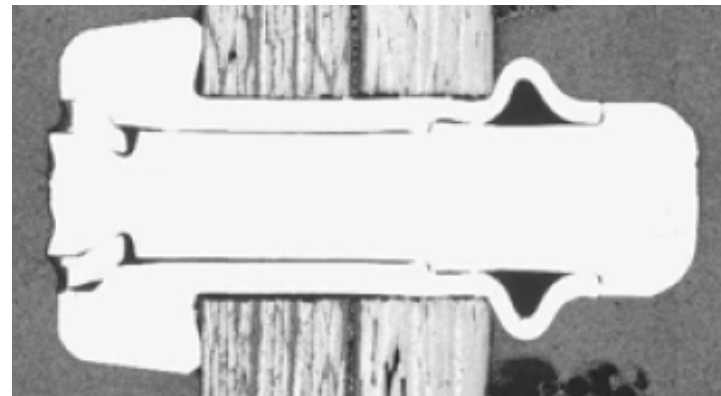
Section cut of blind rivet

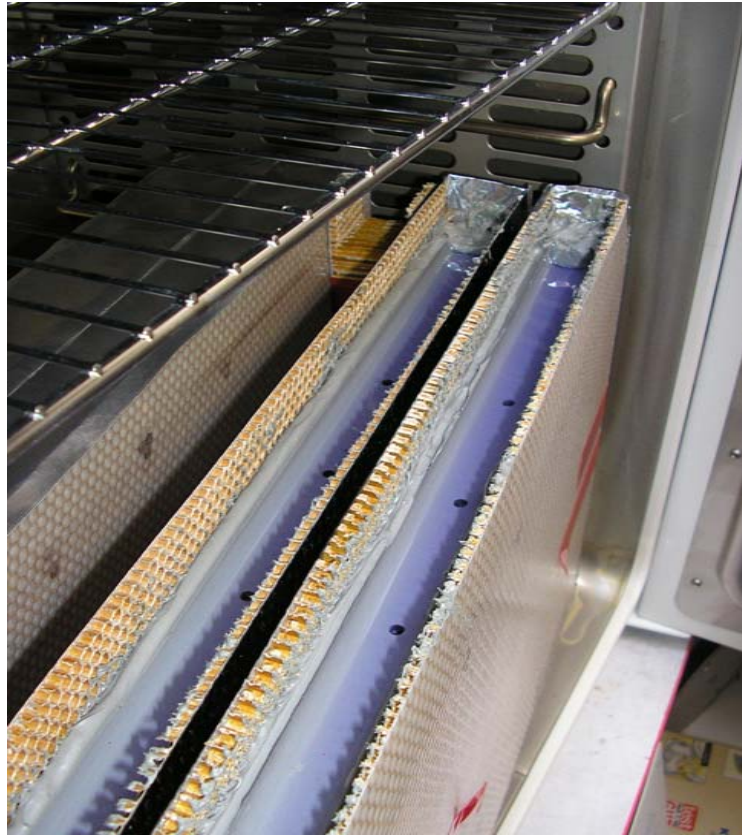
Chanel with holes filled with Skydrol

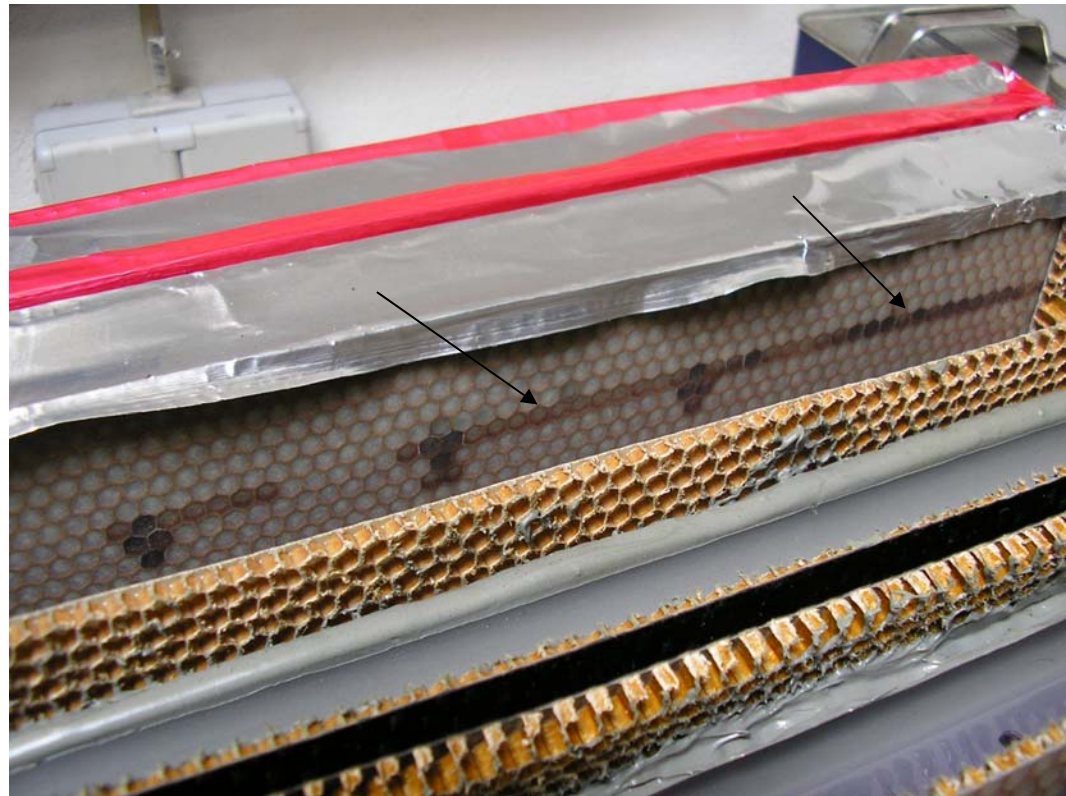
Exposure: 790 h at 50 °C / Water Skydrol Mix

Skin Material: Self Adhesive Prepreg A

- **More liquid at infiltration channel**
- **No further cells filled below holes**

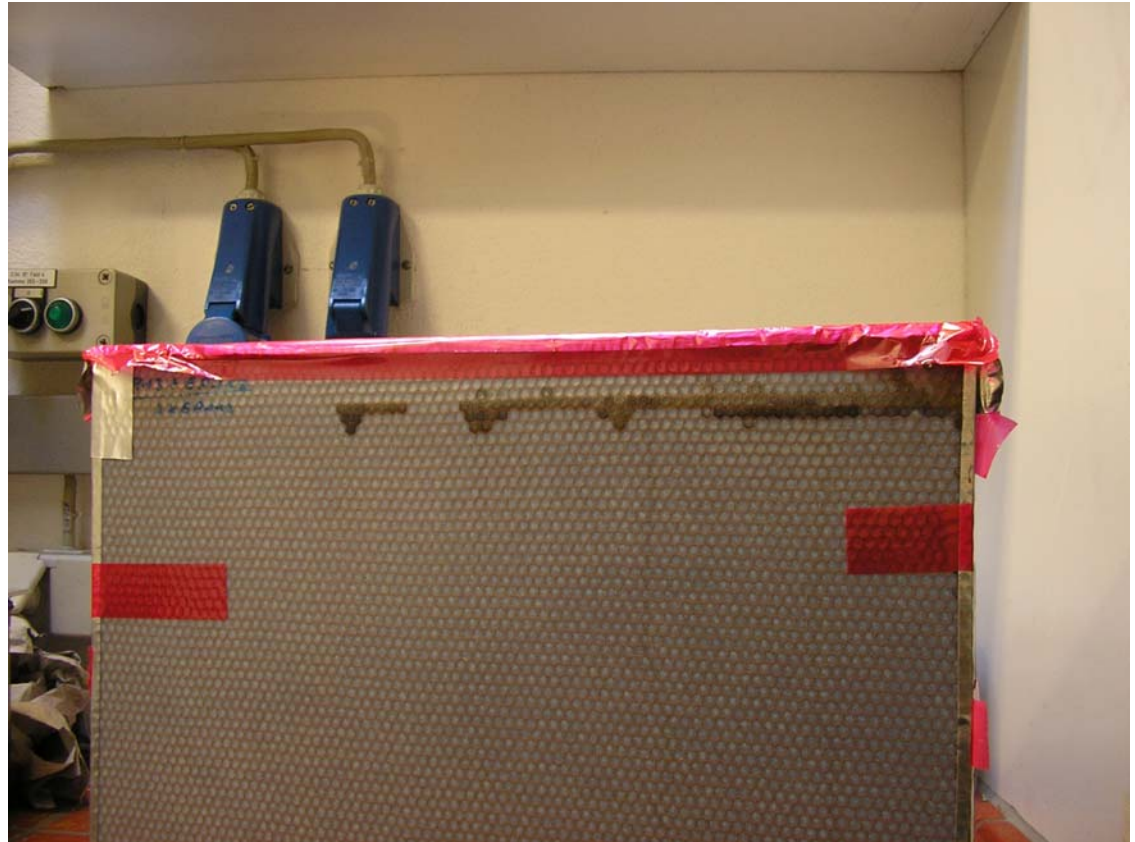
Exposure: 3500 h at 50 °C / Skydrol + Water Mix

Skin Material: Self Adhesive Prepreg A

- **More liquid at and one row below infiltration channel, physical connection by gaps**
- **No further cells filled below holes**

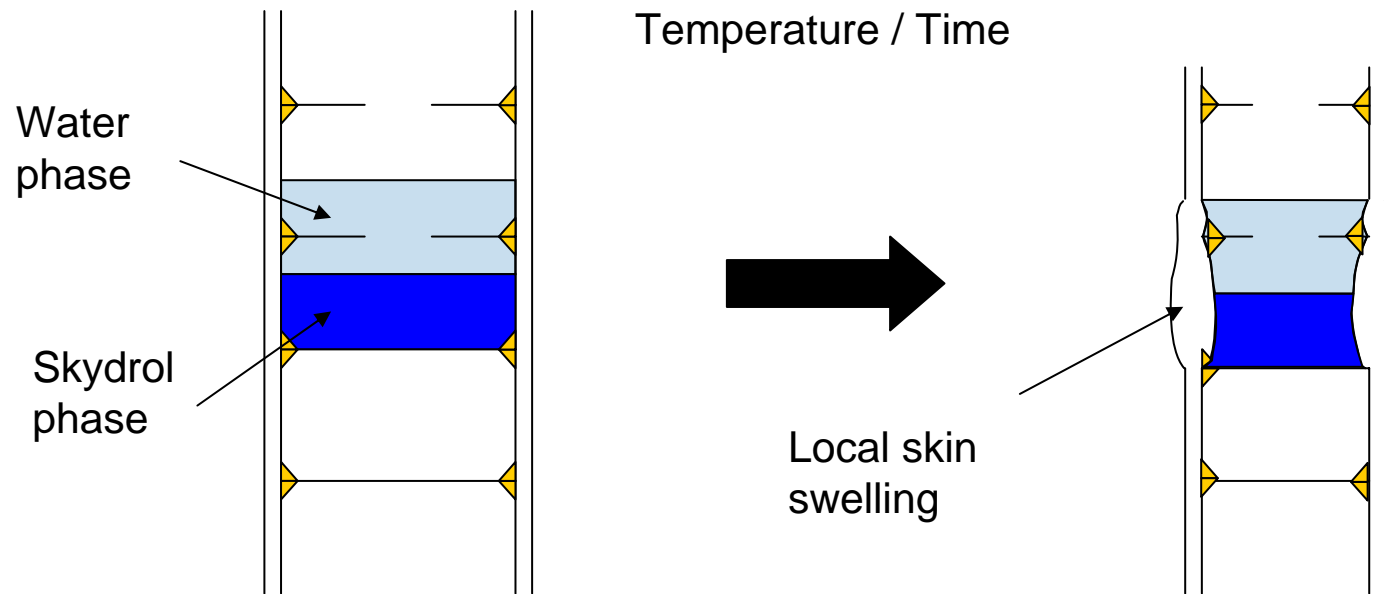
Swelling effect

- Absorption of Water and / or Skydrol

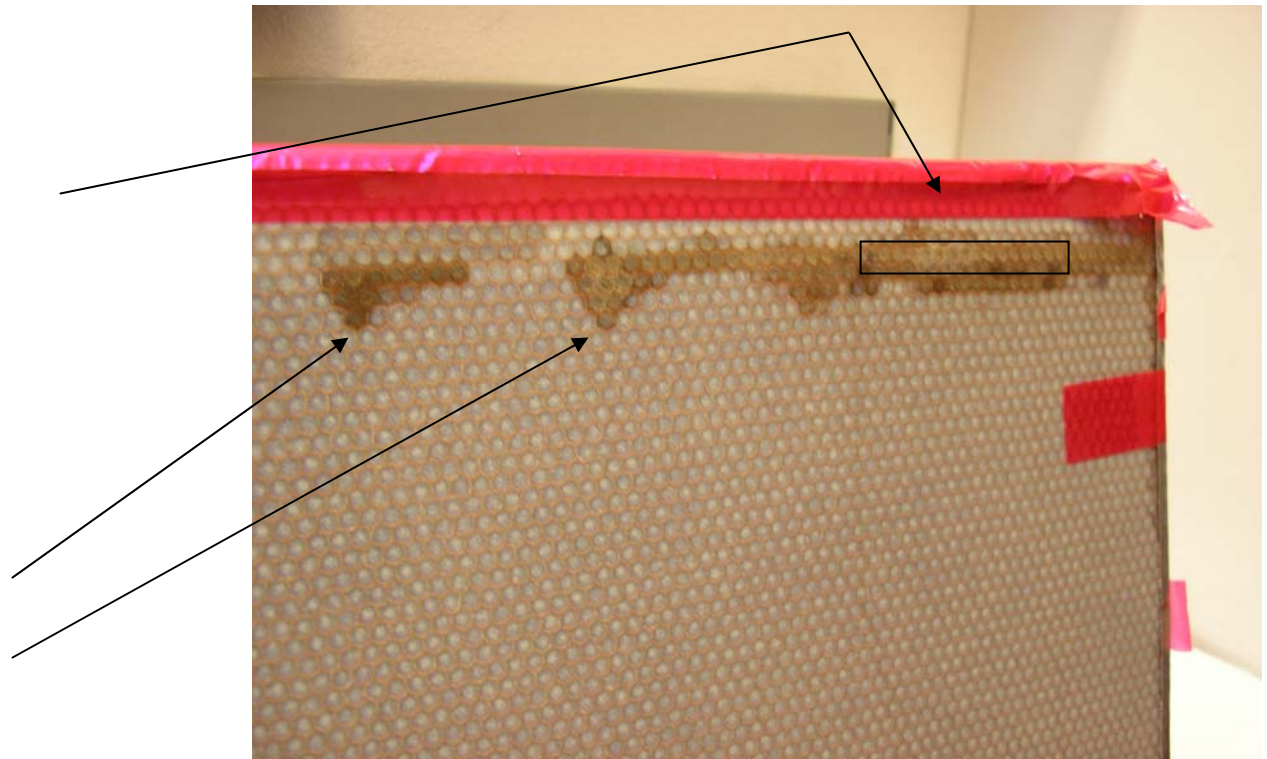
Exposure: 3750 h at 50 °C / Skydrol + Water Mix

Skin Material: Self Adhesive Prepreg A

- **Local Skin Debonding**

- **No Vertical Propagation**

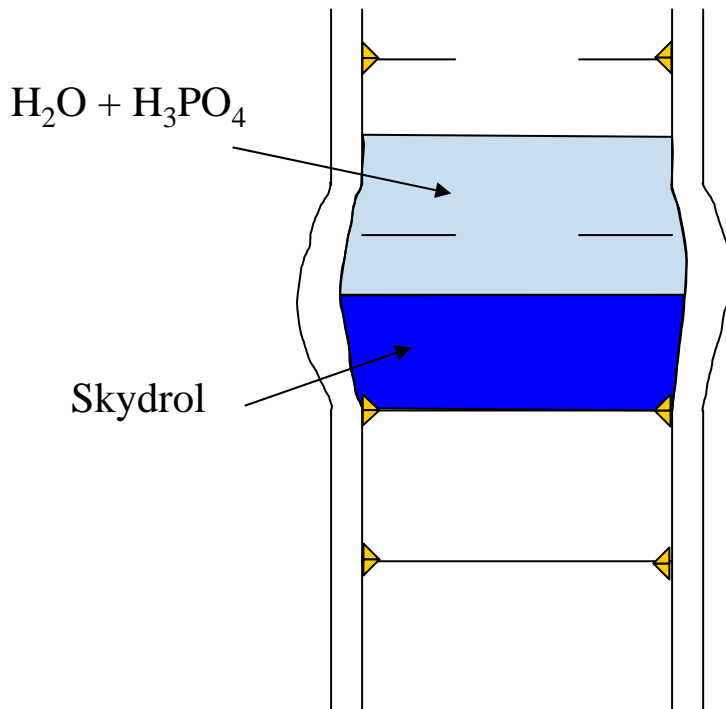
- **Local Skin Debonding**

- In a cell filled with emulsified water and Skydrol the two phases will separate immediately.
- Phosphoric acid develops start under specific climatic conditions only:
 - $T = 40^{\circ}C$ for more than
 - $t = 14$ days
- The phosphoric acid will be dissolved in the water phase
- Fillets are be damaged in water / phosphoric acid
