Lufthansa Perspectives on Safe Composite Maintenance Practices

Damages on composite components

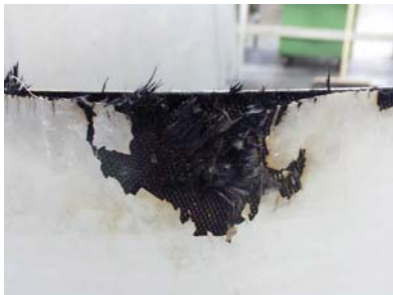
Lightning Strike

Fleet Size: 243 a/c
Total damages: 1647 events
Repair Cost: €33.200.000

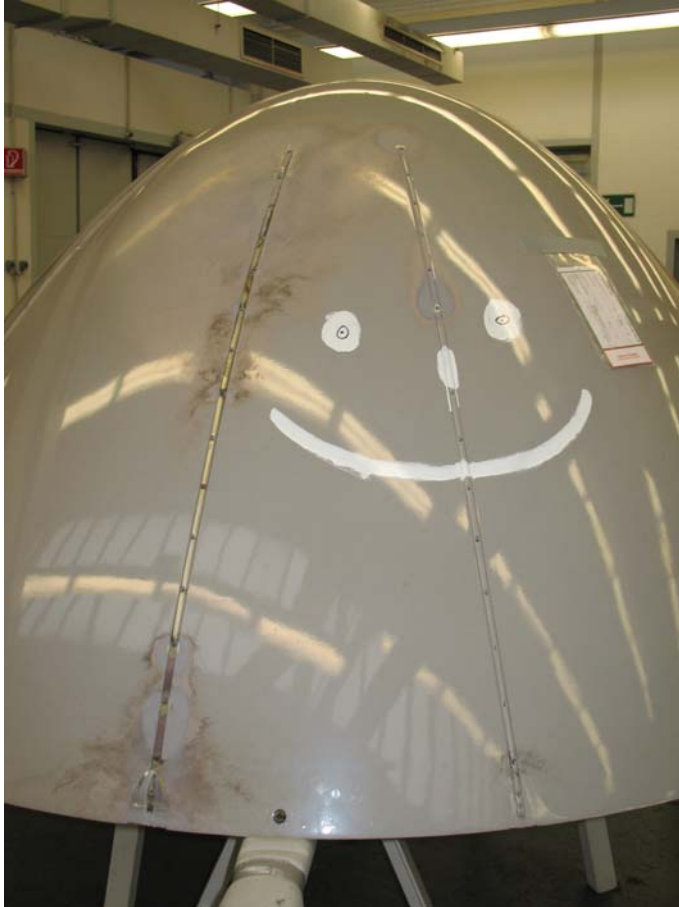
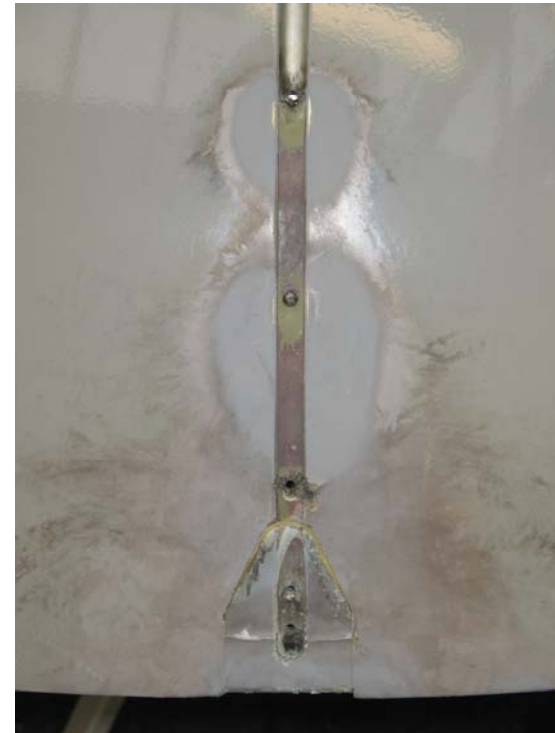
Lightning

Composite materials are electric conductors. Because of thermal overload and/or sparking, adjacent fasteners have to be changed after lightning damage.

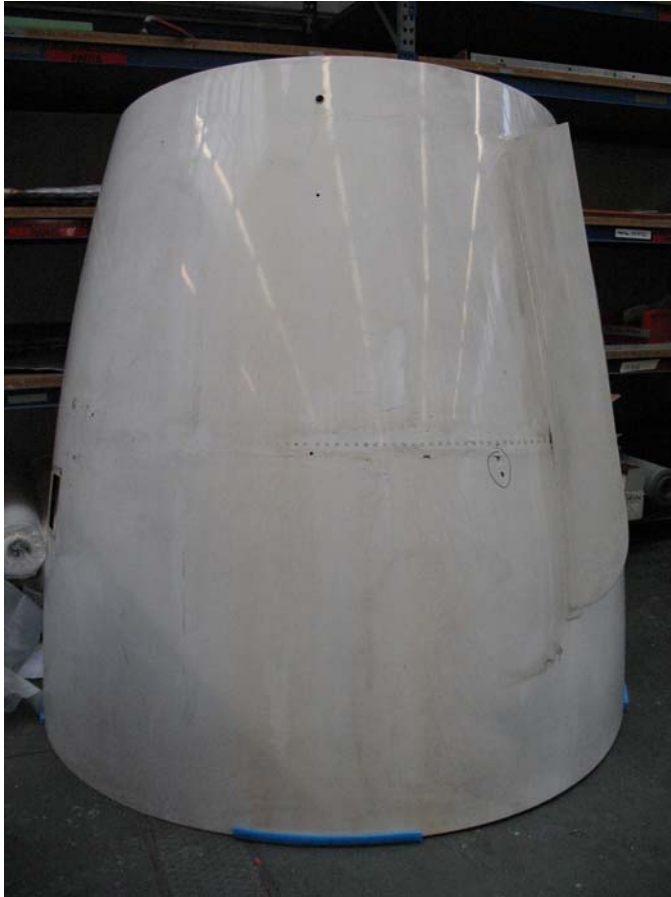
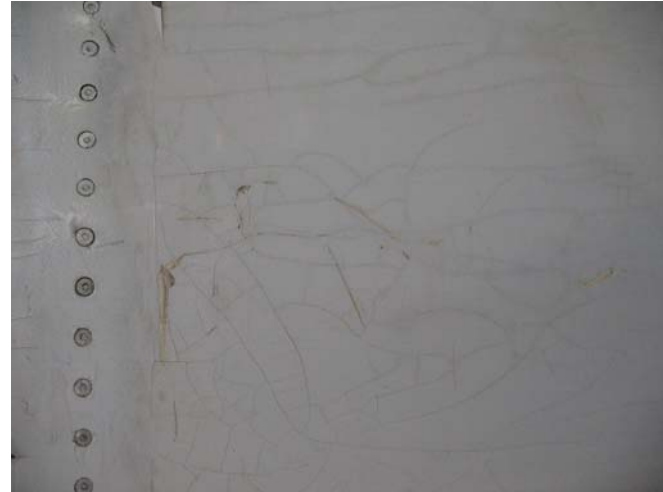
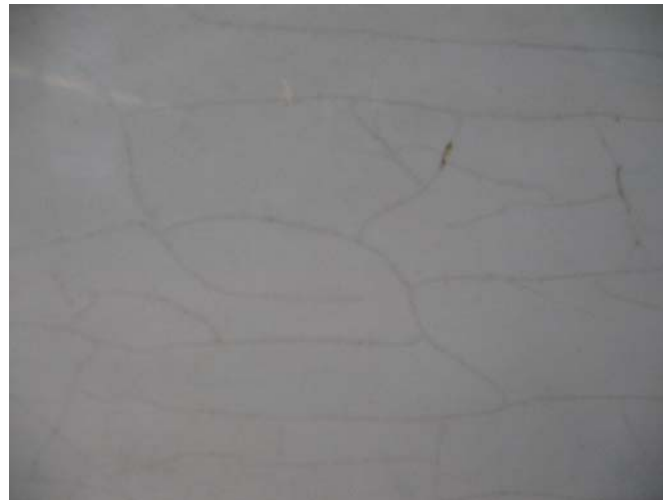
Surface protection

Cracks in the surface protection coat suggest structural damages which could result in a premature removal of the component.

Source of the cracks is not yet completely identified, but can be related to the excessive filler thickness or to a change in the paint flexibility by a chemical interaction with the composite resin hardener.

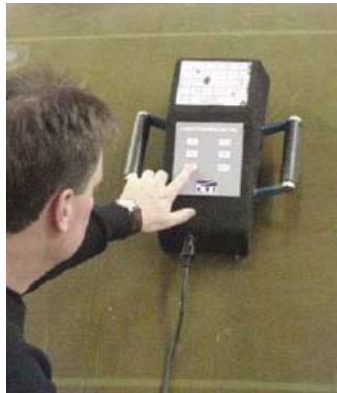
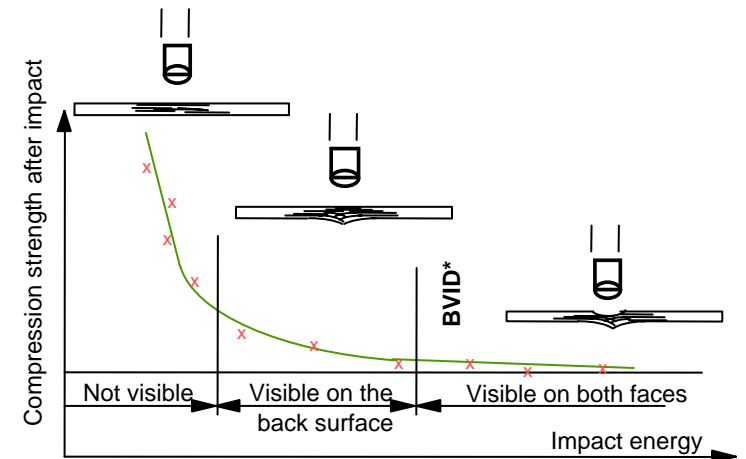
Many damages on composite structures are difficult to detect visually and / or require special trained technicians and special equipment to be detected.

- Fluid ingress on honeycomb sandwich components.
- Overheat on structures covered with heat insulation blankets.
- Lightning damage secondary effects.
- Barely visible impact damages (BVID).
