Service Experience With Early BCA Composite Applications

CACRC Workshop
May 9, 2007

Background **ACEE** 737 Composite HS Program

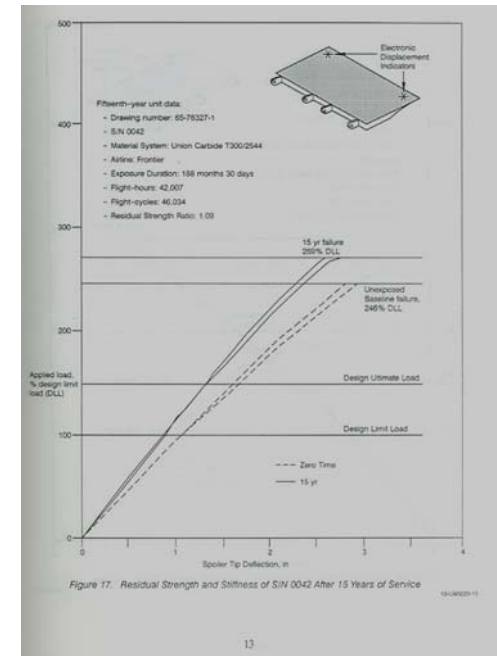
NASA 737 Flight Spoilers

- Approximately 160 units deployed to Aloha, Air New Zealand, Frontier, Lufthansa, Piedmont, and VASP. Several airlines also had ground racks with coupon specimens
- 3 Graphite epoxy systems and one graphite thermoplastic system
- All in-service units inspected annually by Boeing P.I. Three units removed from service each year and tested to destruction to demonstrate adequate strength and stiffness
- As of final tracking date, 6/30/1989, the fleet had 2,593,741 flight-hours and 3,499,941 landings
- High time unit had 42,007 hours
- Units with thermoplastic resin suffered from Skydrol® degradation; removed from service; promptly forgotten
- Remaining units with epoxy resin systems remained in service many years; some may be flying today

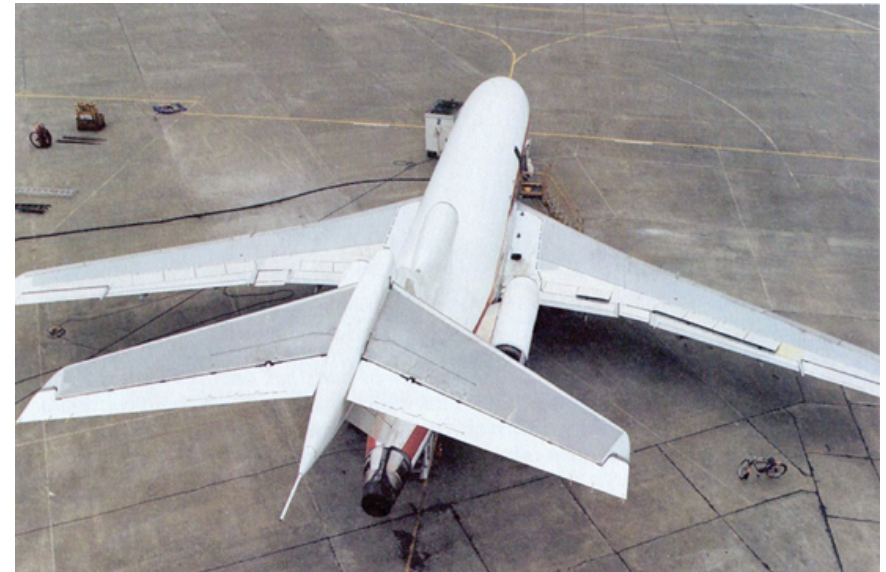
727 CFRP Elevator

- **5 shipsets built and certified / 4 placed in revenue service / one held as spares**
- **Performed well with original carrier until fleet sold in 2001**
- **Certification basis for these parts largely remains in place today**
- **I think of these as the “forgotten” components. (Bigger is better syndrome)**

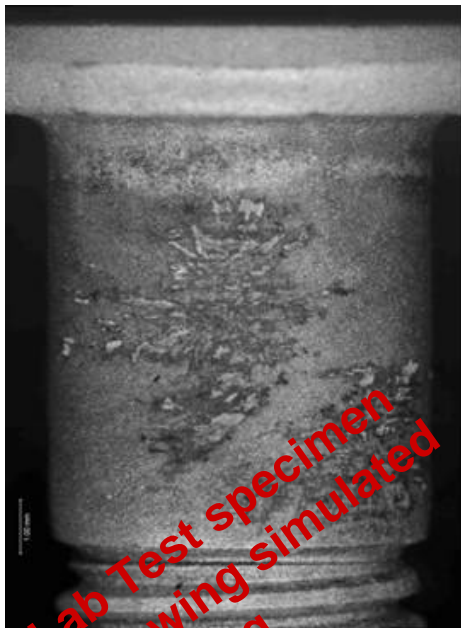
Lab Test specimen following simulated lightning strike
