Presented by  
Dr Roland Thévenin  
Senior Expert Composite  
Structure Conformance

# ***Airbus Composite Structures***

## ***Perspectives on safe maintenance practice***

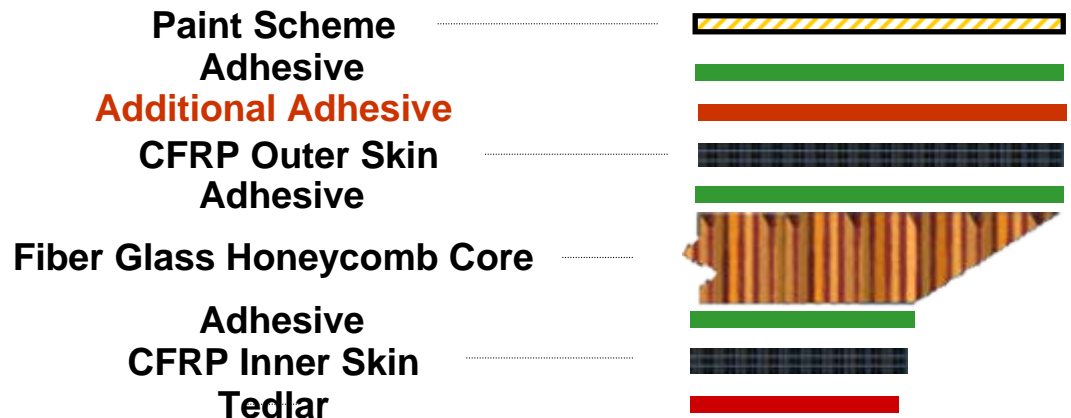
### Post-mod

## Improvements

- In production

- By adding one adhesive film
- Systematic Water Leak Test

- SB A320- 55-1024

- 1 time thermography inspection mandatory at 10 Years
- Re-protection with 1 additional layer of pore filler and new paint
- All completed in 2002

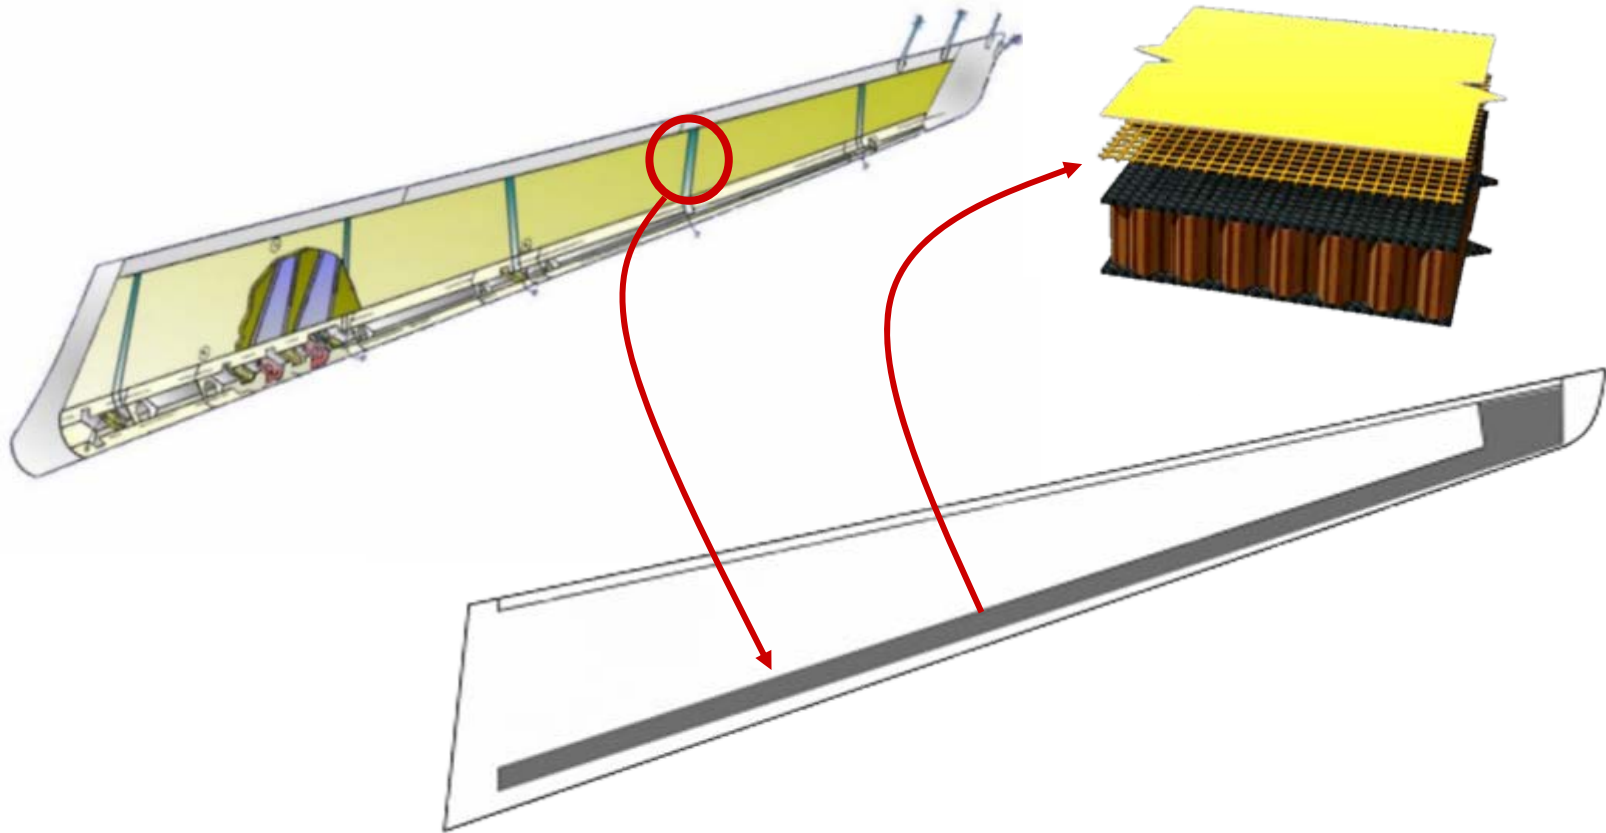
- **Bonding straps replaced by mesh**

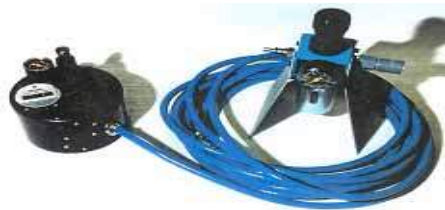
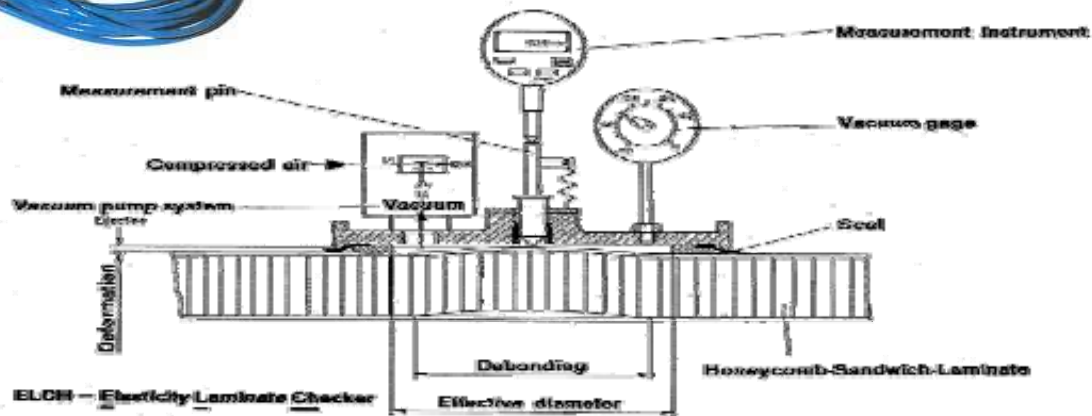
- Principle : vacuum based tool:

- Check for no stiffness changes
- Allows checking correct skin bonding condition (inner not directly accessible)
