FAA Workshop for Composite Damage Tolerance & Maintenance in Tokyo 2009

Ralf Hilgers Composite Structure

Substantiation of Damage Growth within Sandwich Structures

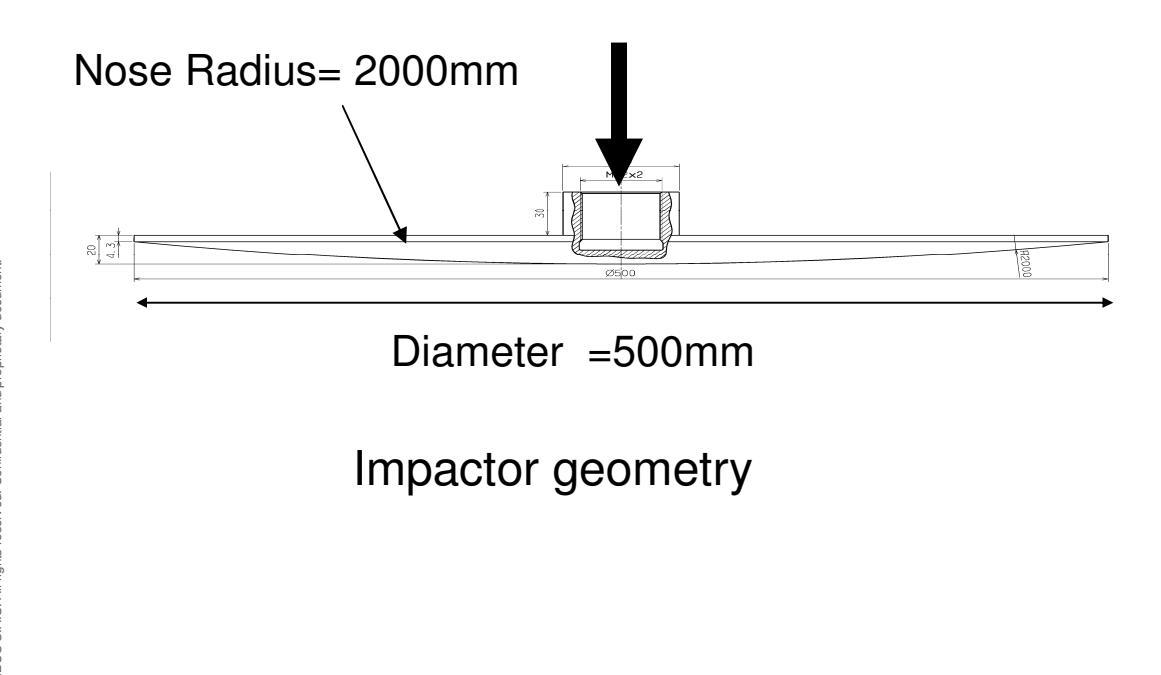
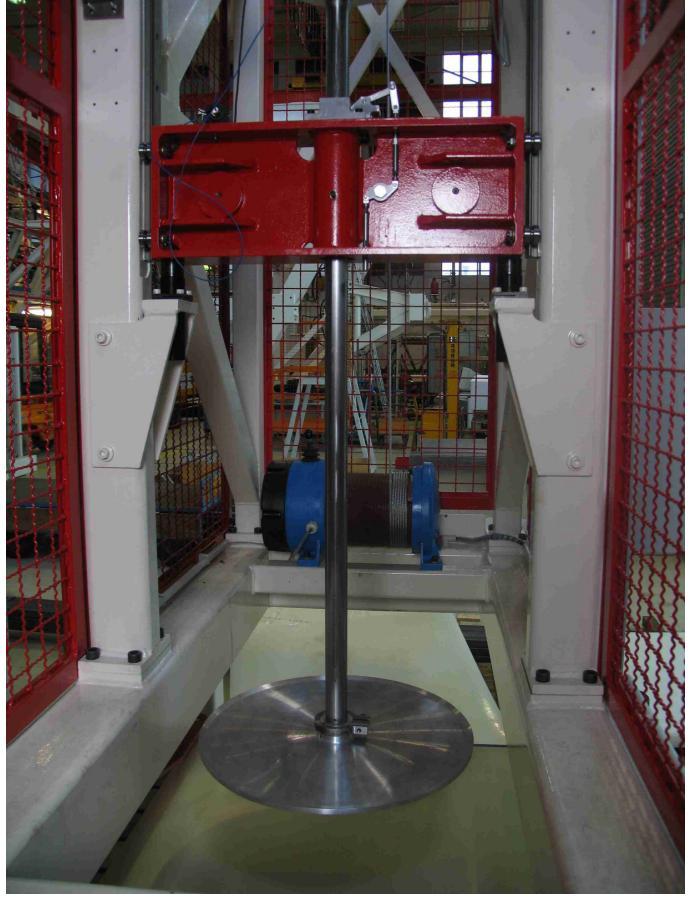
Source of damage \rightarrow Large blunt impact damages

- Energy levels: 200 and 300J
- Low velocity impacts

The blunt impact test on both panel configurations revealed that hidden disbond or core fracture does not occur.

Subsequent ground-air ground cycling showed no disbond initiation

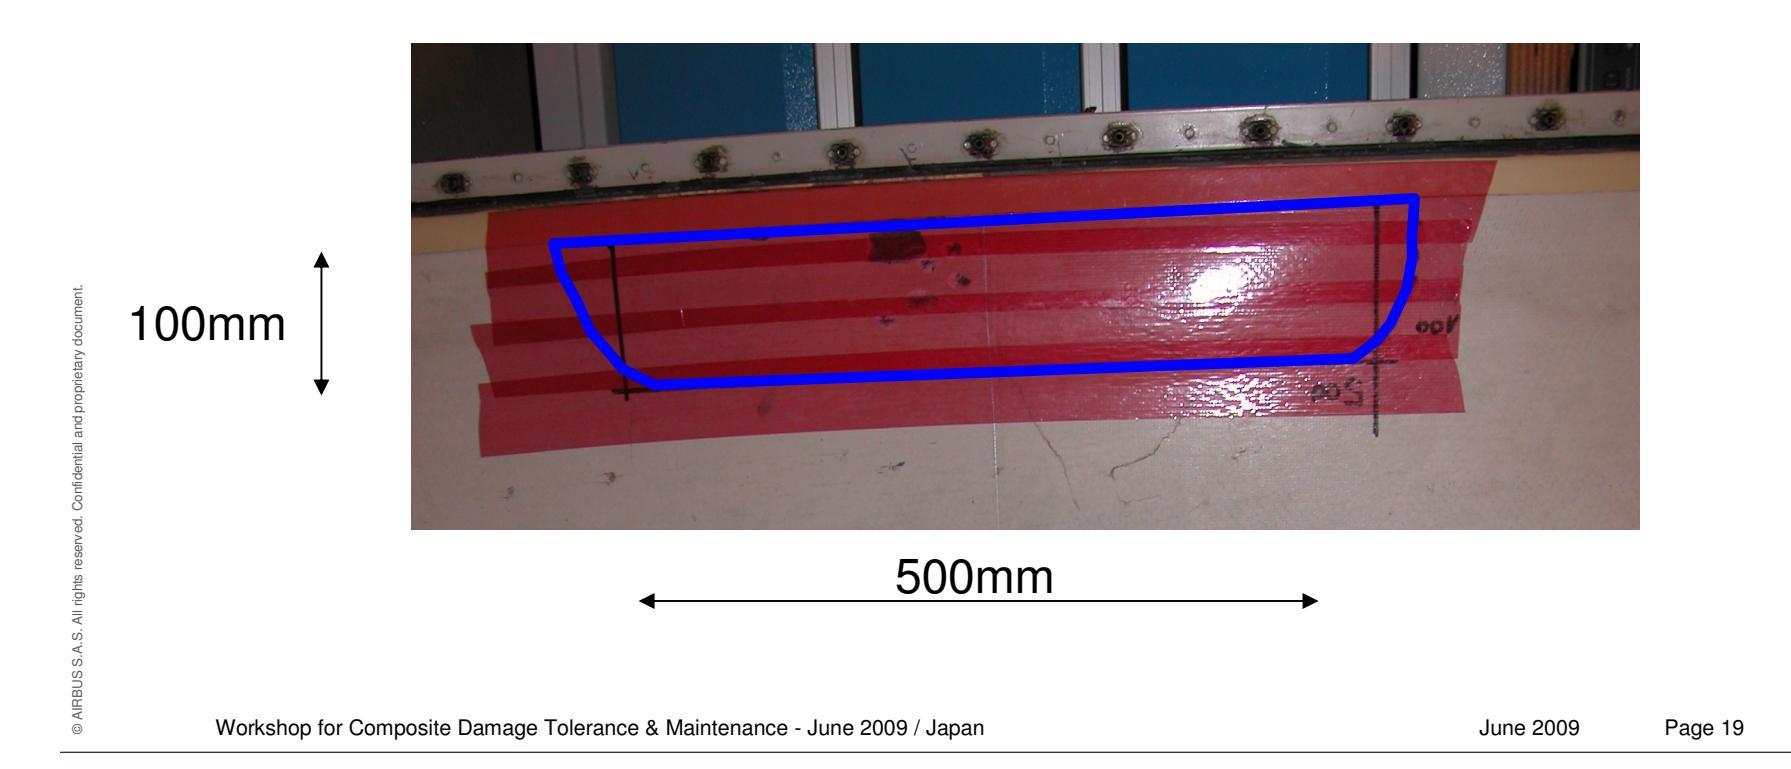
Sandwich panel propagation test

- A face-sheet to core separation of 500x100mm was introduced in a sandwich panel.
- The vacuum chamber pressure was decreased from ambient pressure (P=1000mbar) down to 200mbar in 20minutes.

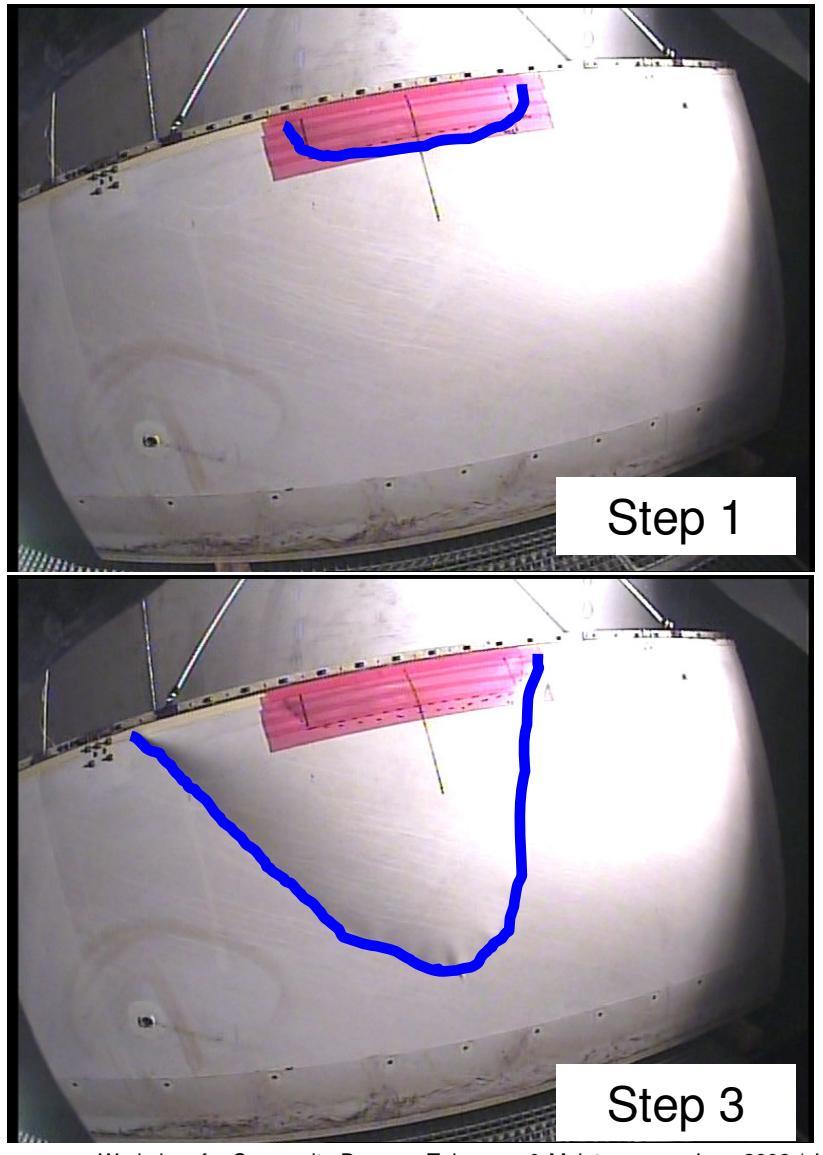
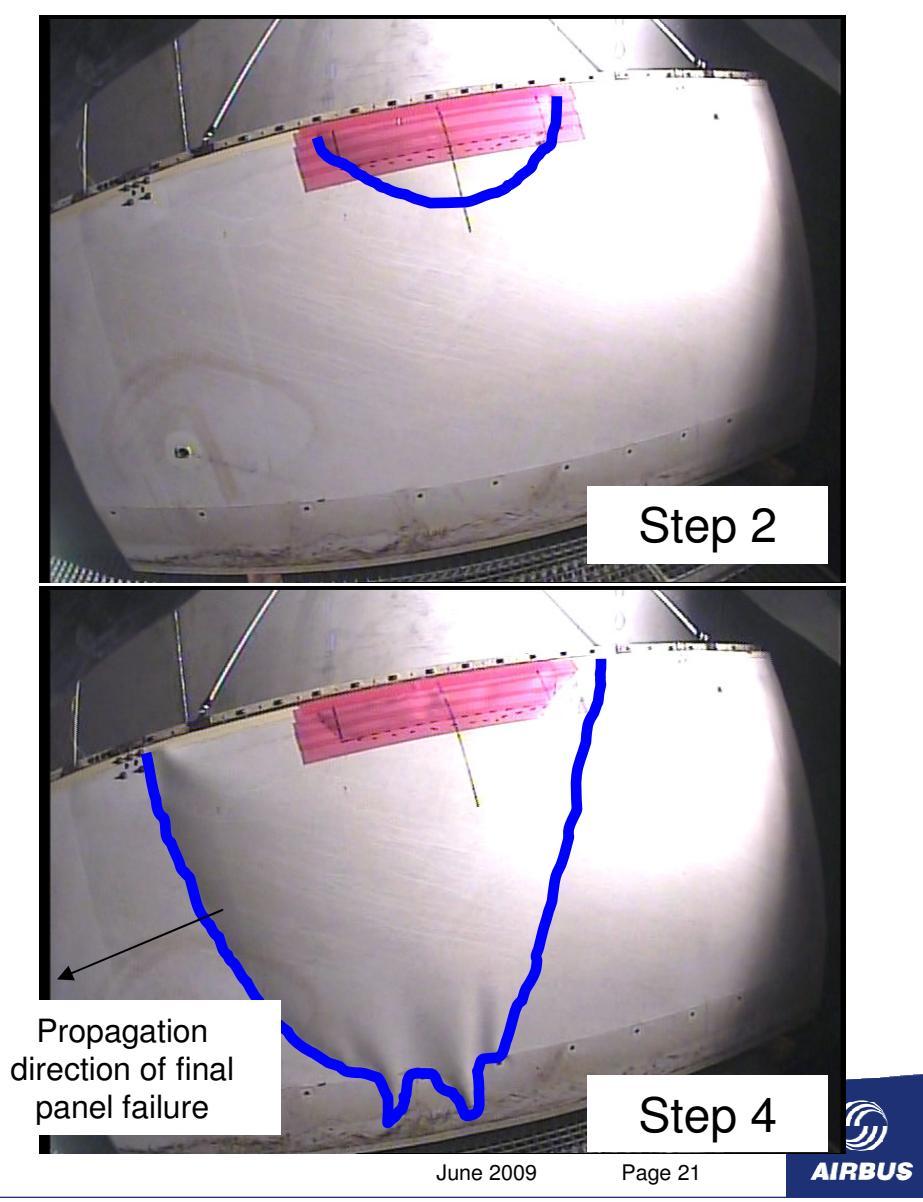
Test results (Extract from video clip)

The chamber pressure and pressure inside the core vs. time indicates several disbond propagation steps, before the complete panel fails at $p_{ambient}=240$ mbar.

Pressure inside core \rightarrow stepwise decrease \rightarrow damage propagation [2 – 5]

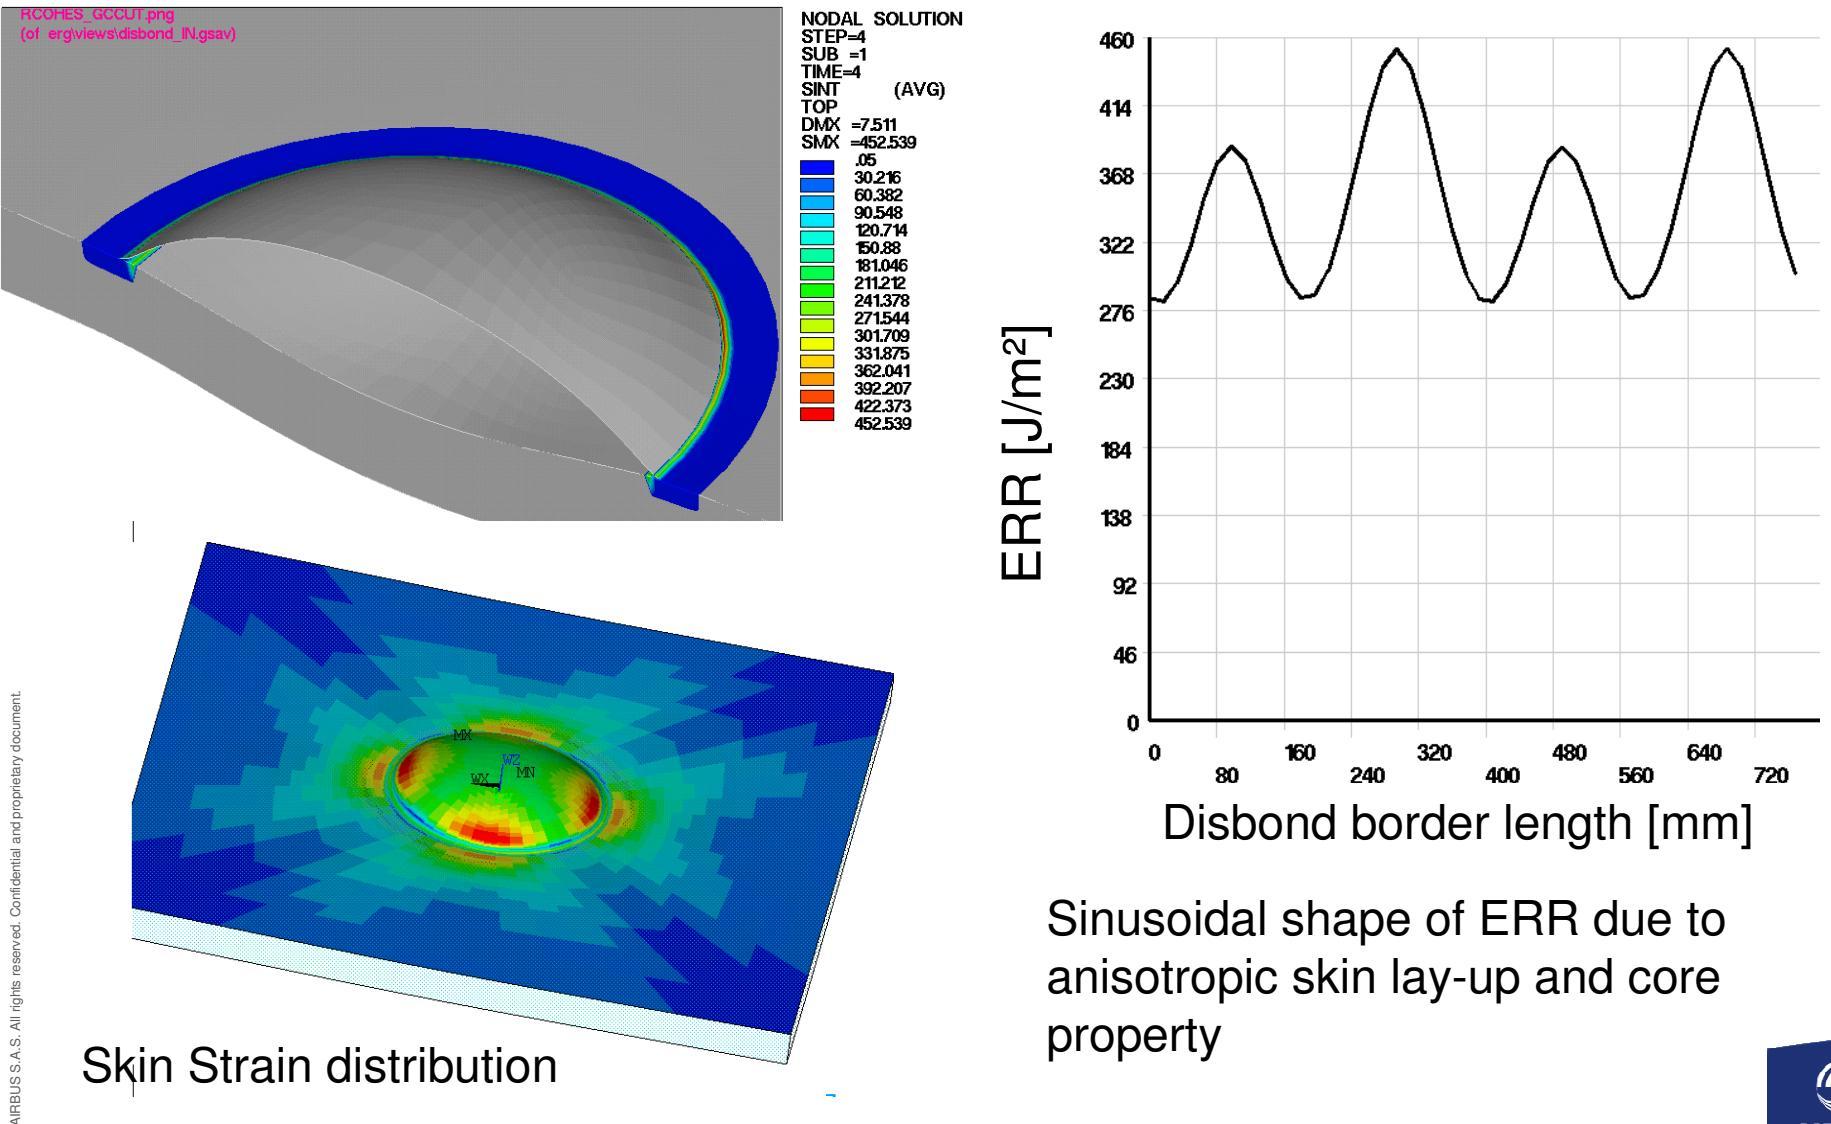
Energy release rate ERR [J/m²] along disbond border

- Cohesive interface element adequate to simulate disbond propagation
- G1C- and G2C-relevant parameter variation confirmed disbond propagation is mode I tension domination
- Criticality of individual disbond sizes and location on ground-air-ground effect can be demonstrated
- FE Analysis revealed that disbond propagation is mainly due to ground-airground effect.
- In undisturbed areas the combination with aerodynamic loading showed an influence of 10% on the ERR
- FE Analysis assume constant G1C value over complete panel
- Prediction of disbond propagation onset validated by test

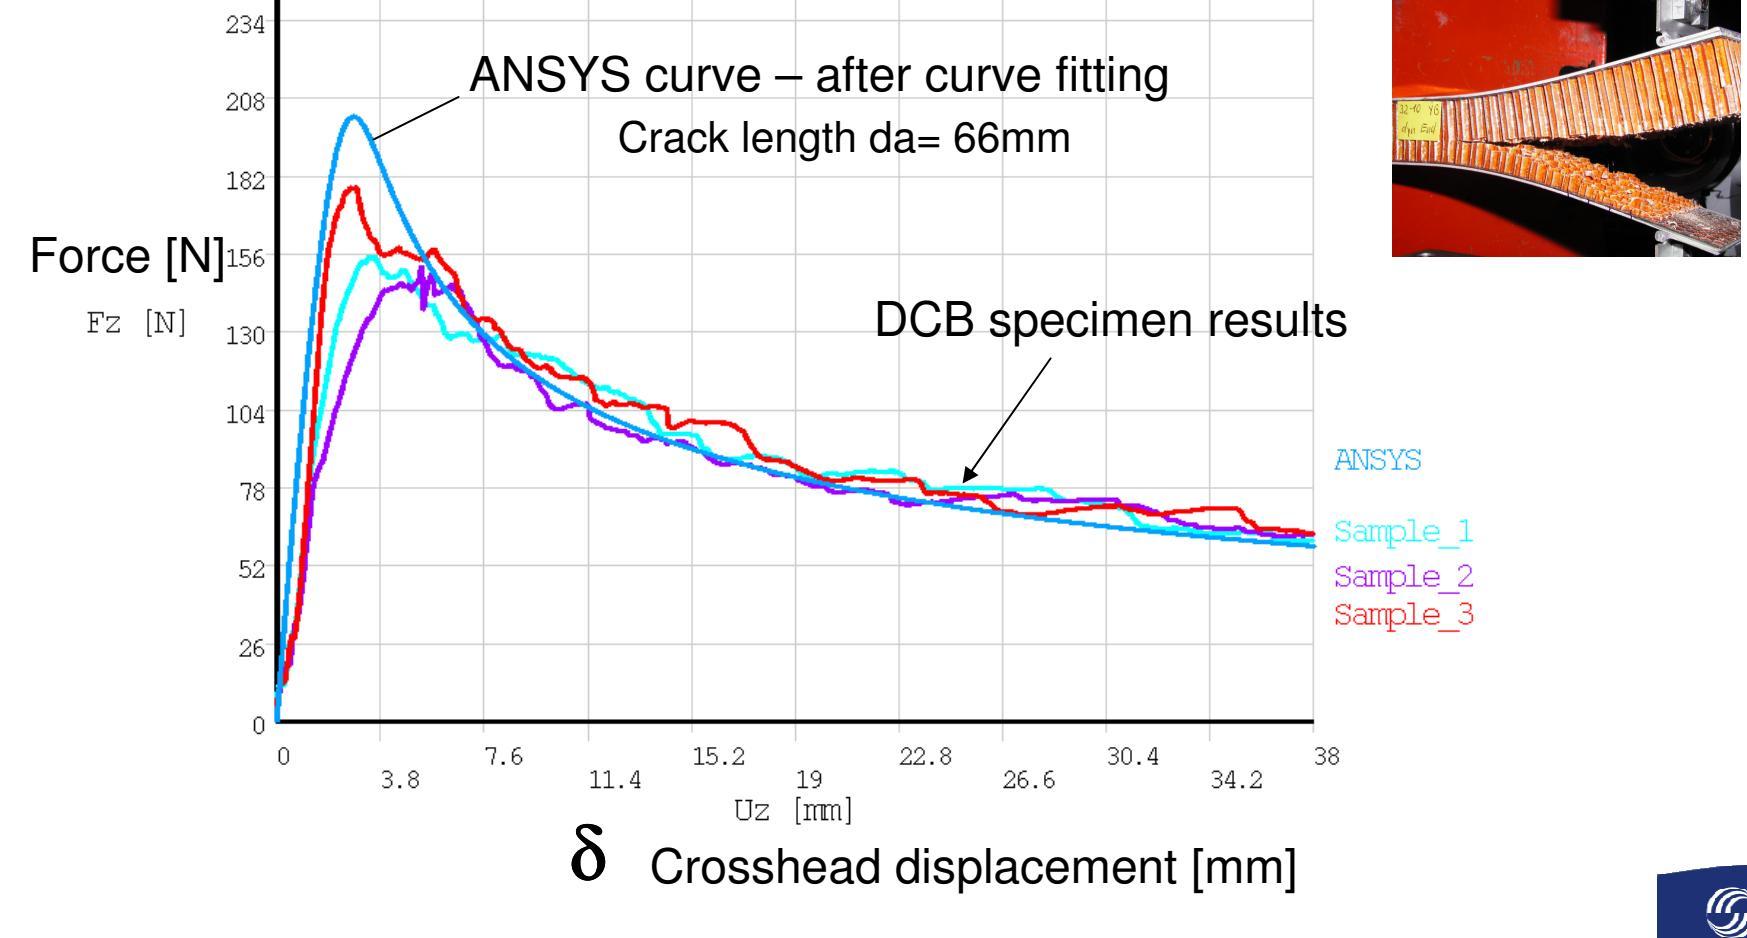
DCB specimen test results vs. analysis

- Cohesive interface element properties fitted with FWT- and G1C- test results
- Analysis showed good correlation with test results

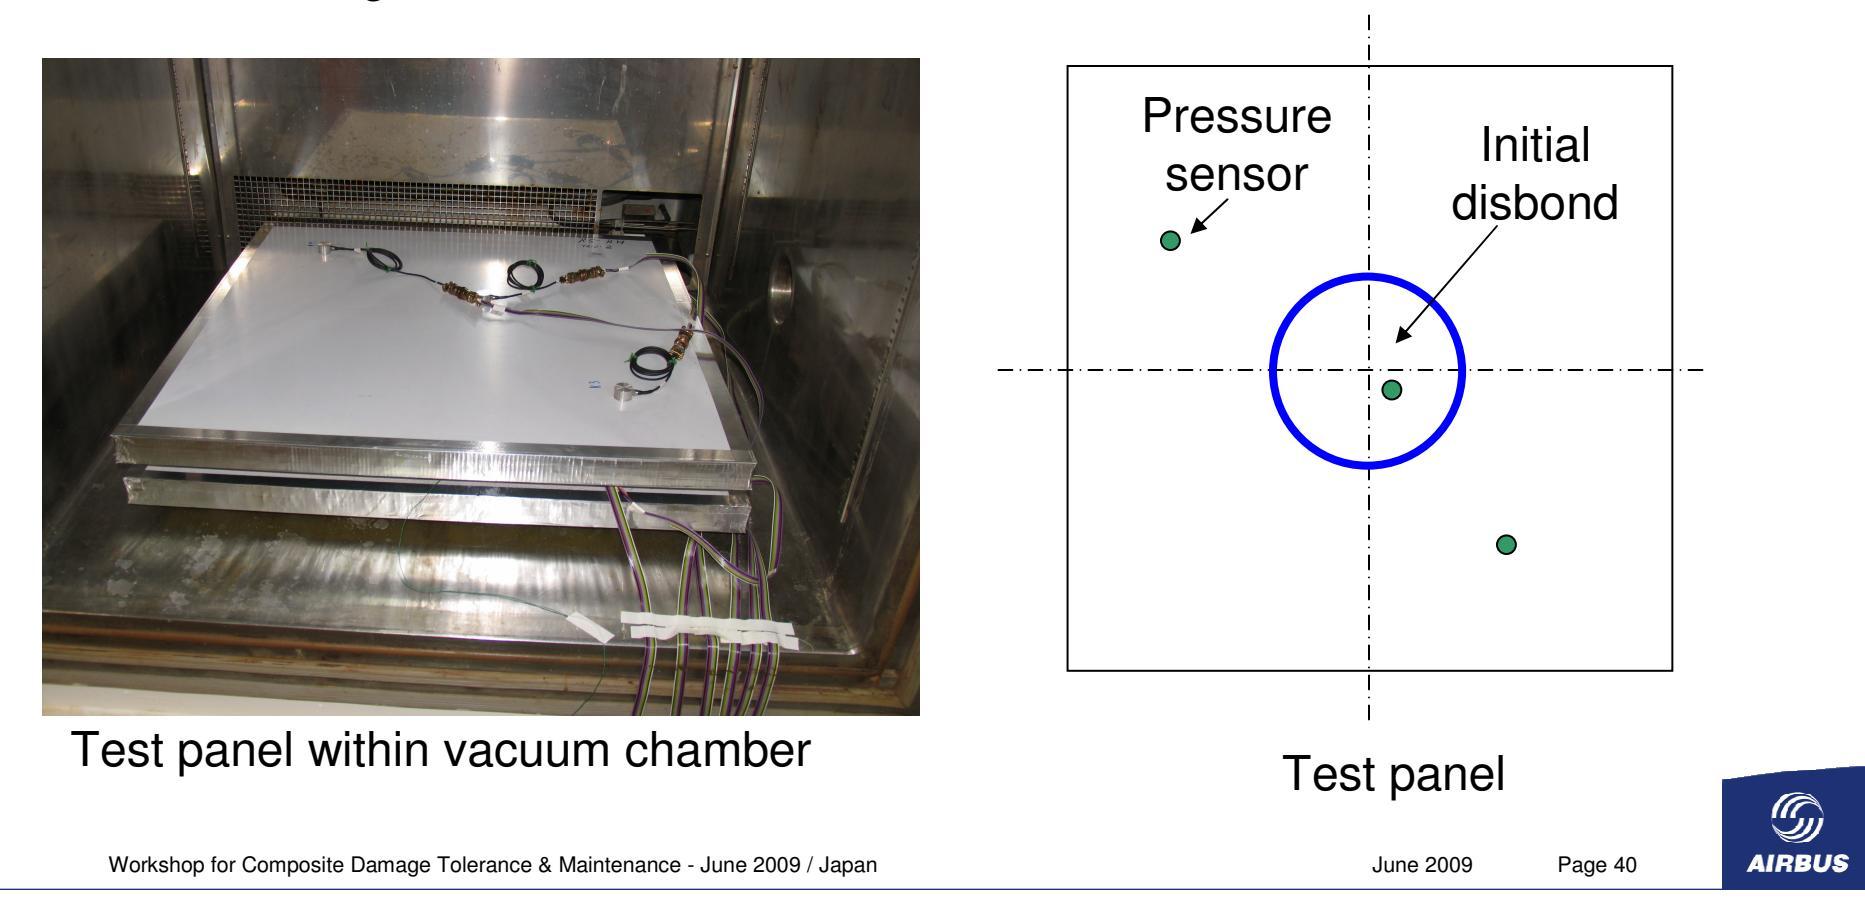
Sandwich panel tests including circular disbonds

■Sandwich panel with different face-sheet to core separation were tested in a vacuum chamber at RT and T=-55 $^{\circ}$ C to demonstrate disbond propagation.

Chamber pressure and the pressure inside the core underneath the disbond measured during test
