Presented by
Dr Roland Thévenin
Senior Expert Composite
Structure Conformance

FAA Workshop for Composite Damage Tolerance and Maintenance
June 4-5, 2009
Tokyo

Flight Control Sandwich Structures and Inspections

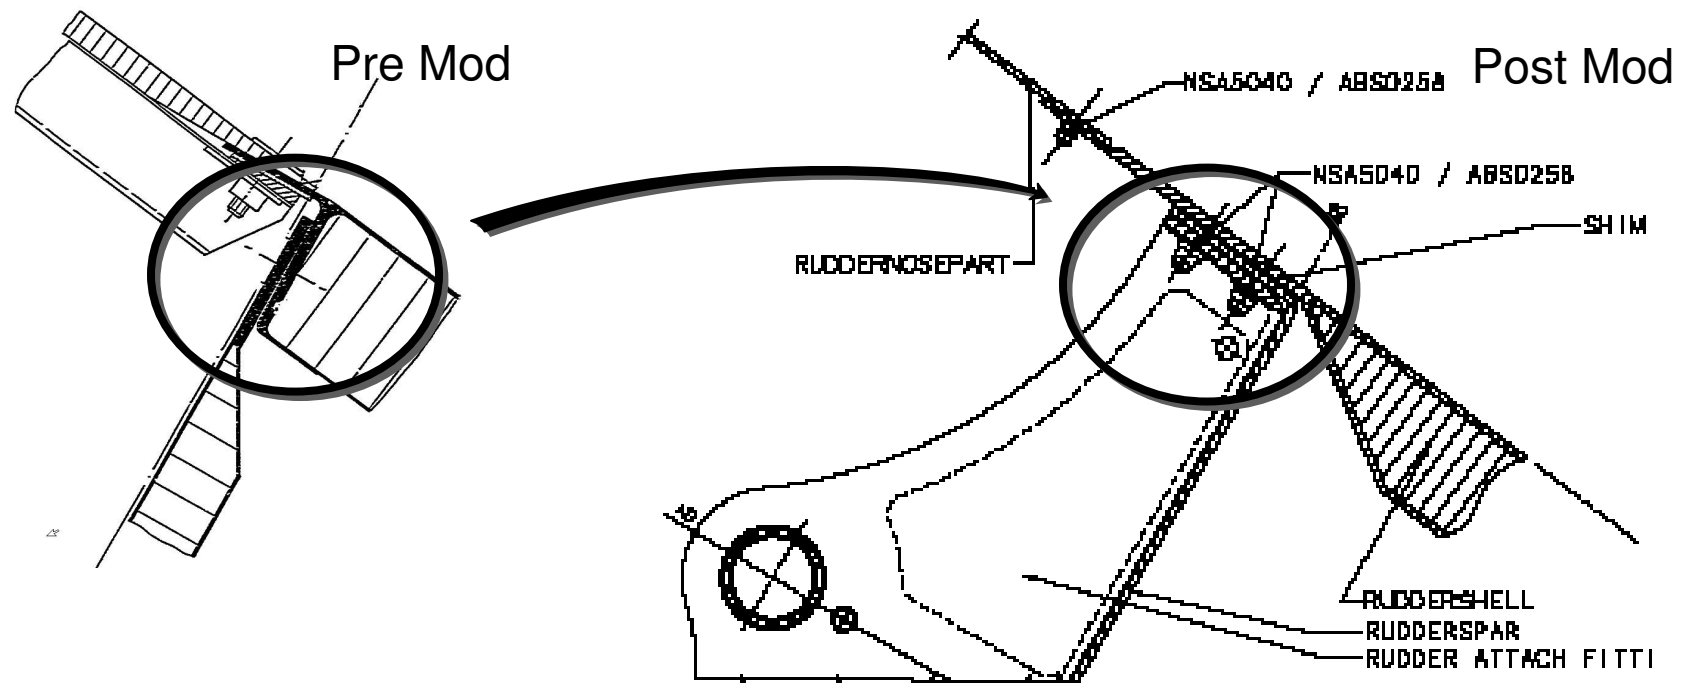
► Mod 8827

Panels (Skin and Spar) are attached through monolithic area

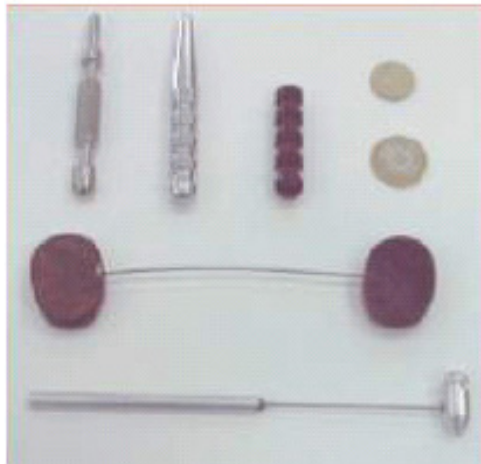
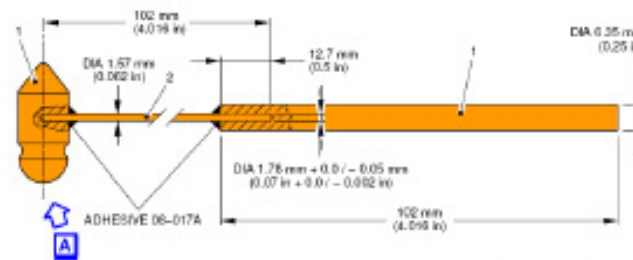
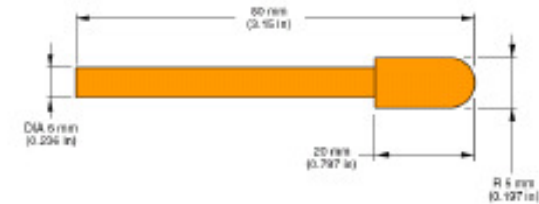
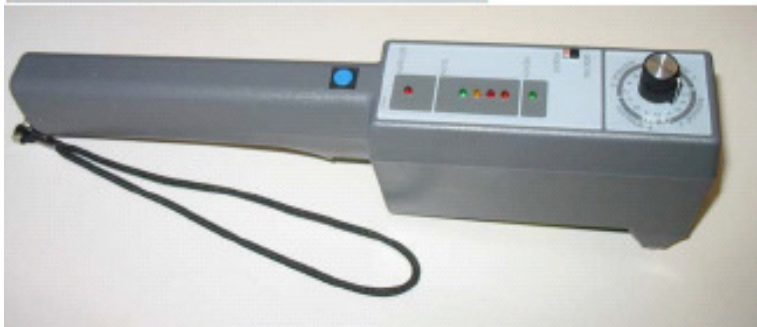
Manual Tap Test

► Detection of Outer skin debonding

- Min. detectable damage size: 25x25mm depending on sandwich configuration (face sheet thickness up to 1.8mm)

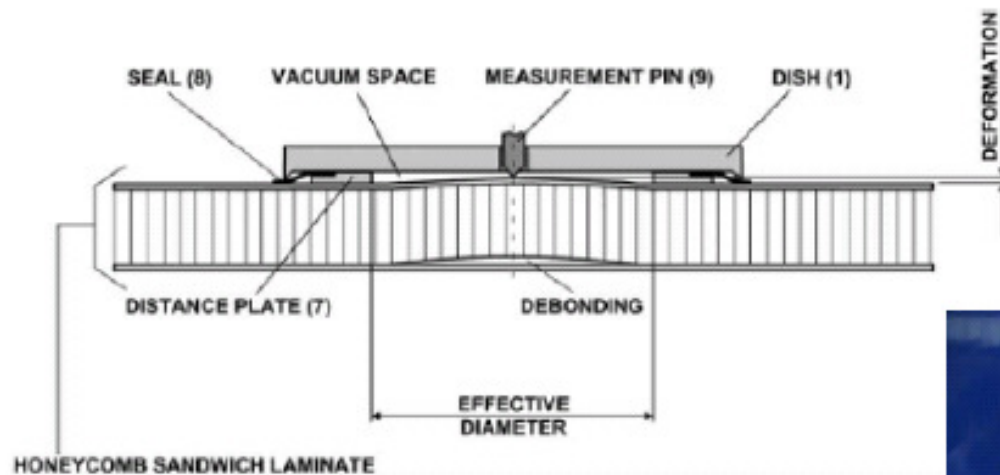
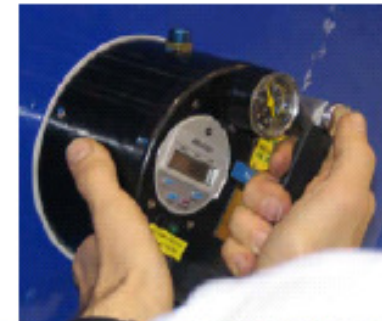
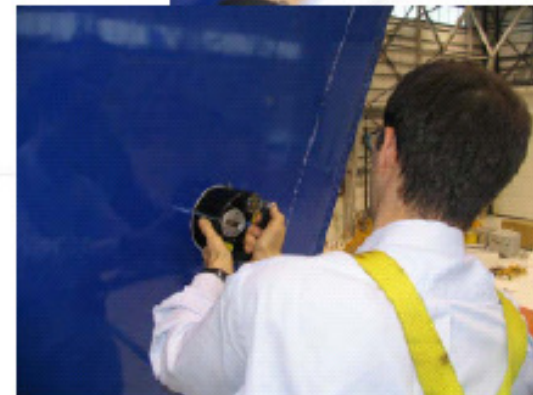
ELCH (Elasticity Laminate CHecker)

▶ Detection of Outer and inner skin debonding and core fracture

- Min. detectable damage size: $D=100\text{mm}$ depending on sandwich configuration (face sheet thickness and core height, density)
- The test unit operates to the principle of deformation measurement of a sandwich structure under vacuum

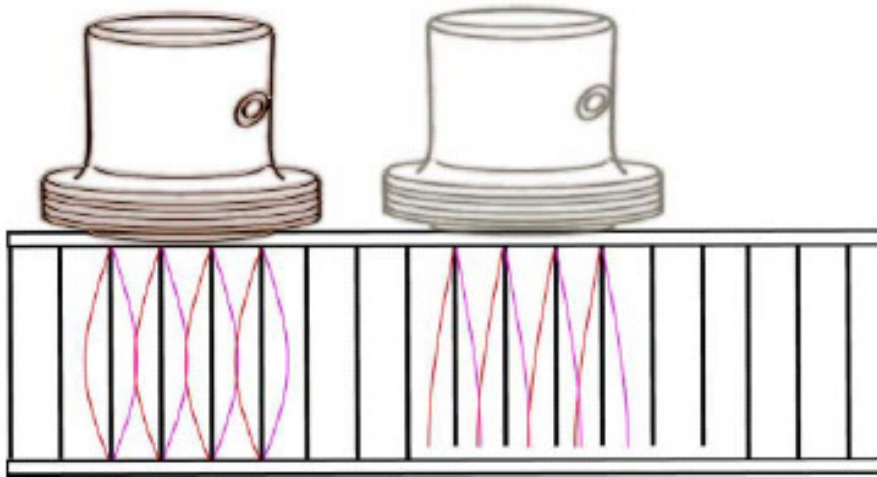
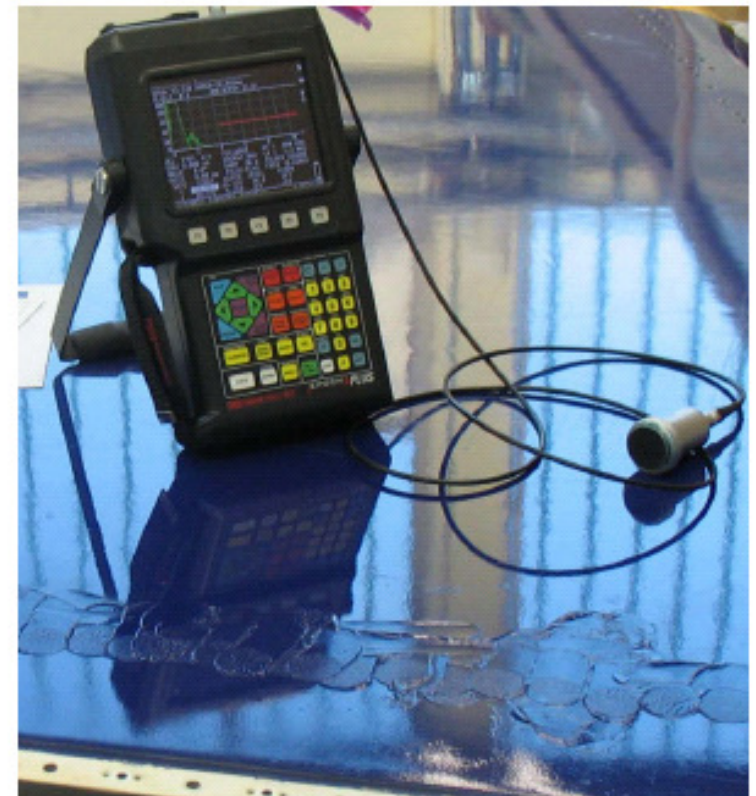
Ultra Sound

► Detection of debonding, core fracture and fluids

- Min. detectable damage size: 40x40mm
- The UT Procedure uses kind of guided wave. System must be tuned to core height (membrane length = $\frac{1}{2} \lambda$)

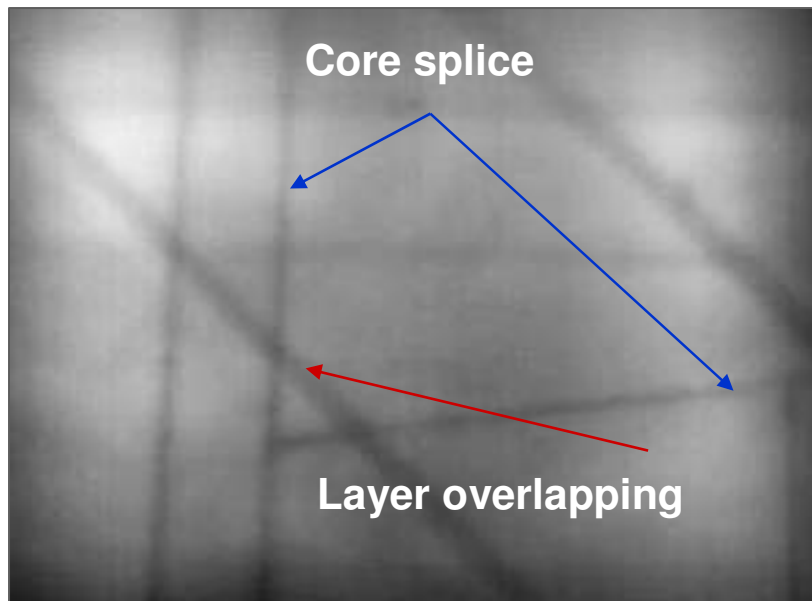
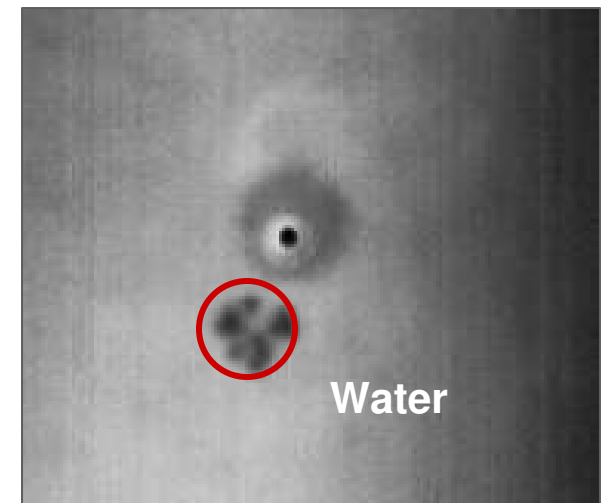
Thermography

► Detection of fluids

- By measurement of temperatures difference on the surface, following thermal excitation with hot air gun.
- Performance
 - Few millimeter Penetration
 - Honeycomb cells containing more than 50% of trapped fluid per cell in areas equal to or greater than 100 mm² in size.
