Lessons Learned from CACRC Depot Bonded Repair Round Robin Investigation

Dr. John Tomblin and Dr. Lamia Salah
NIAR/ WSU

September 15th, 2015

CACRC Depot Bonded Repair Investigation

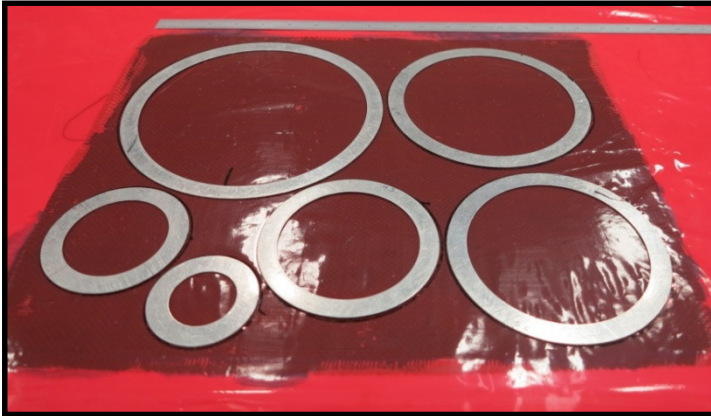
Wet lay-up ply impregnation

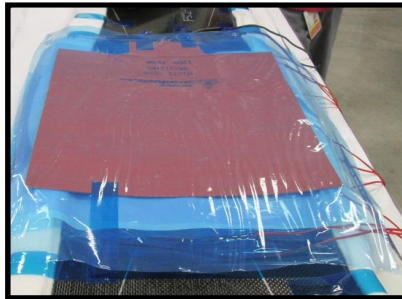
Repair panel cure
