CACRC AE-27 Guidebook: Design of Durable Aircraft Composites: Problems with Sandwich Structure

Eric Chesmar, United Airlines

17 May 2011

# AE-27: Design of Durable, Repairable and Maintainable Aircraft Composites

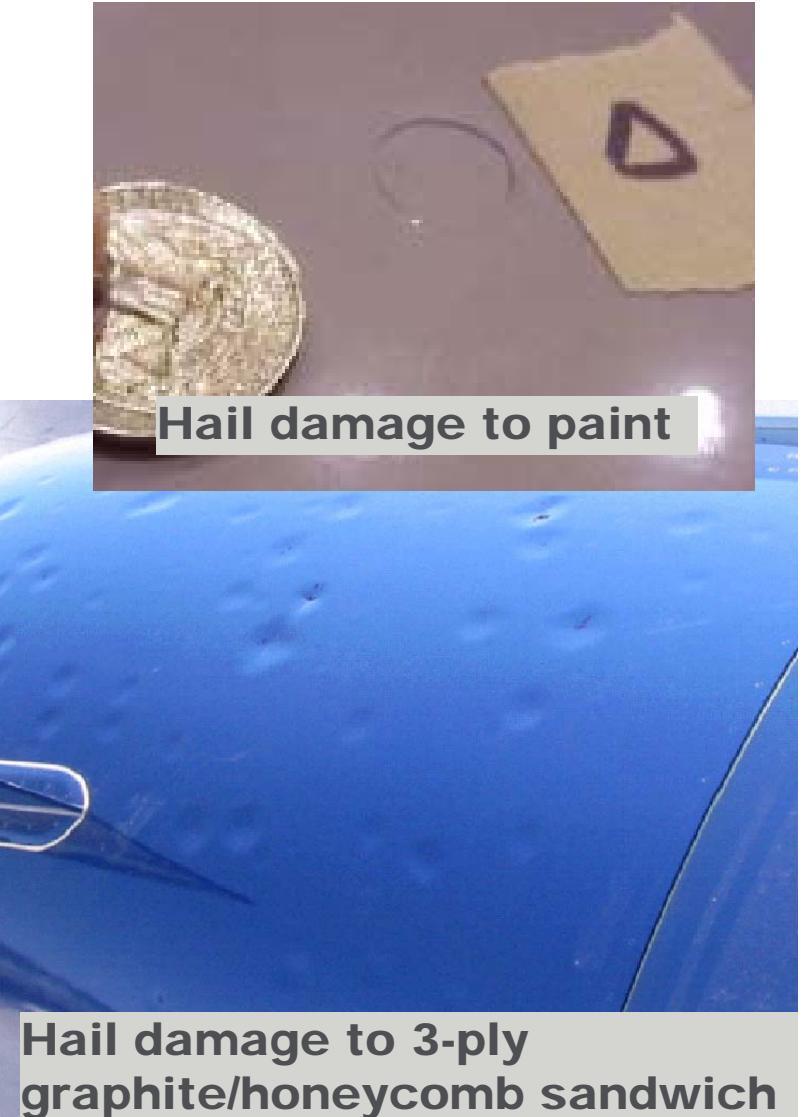
#### Impact Resistance – Hail:

## Evaluation, Allowable damage and repairability:

- Requires significant time just to evaluate. Consider there may only be cracked or delaminated paint.
- If beyond or not covered SRM, to get approval from OEM, the evaluations must be transferred to maps. Time increases ten-fold.

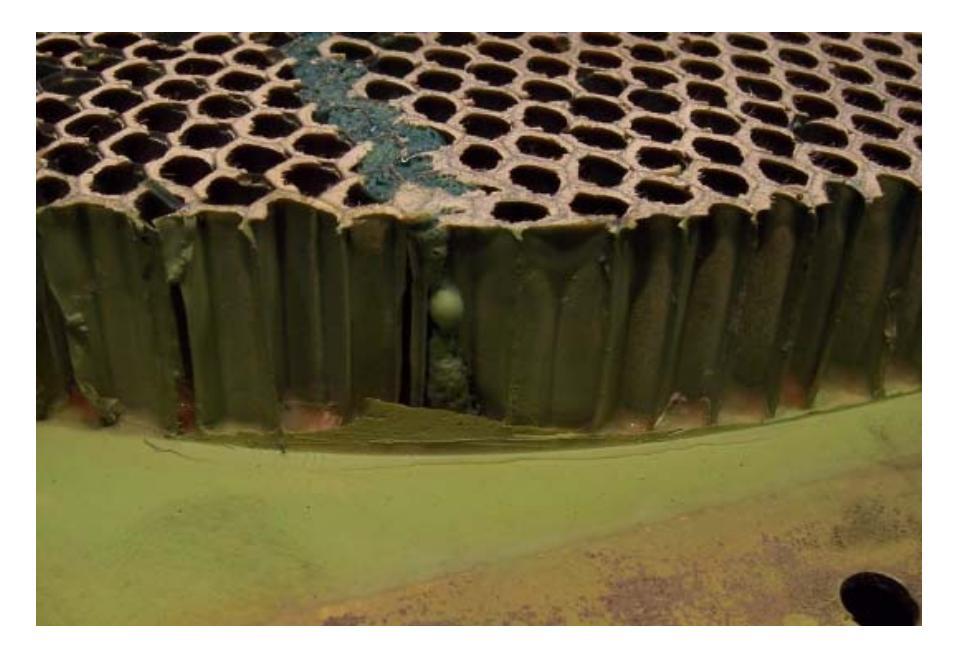
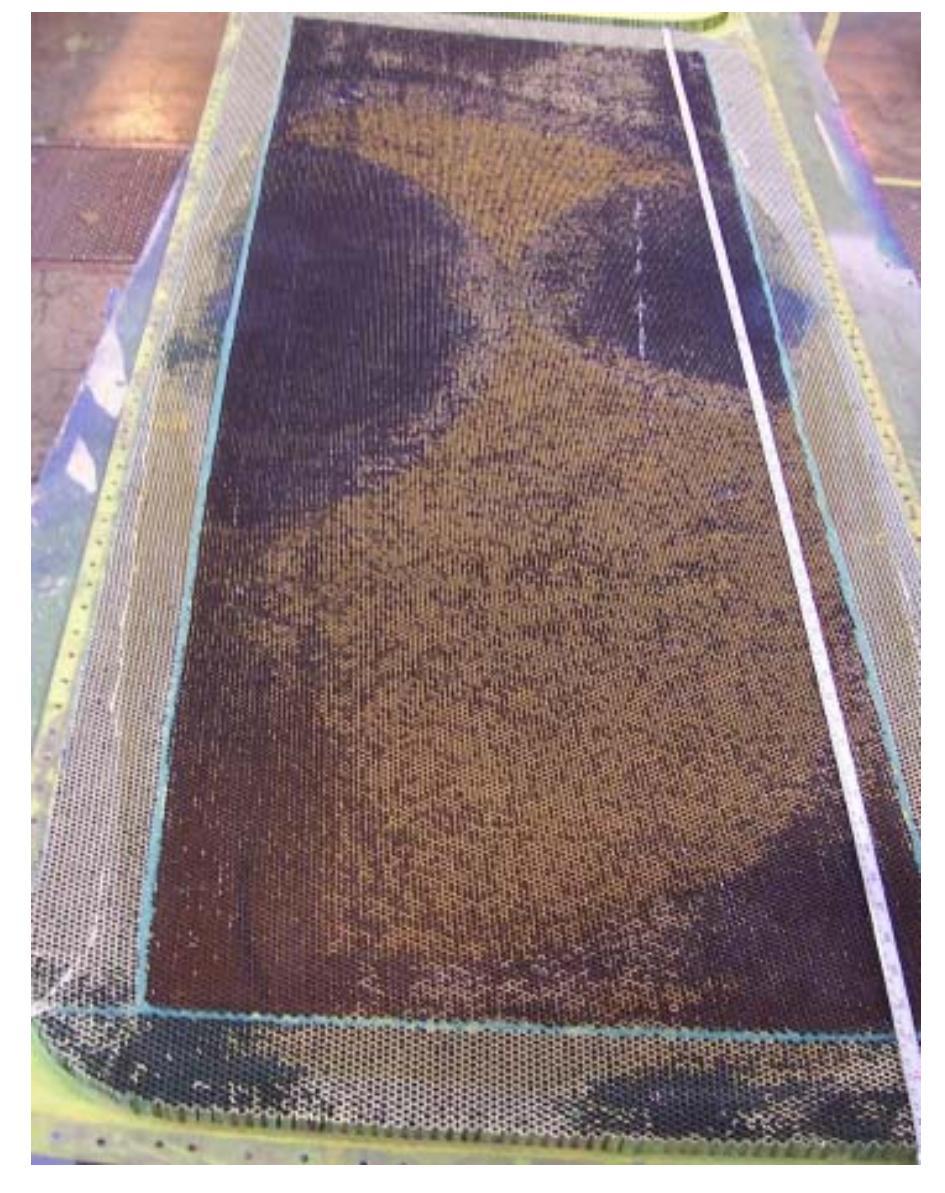
#### Fluid Ingression:

- Square-edged panel close-out
  - Porous Foaming adhesive
  - Film adhesive bondline
  - Alum honeycomb edges painted with primer
  - Alum honeycomb corrodes

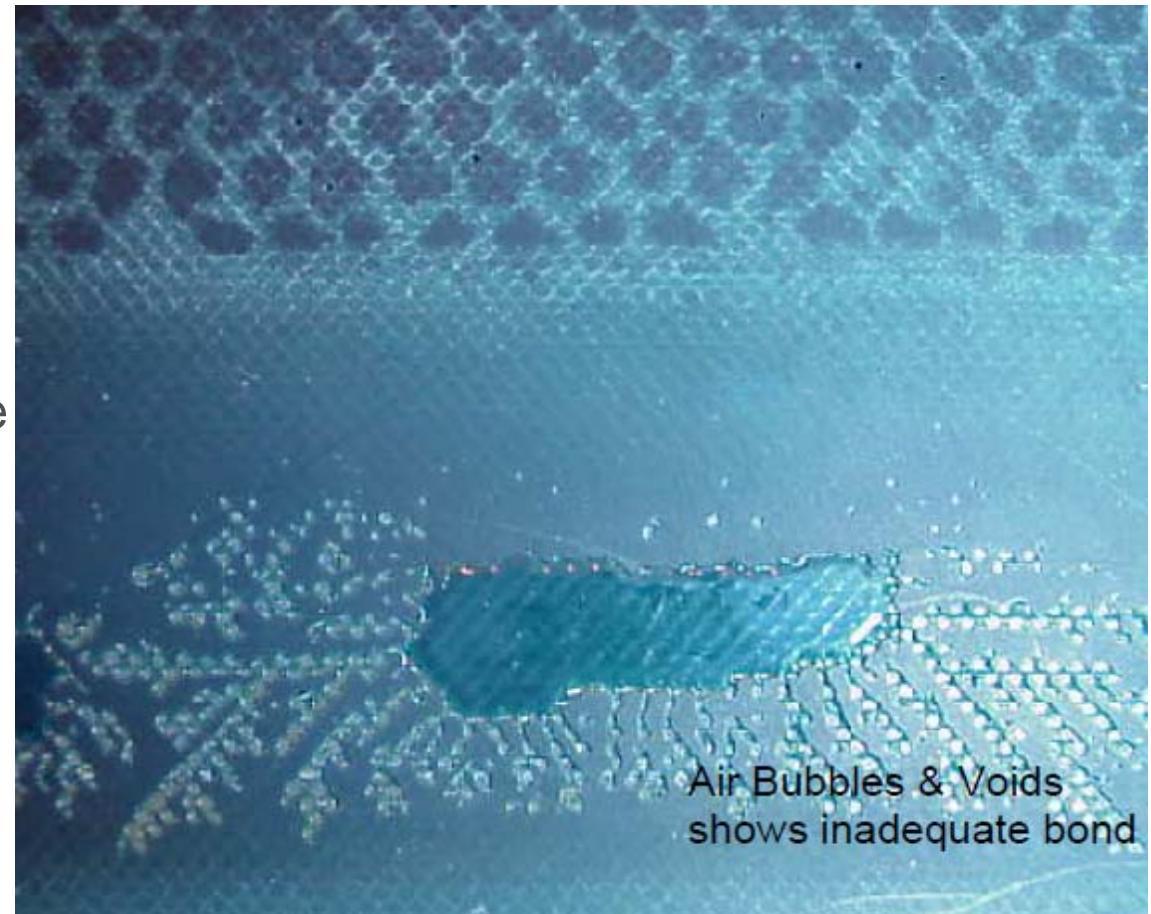
Vacuum-bag metalbond repair

#### Fluid Ingression:

Water progression/propagation (continued)

- Through film adhesive
  - Along scrim/carrier
  - Gaps due to poor fit-up core and skins

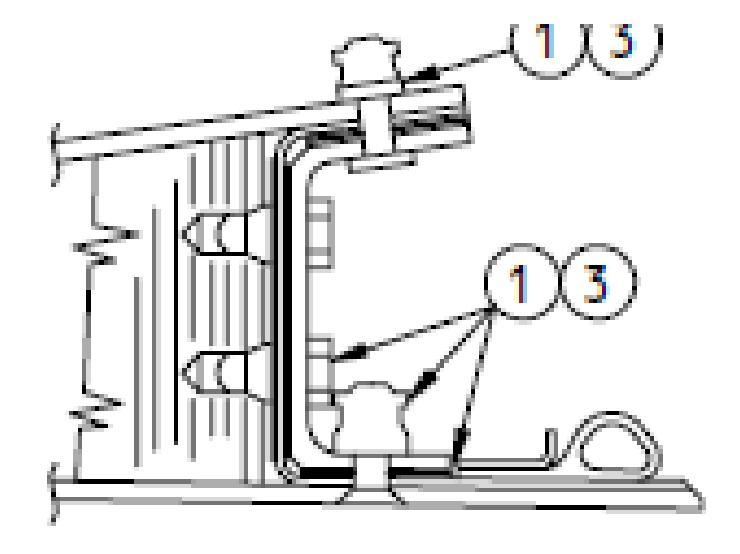
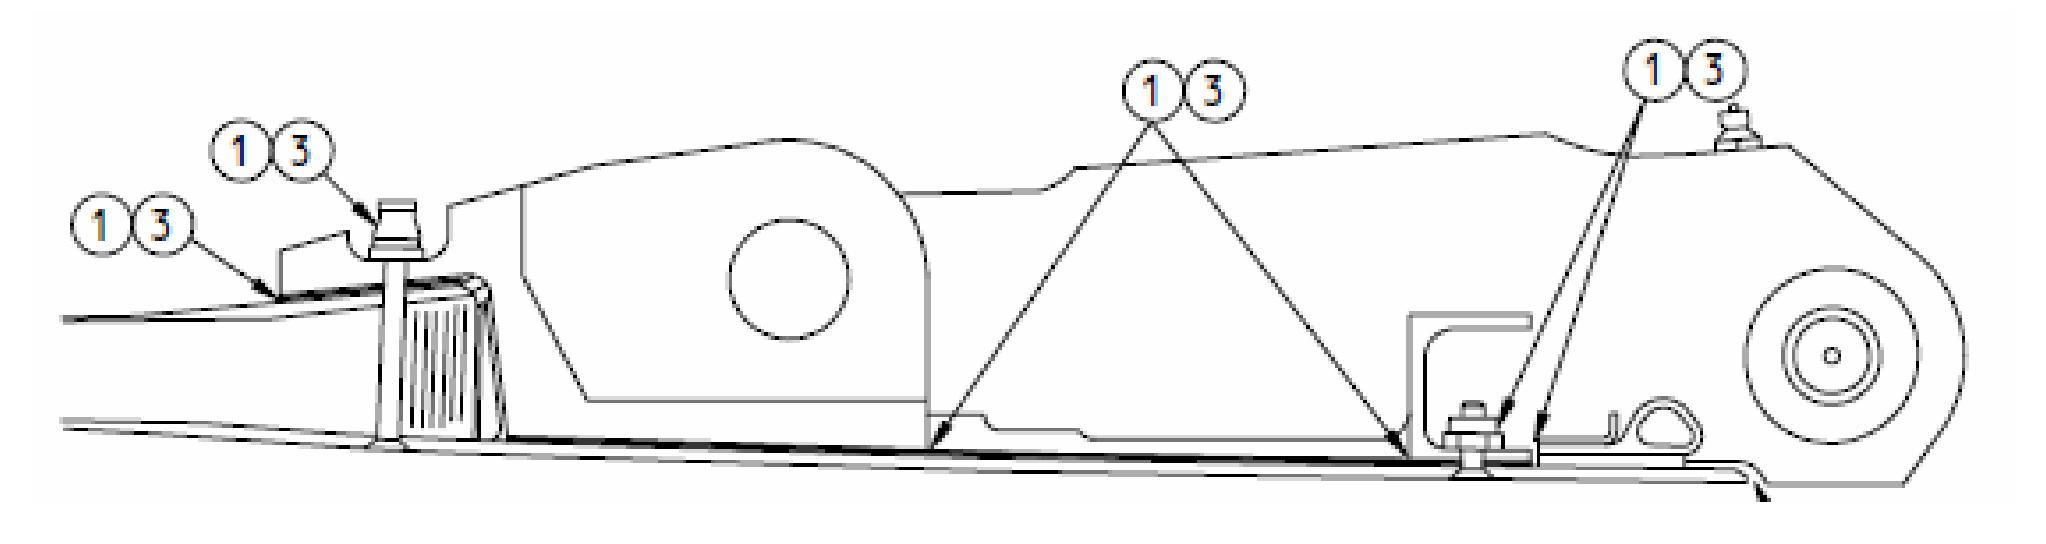
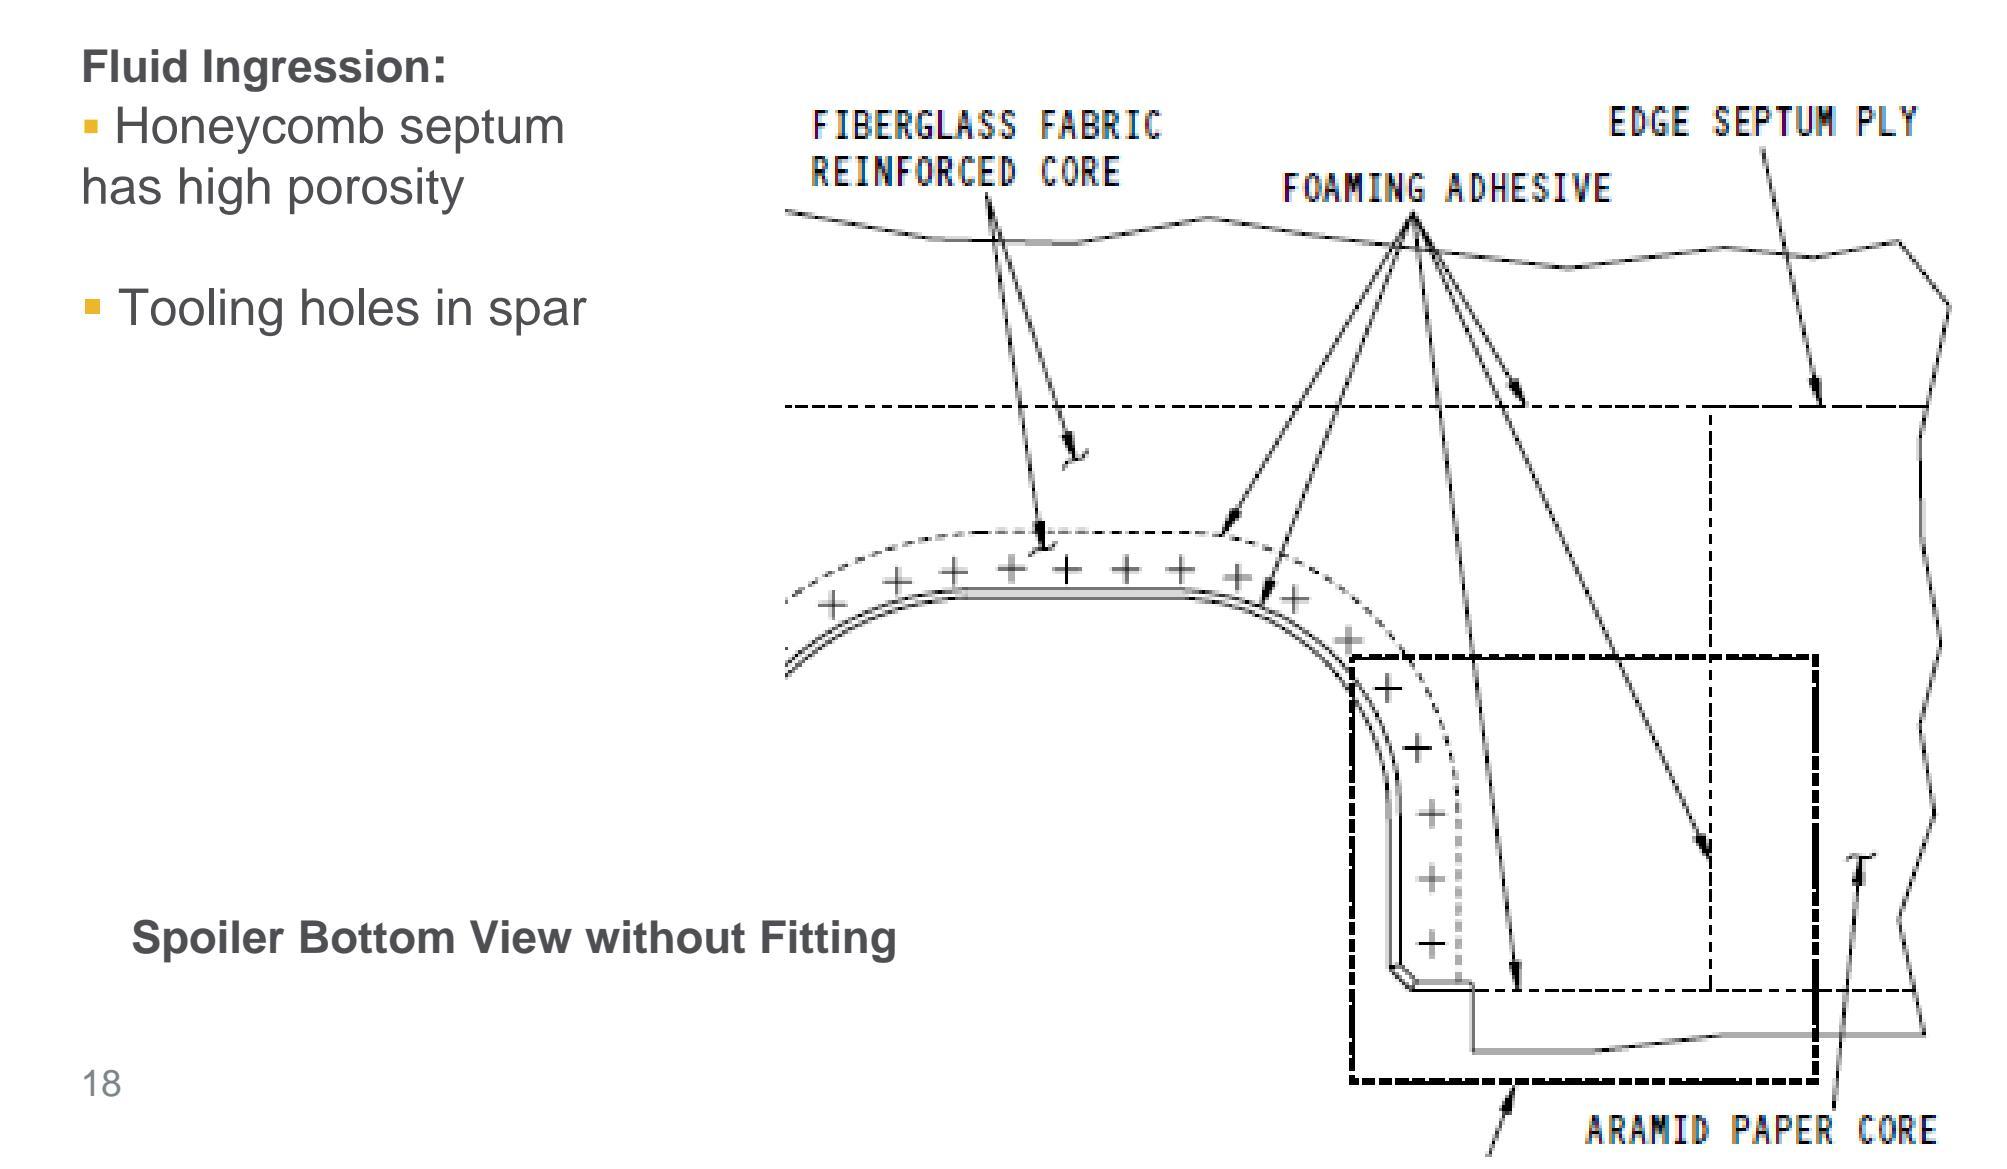
#### Fluid Ingression:

- Fasteners through skin into core
- Porous Foaming Adhesive or potting porous so acts as water path
- Honeycomb splices and cavities not completely filled

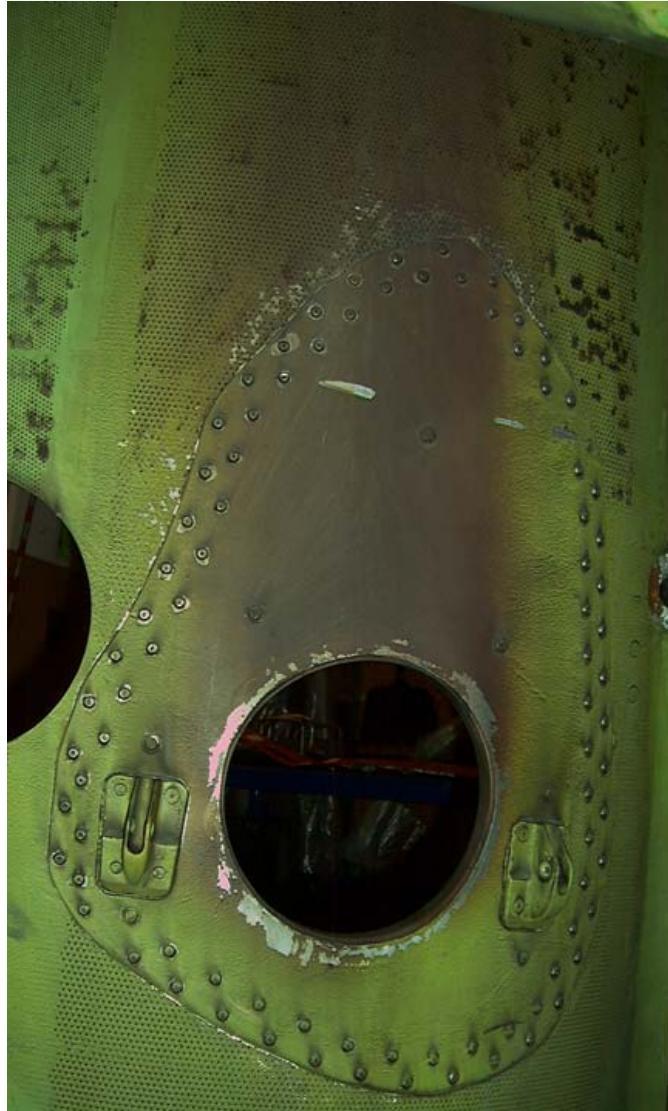
#### **Overheating:**

- Engine cowls
  - Heat due to normal engine exhaust on pylon panels above and aft of tail cone
  - Actual in-service temperatures and heat higher than design. Example: Accessory compartment hotter due to engine core temperature
  - Heat due to failed valves in openposition
  - Heat from bleed air exhaust

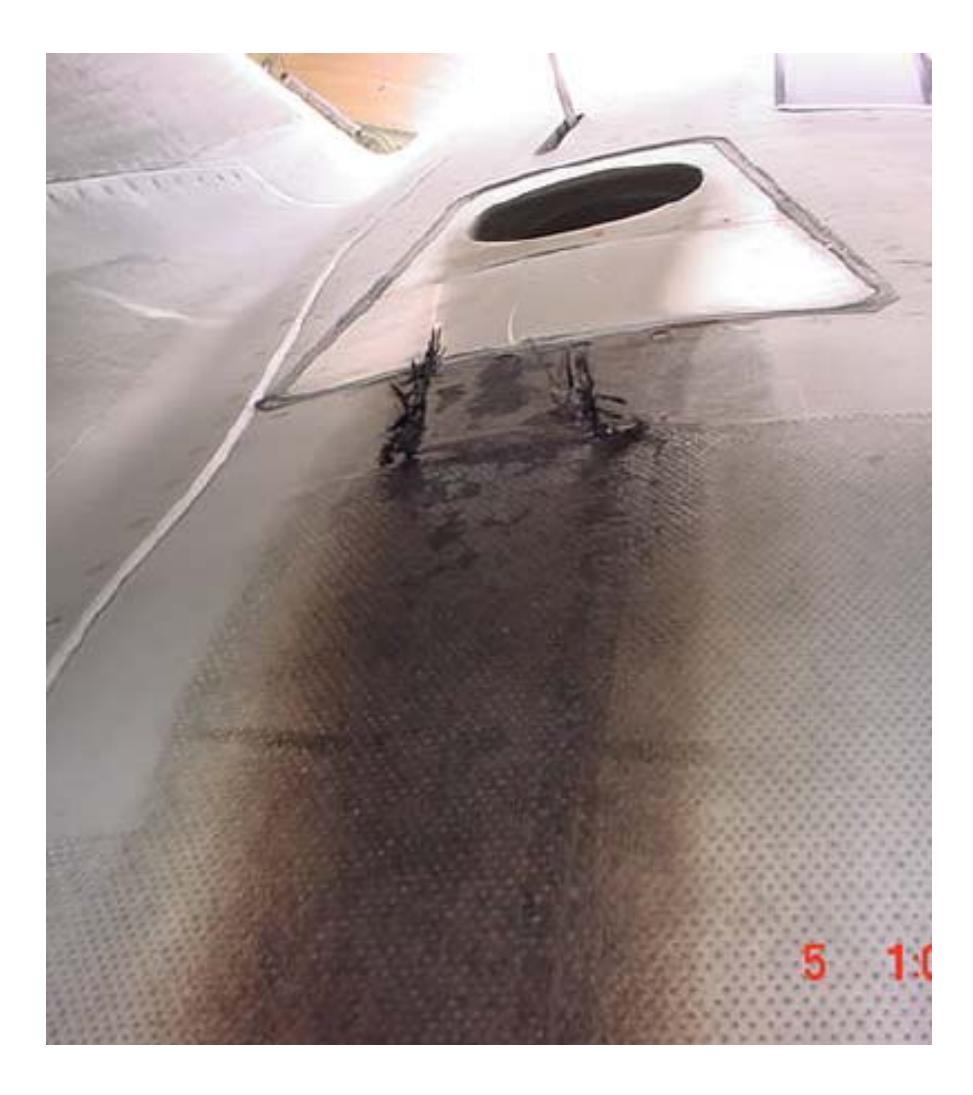
#### **Overheating:**

- Engine cowls
  - Abnormal heat due to failed valves in open-position, or boroscope plug left out
  - Heat from to bleed air exhaust
  - Heat from due to failed valves in open position
