# Cobonding Primary Structure – Processing Issues and Related Tests

# **Cobonding Primary Structure – Processing Issues and Related Tests**

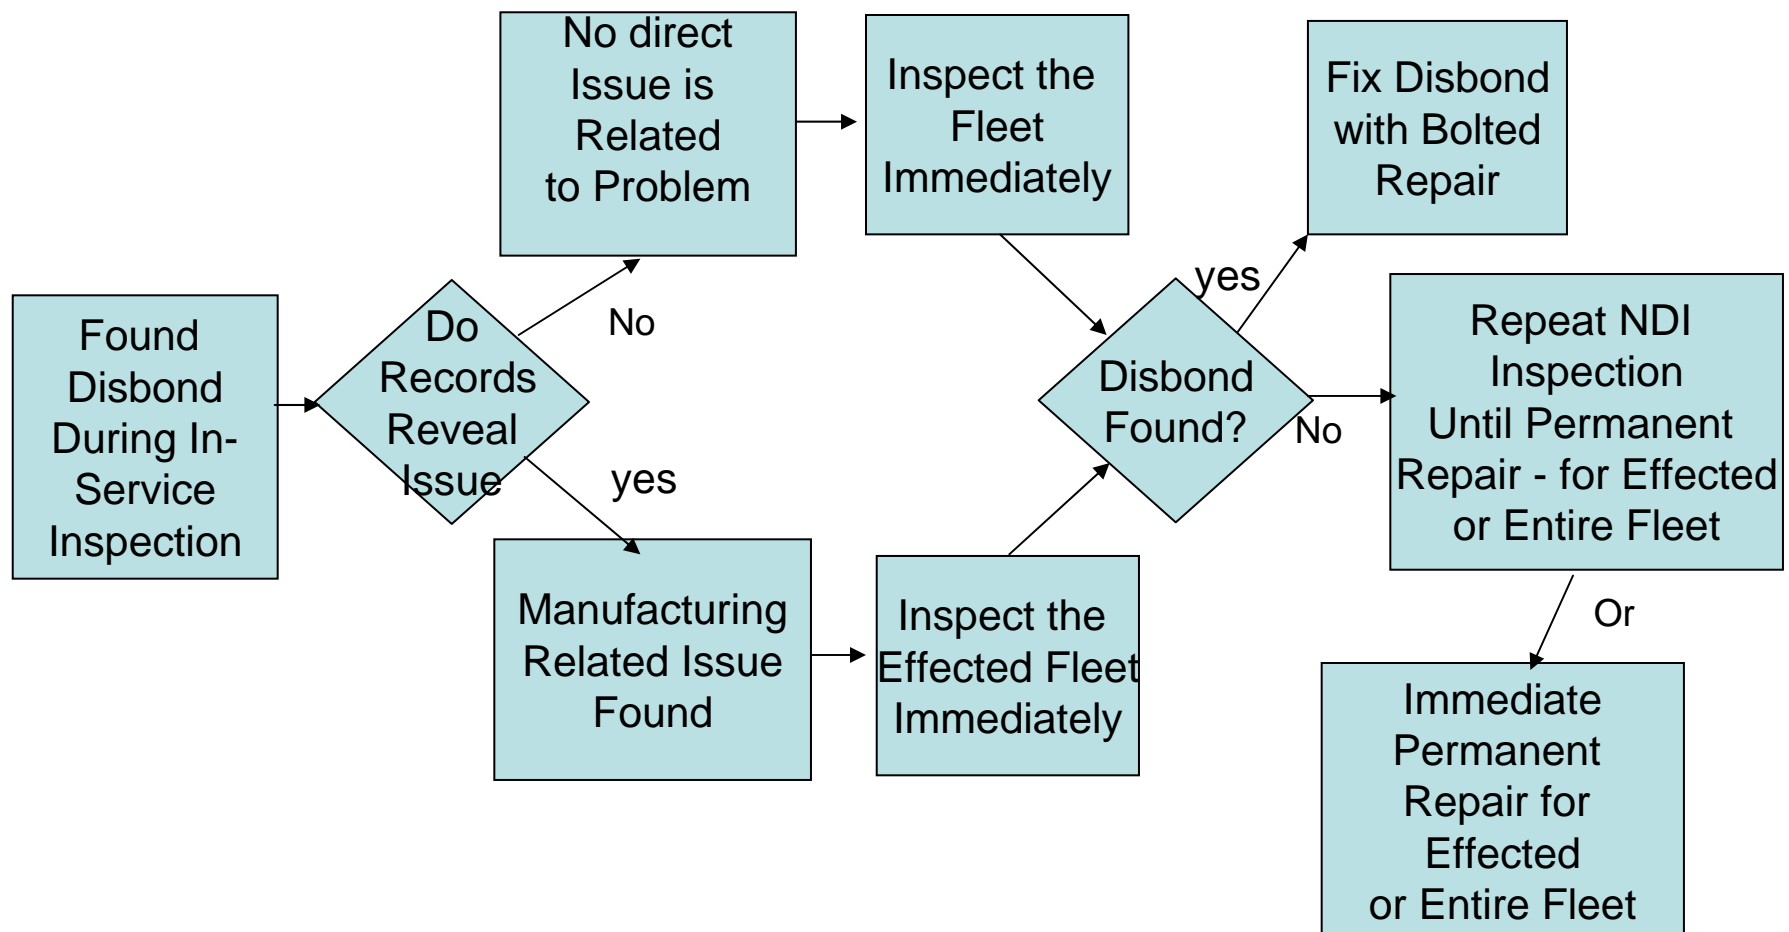
## *What Happens When a Bondline Fails In-Service*

- No current inspection available to find weak bondlines
- It is not acceptable to repair areas of high peel only
- This is an overall durability issue
- All effected or *possibly* effected bondlines must be repaired or repeatably inspected until a permanent can be done
- Instrumental NDI required for inspections

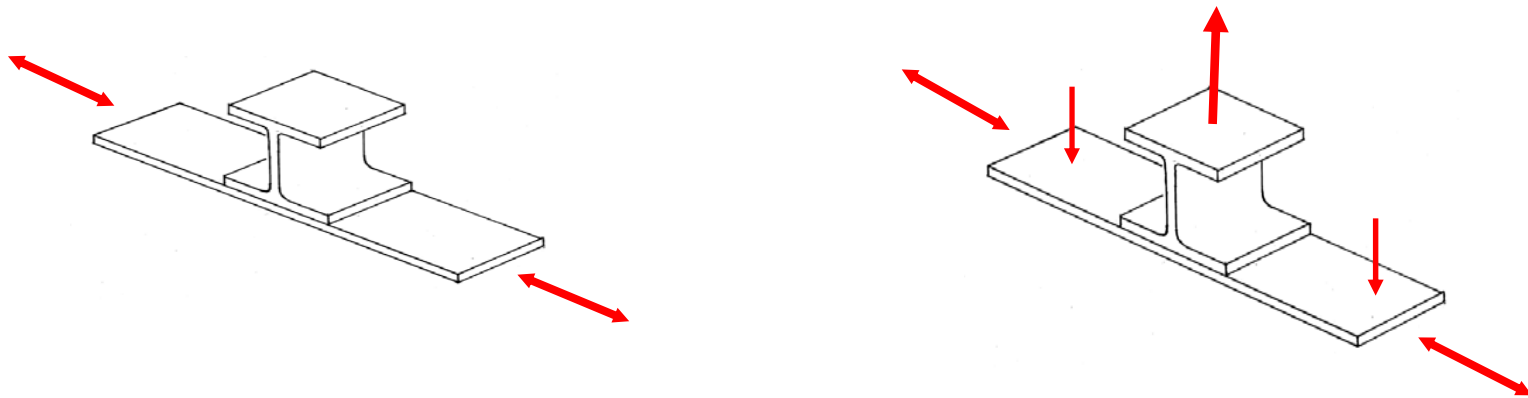
- Transverse load and transverse load with pulloff
- Tested with and without process defects
- Understand the effect of bow waves and combined loads on the analysis method
- Various geometries, support widths and environments – some fatigue
