Staying Ahead Of The Game: Keeping a Composite Airplane Fleet Airworthy

Cirrus Design Corporation

What is a Cirrus airplane?

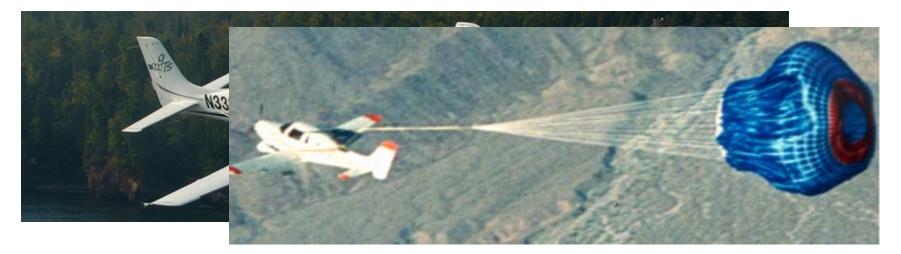
- Certified FAR 23 Normal in 1998
- 4 place single engine, 3000 3400 MTOW
- Two models 200 or 310 horsepower, unpressurized
- S- and E-glass/Epoxy primary structure
- Paste Adhesive bonded primary structure
- Cirrus Aircraft Parachute Recovery System

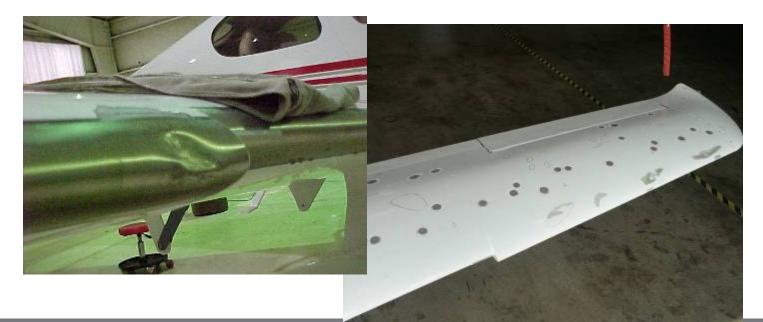
- In the field:
 - Tolerant of damage detected and repaired by defined maintenance
 - For limited amounts of time up to limit load

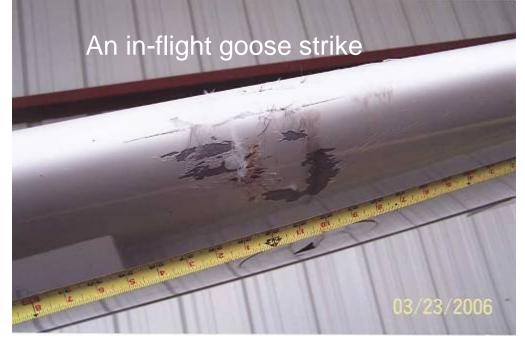
- Tolerant of a damage event the pilot is aware of
- For "fly home" loads for the completion of the flight

... or a parachute deployment

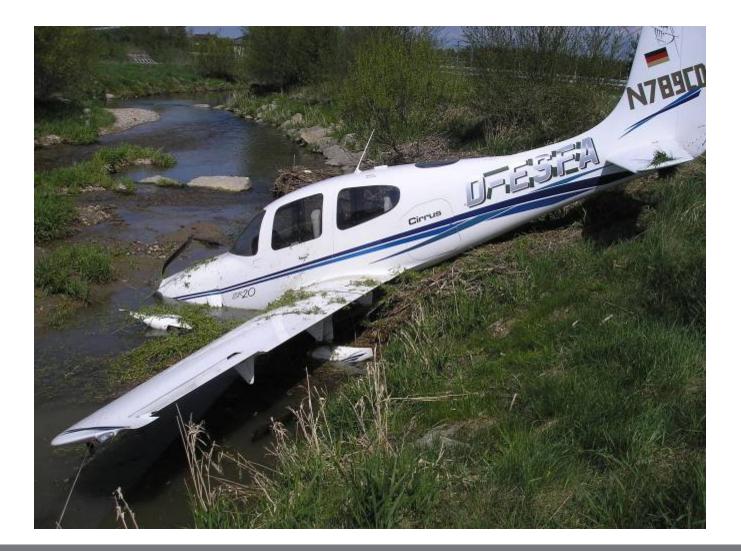
Repair Example

- Cut three glass-fiber repair plies at ±45°. (Refer to 51-20)
- (o) Mix MGS L418-based structural resin. (Refer to 51-30)
- (p) Layup glass fabric repair plies. (Refer to 51-20)
- (q) Cure repair plies. (Refer to 51-20)
- Serials 0821 & subs: Install Expanded Metal Mesh (EMM) lightning protection. (Refer to 51-20)
- (s) Match drill hinge installation holes covered by glass fabric repair layup.
- (t) Match drill aft tie down installation hole covered by glass fabric repair layup.
- (u) Using 0.75 inch (19.05 mm) hole saw, cut aft tie down installation hole through skin and centered on BL0.
- (v) Serials 0821 thru 1153: From aft tangent of tie down installation hole to aft edge of empennage skin, cut a 0.18 inch (4.57 mm) wide slot centered on BL0.
- (w) Prepare the surface for primer and paint. (Refer to 51-20)
- (x) Paint repair area. (Refer to 51-20)

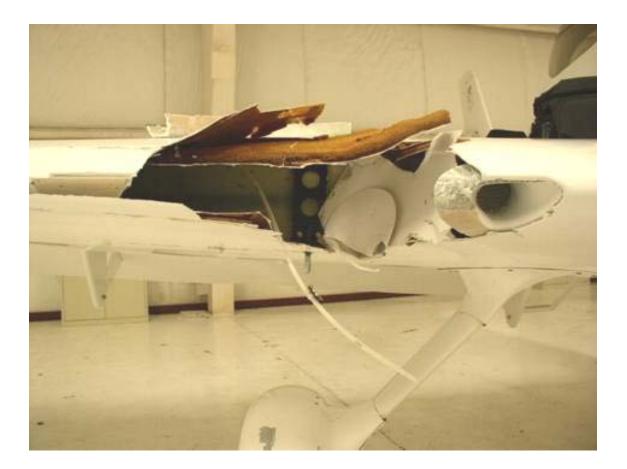
Another Repair Example

• An Atypically Large LE Repair – Deer Strike

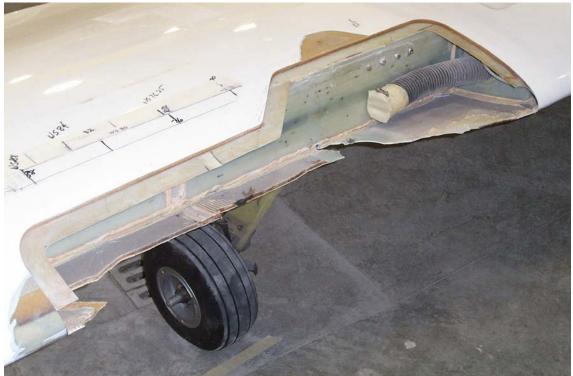
Another Repair Example

- Remove damage
- Inspect for other damage/disbonds
- Prepare for repair installation
