GLARE[®] and Bonded Repairs Friday May 11th 2007

Stork Fokker AESP B.V.

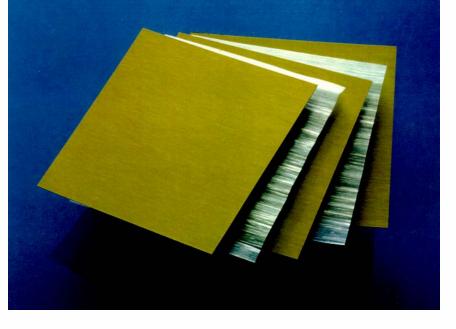
GLARE is a hybrid material built-up from alternating layers of aluminium and glass fibre reinforced metal adhesive

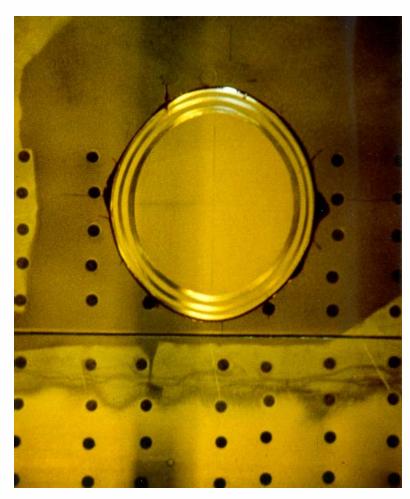
GLARE[®] repairs patches (cont'd)

- Status:
 - No skin crack extension
 - No debonding
 - No damage to GLARE patch

- Material: Two GLARE 2-3/2-0.2 repairs installed October 1995
- Design: Patch bonded over a fuselage longitudinal butt-joint with AF 163-2M
- Due to the poor fatigue performance of the aluminium 7079-T6 skin, significant fatigue damage did occur. When riveted aluminium patches were used, new cracks typically nucleate in the skin at the corners of the patches, leading to ever larger repairs.
- Status:
 - No skin crack extension
 - No debonding
 - No damage to GLARE patch

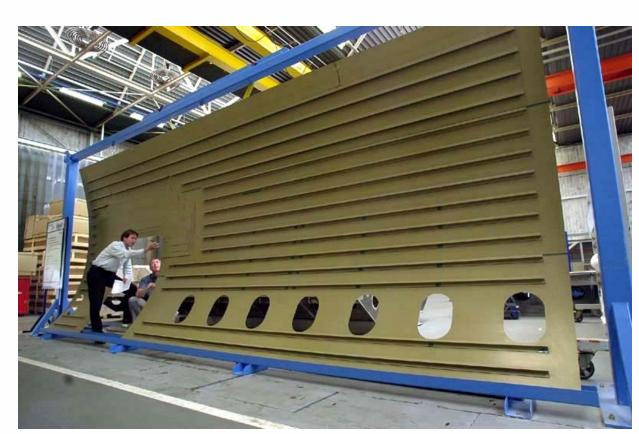
- Larger panels:
 - Easier Assembly
 - Less joints

Dimensions: 3.5 x 11 meters (10x33ft)

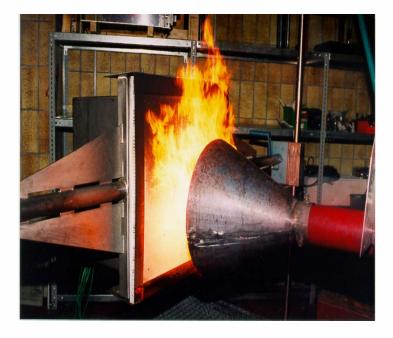
Fire resistance

- GLARE shows excellent fire resistance behaviour
 - fire wall tests: 15 minutes minimum at 1100°C
 - No flame penetration
 - Exposed aluminium layer melts
 - Epoxy around glass fibres carbonizes and protect remaining aluminium layers.
 - Backside temperature reduced by more than half due to isolating effect of delaminated glass fibre layers
