**CIRRUS SR22 General Inspection & Maintenance  
July 2005 - Morocco**

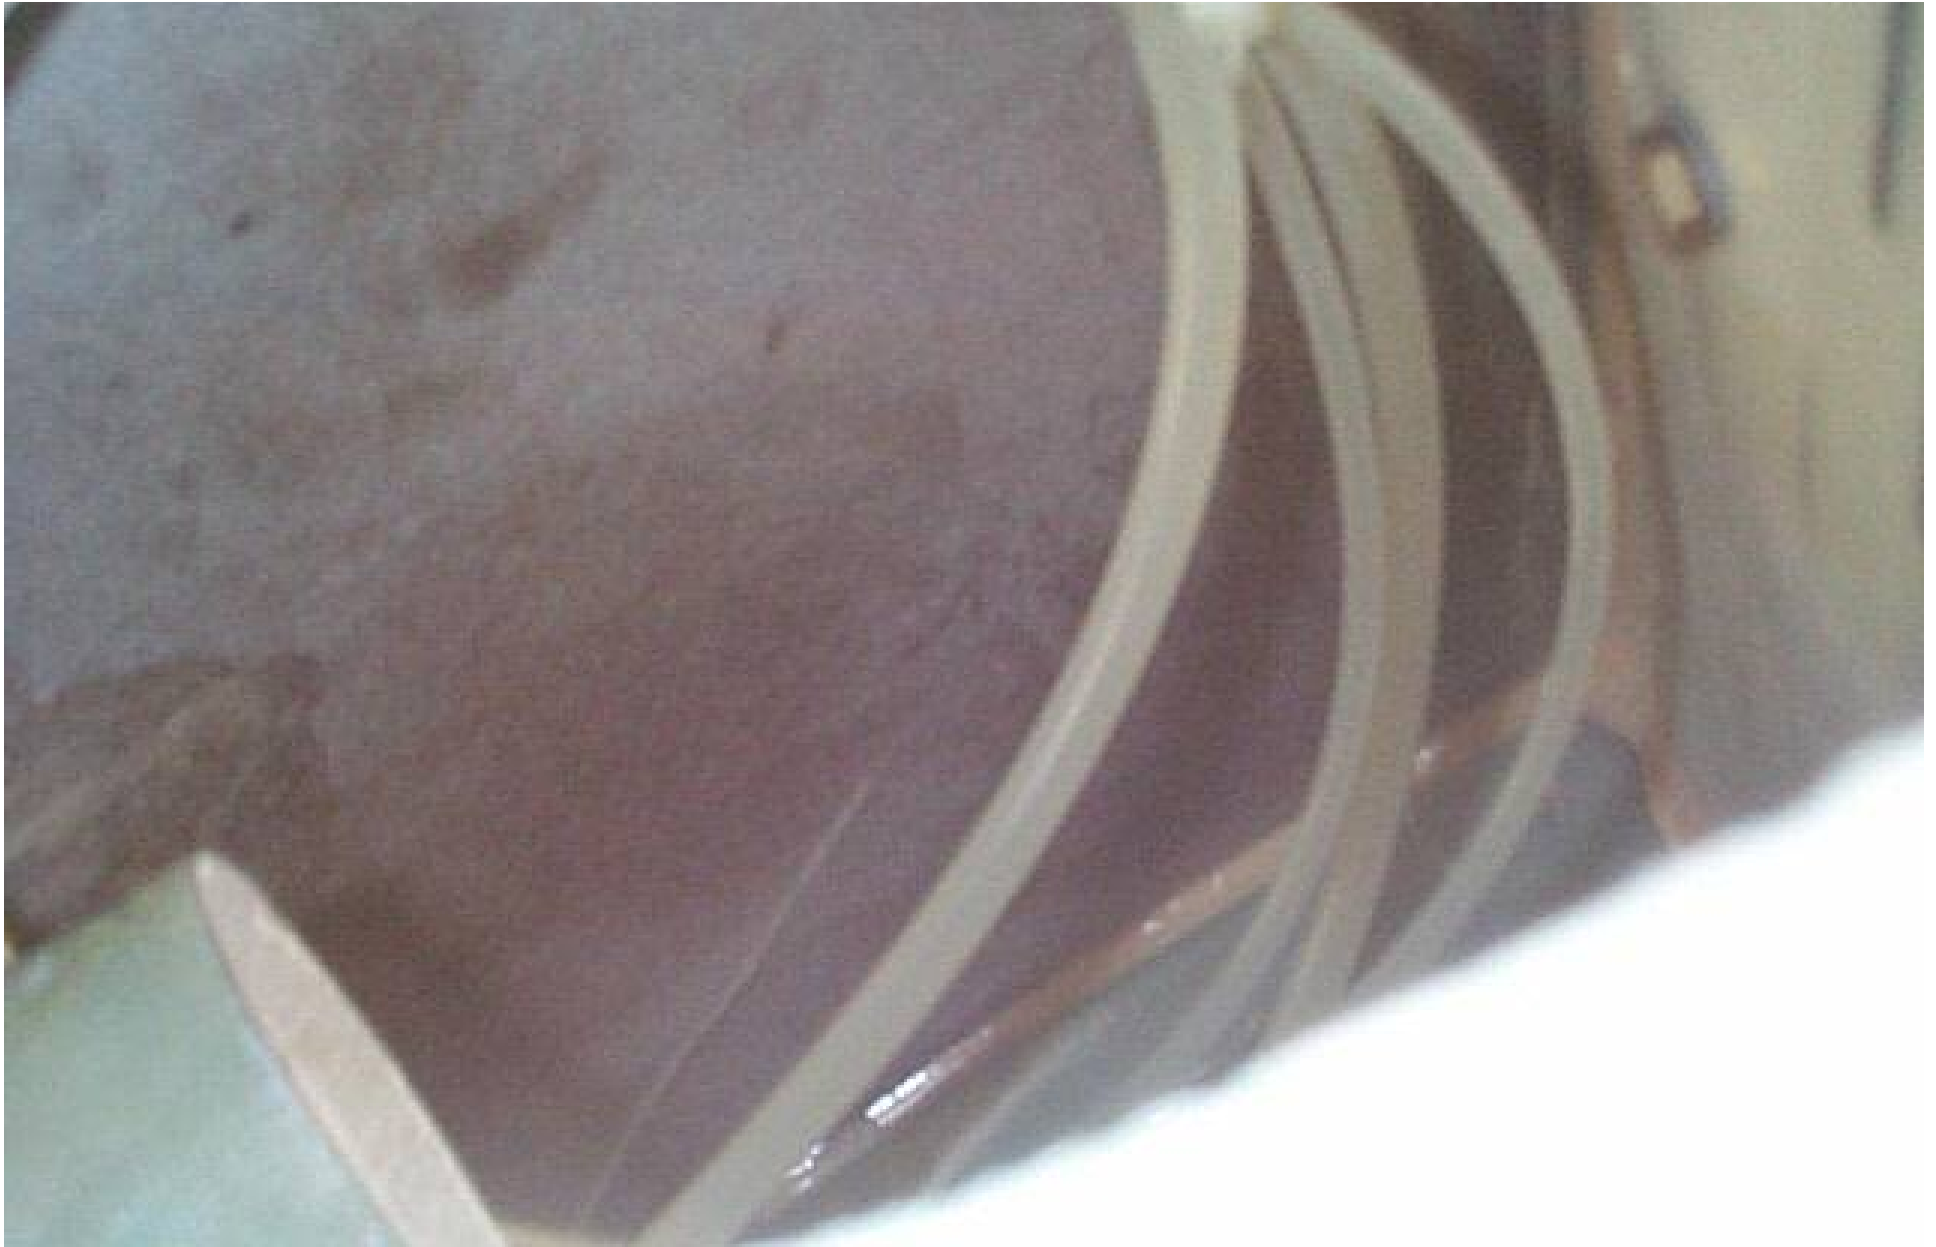
- 3.0 CUT OUT AN AREA OF THE BAGSIDE PLYS OF THE UPPER SKIN TO ACCESS RIB, W.S 41 AS WELL AS THE AREA OF DELAM OVER THE SOLID LAMINATE.
  - A. MAINTAIN A MINIMUM RADIUS OF 1.0" ON ALL CORNERS.
  - B. KEEP CUTOUT A MINIMUM OF 2.0" FROM DAMAGE TO LEAVE ADEQUATE SPACE FOR REPAIR PLY OVERLAP.

REPAIR INSTRUCTIONS (CONTINUED):
