Lufthansa Technik

**Lufthansa Perspective on Applications &
Field Experiences for Composite
Airframe Structures**

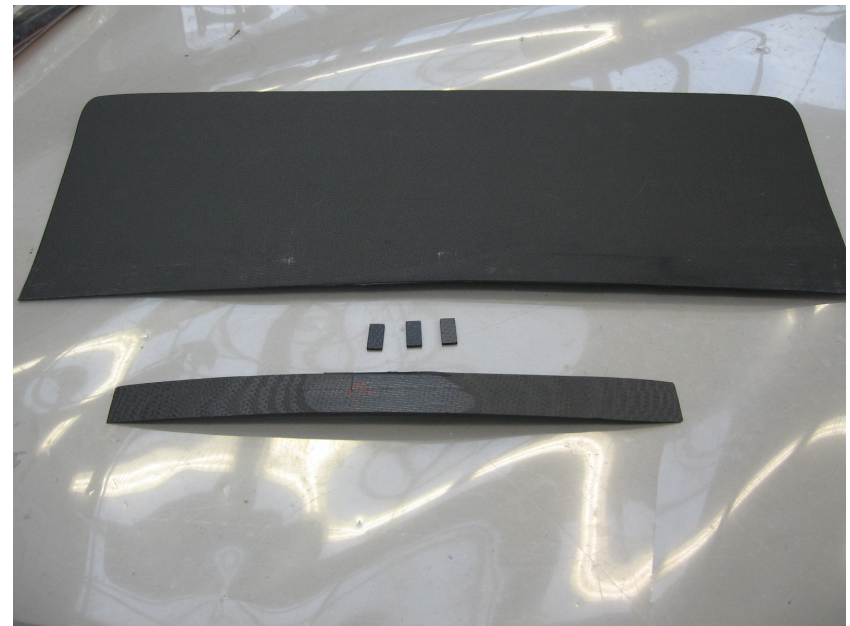
Fillers & Coupons after autoclave curing and reworking
