Lessons Learned from CACRC Depot Bonded Repair Round Robin Investigation

Dr. John Tomblin and Dr. Lamia Salah
NIAR/ WSU

September 15th, 2015

CACRC Depot Bonded Repair Investigation

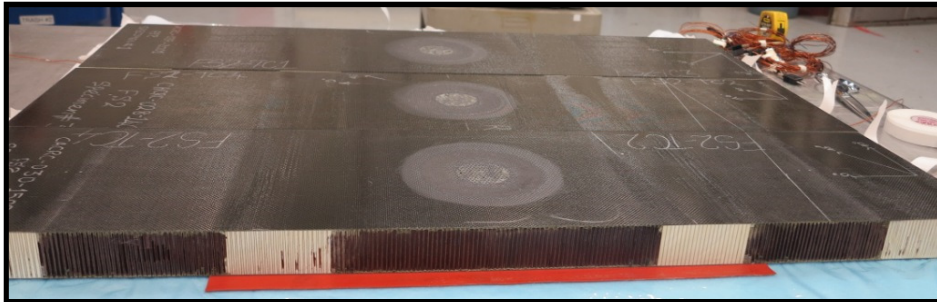
Scarfed Elements prepared for drying

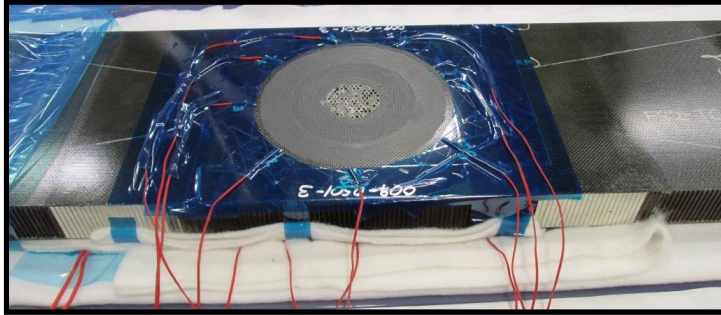
Scarfed panel ready for repair
